# Waukon Municipal Airport

## Pavement Management Report

**AUGUST 2025**

# WAUKON MUNICIPAL AIRPORT PAVEMENT MANAGEMENT REPORT

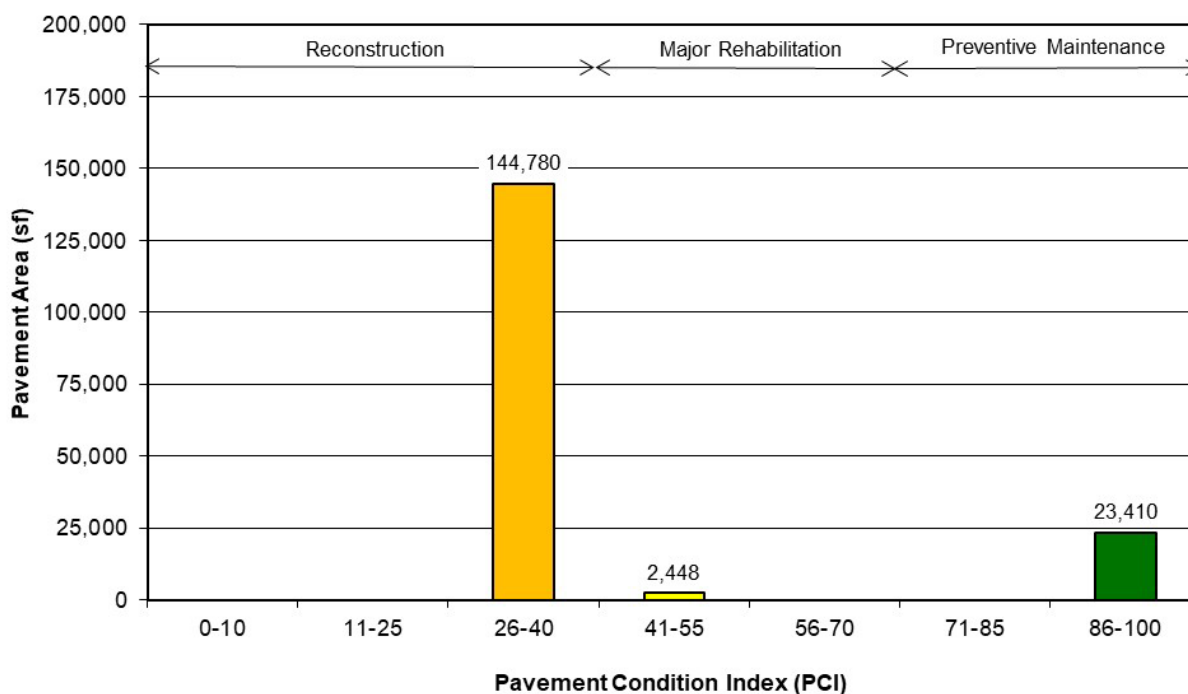
Figure 6. Pavement area by PCI range at Waukon Municipal Airport.

The pavements at Waukon Municipal Airport were inspected in March 2025. The 2025 area-weighted condition of Waukon Municipal Airport is 42, with conditions ranging from 35 to 88 (on a scale of 0 [failed] to 100 [excellent]). During the previous pavement inspection in 2018, the area-weighted PCI of the airport was 43.
