Waverly Municipal Airport

Pavement Management Report

JULY 2023

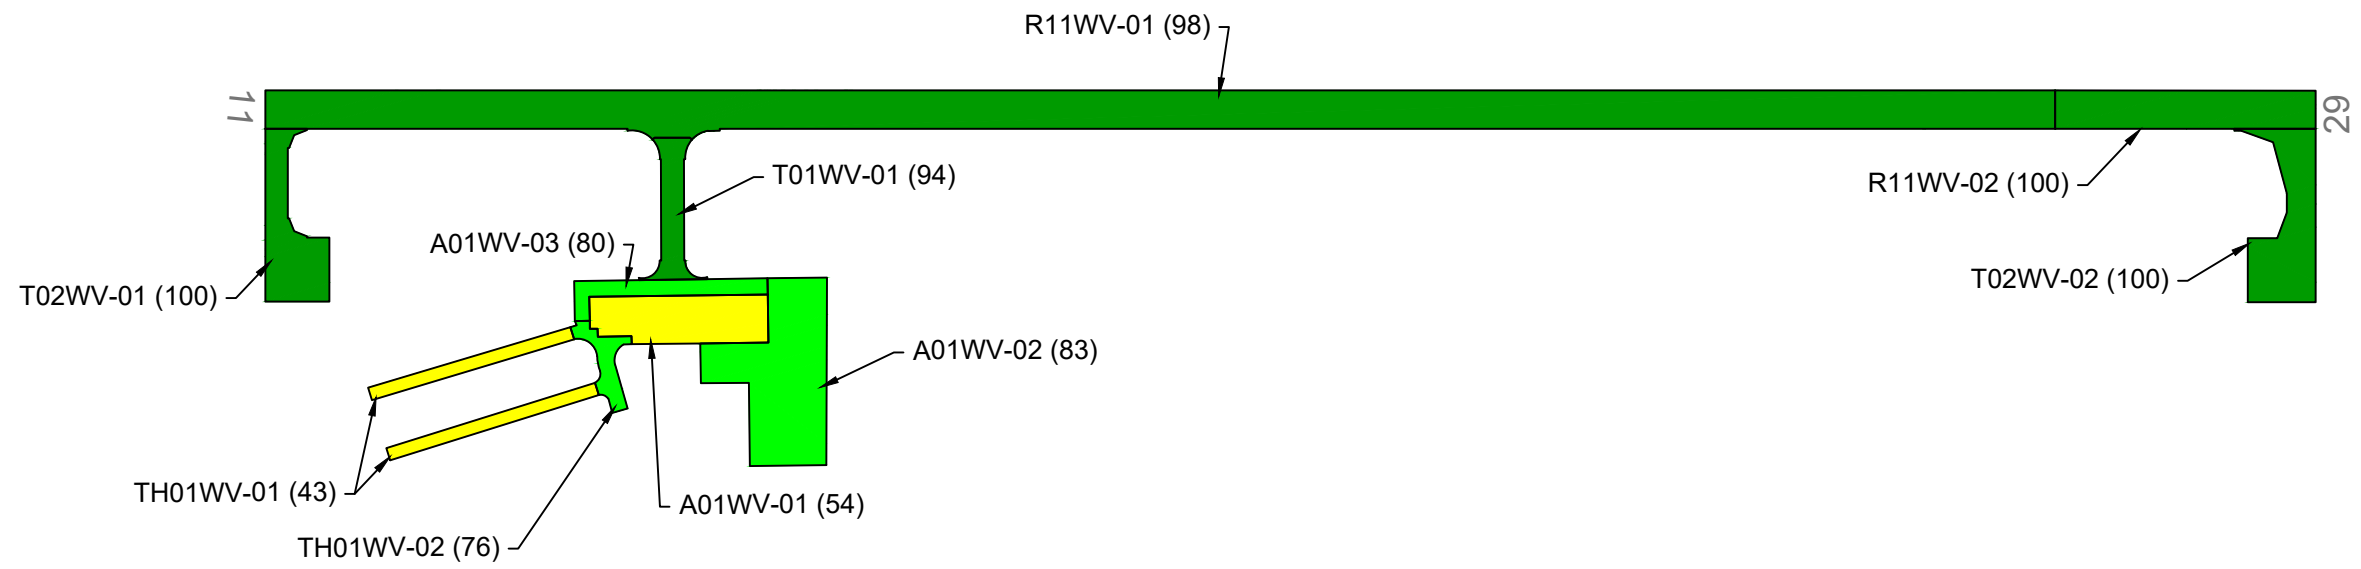
FIGURE 8. PCI MAP.

The pavements at Waverly Municipal Airport were inspected in November 2022. The 2022 area-weighted condition of Waverly Municipal Airport is 91, with conditions ranging from 43 to 100 (on a scale of 0 [failed] to 100 [excellent]). During the previous pavement inspection in 2019, the area-weighted PCI of the airport was 69.

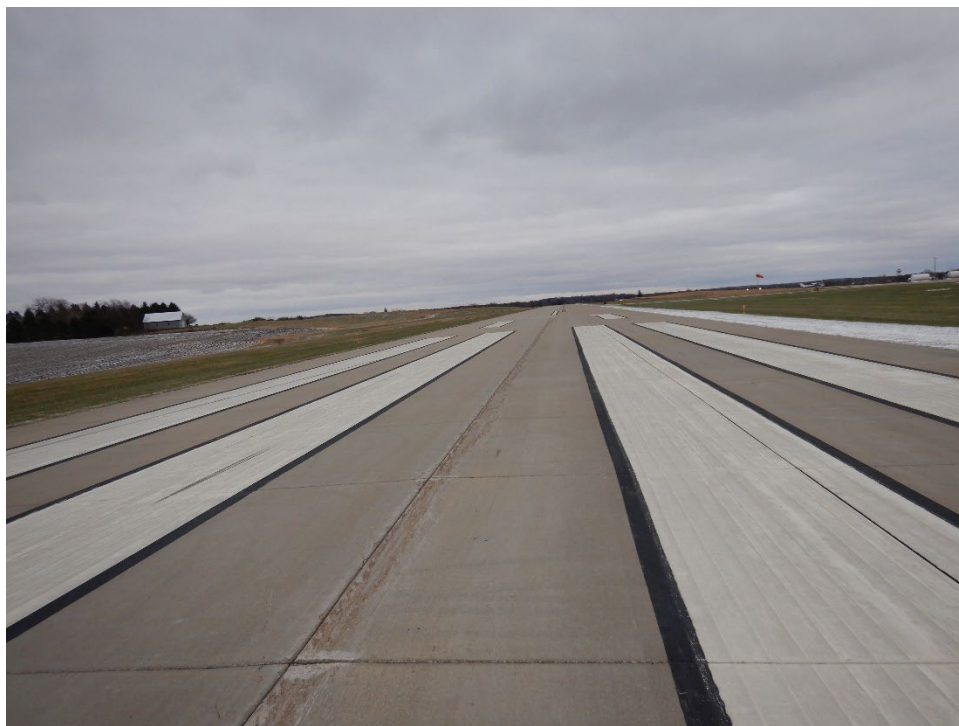
R11WV-01. Overview.

Runway 11/29 contained two sections. Section 01 was in excellent condition with only areas of low-severity faulting recorded. Section 02 was also in excellent condition with no distress observed at the time of inspection.

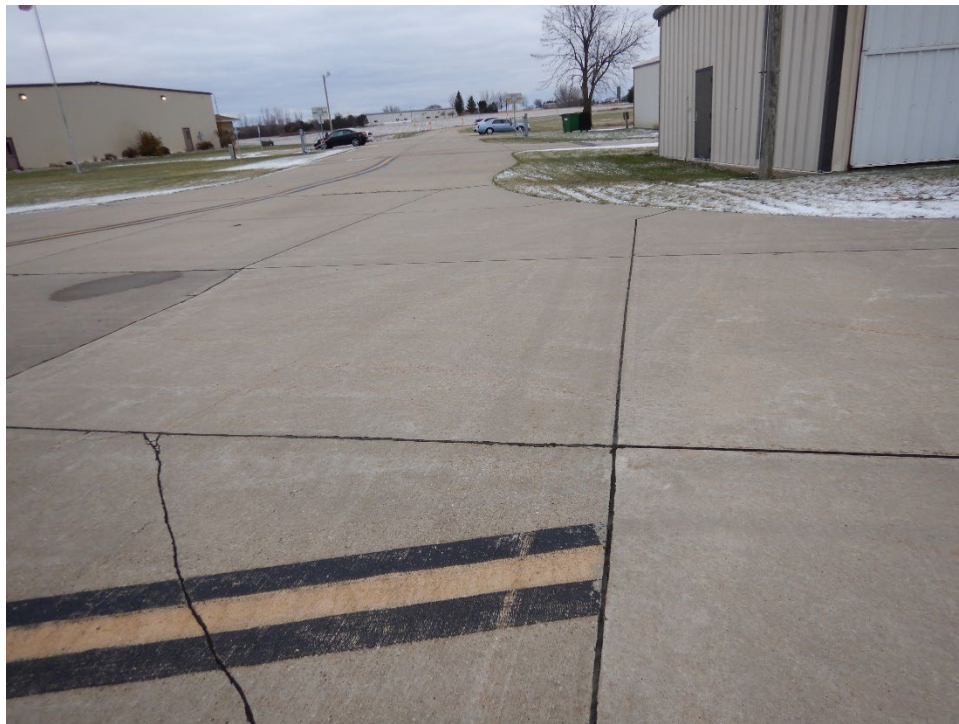
TH01WV-02. Overview.

TH01WV	02	PCC	4,938	1/1/2012	76	40	39	21	Corner Break, Corner Spalling, Durability Cracking, Joint Spalling, Joint Seal Damage, LTD Cracking, Small Patch
