# Waverly Municipal Airport

## Pavement Management Report

**AUGUST 2026**

# WAVERLY MUNICIPAL AIRPORT PAVEMENT MANAGEMENT REPORT

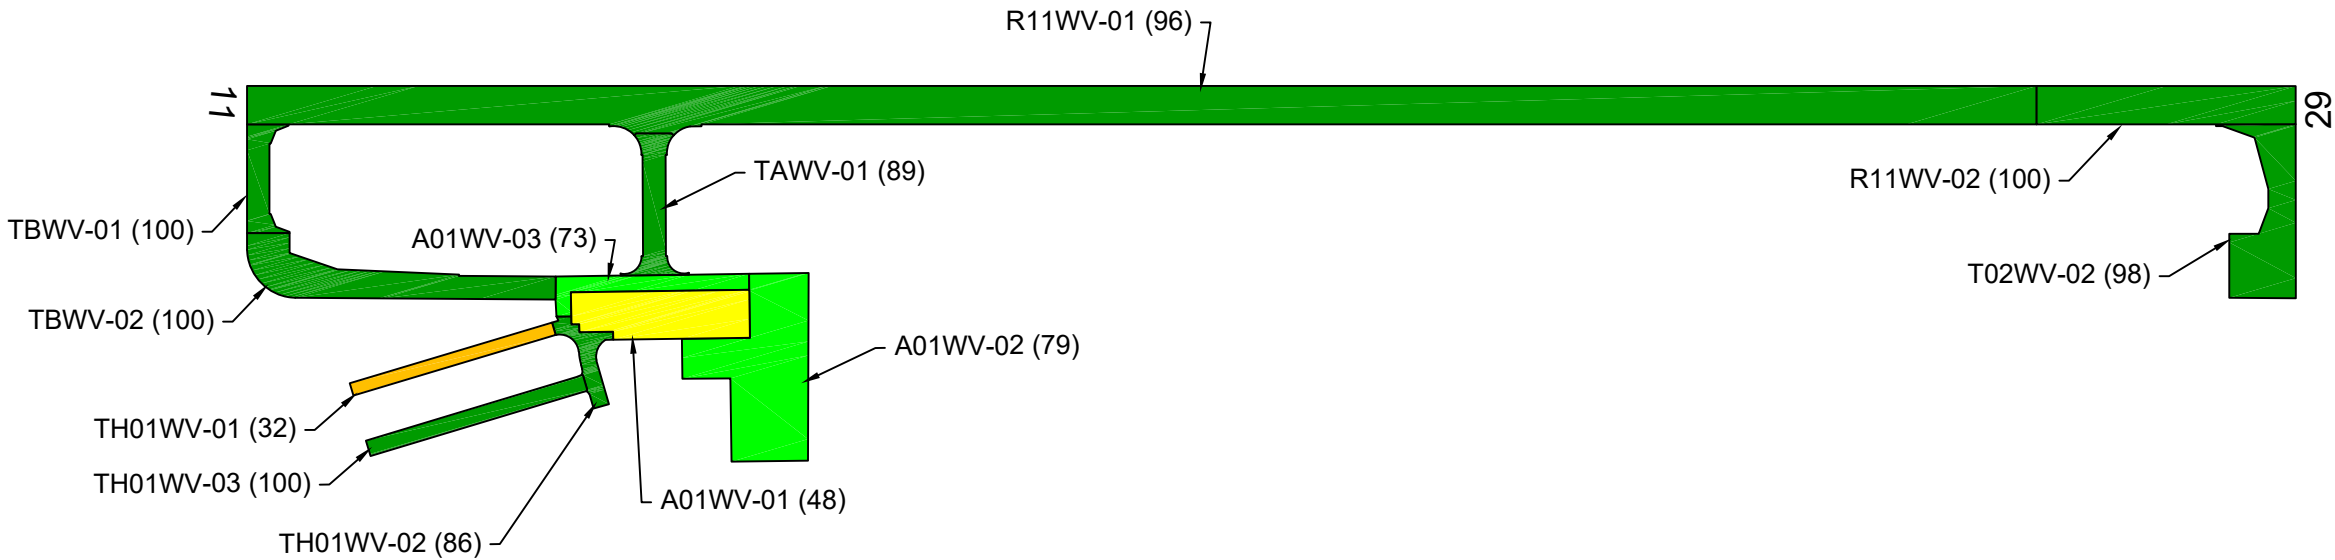
FIGURE 8. PCI MAP.

The pavements at Waverly Municipal Airport were inspected in February 2026. The 2026 area-weighted condition of Waverly Municipal Airport is 90, with conditions ranging from 32 to 100 (on a scale of 0 [*Failed*] to 100 [*Excellent*]). During the previous pavement inspection in 2022, the area-weighted PCI of the airport was 91.

Figure 6 summarizes the overall condition of the pavements at Waverly Municipal Airport, and Figure 7 presents area-weighted condition (average PCI adjusted to account for the relative size of the pavement sections) by branch use. Figure 8 is a map that displays the condition of the evaluated pavements. Table 1 summarizes the results of the pavement evaluation. Appendix B presents photographs taken during the PCI inspection, and Appendix C contains detailed information on the distress types observed during the visual survey. Appendix D includes detailed work history information that was collected during the record review process.

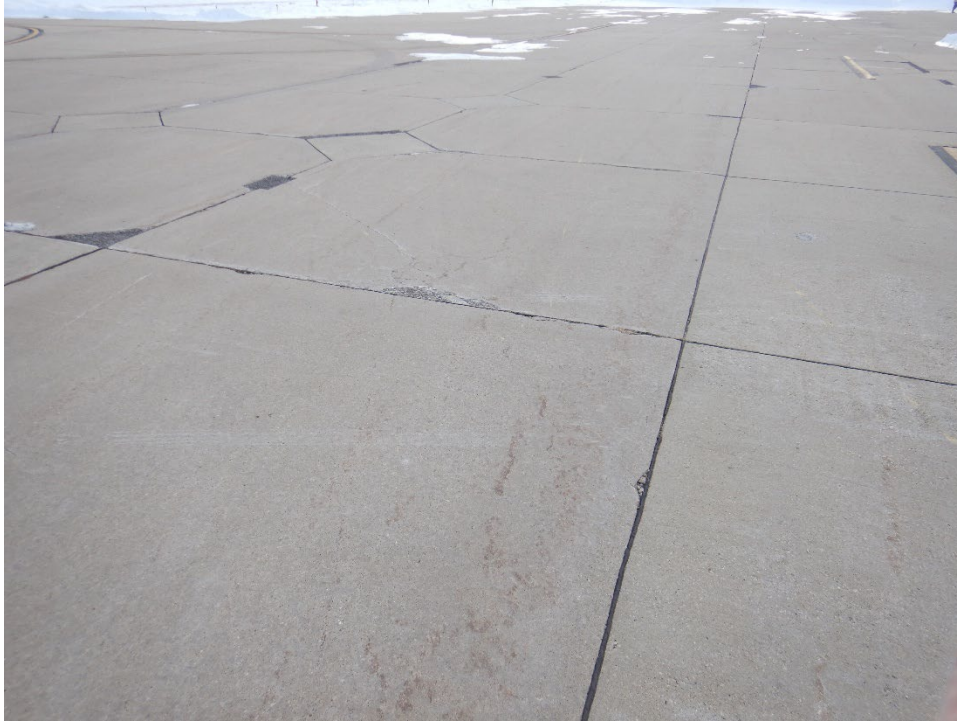
A01WV-01. Overview.

The apron area was defined by three sections. Low-severity faulting and large patching; high-severity joint seal damage; and low- and medium-severity corner spalling, durability cracking, small patching, and longitudinal, transverse, and diagonal (LTD) cracking were observed in Section 01. Section 02 had low- and medium-severity corner spalling and small patching; low-severity faulting, joint spalling, large patching, and LTD cracking; and medium- and high-severity joint seal damage noted during the inspection. Low-severity corner break, corner spalling, and shattered slab; medium-severity joint seal damage; and low- and medium-severity joint spalling, LTD cracking, and small patching were recorded in Section 03.

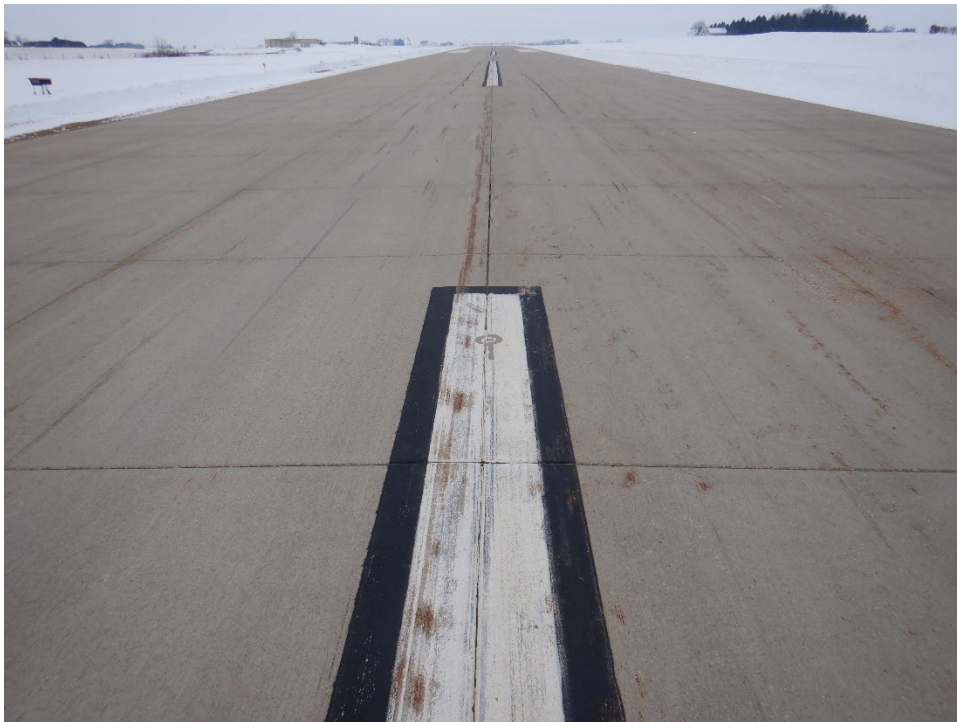
R11WV-01. Overview.

Runway 11/29 consisted of two sections that were both in *Excellent* condition. Section 01 contained only low-severity faulting. Section 02 had no distress observed at the time of inspection.

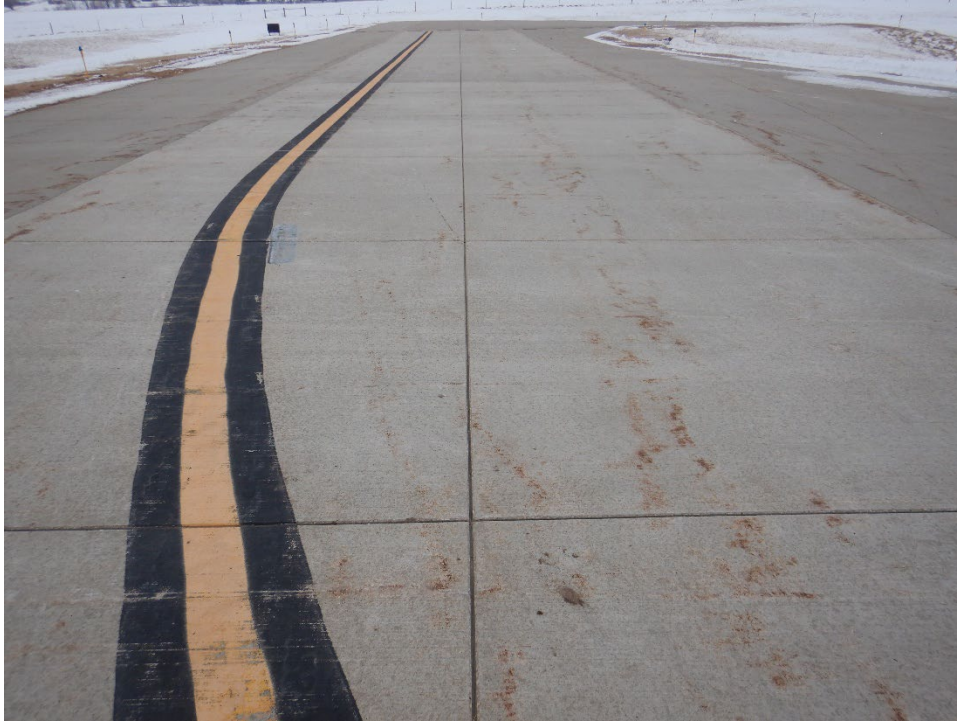
T02WV-02. Overview.

Taxiway 02 contained one section that was in *Excellent* condition. Low-severity faulting and joint spalling were identified in Section 02.

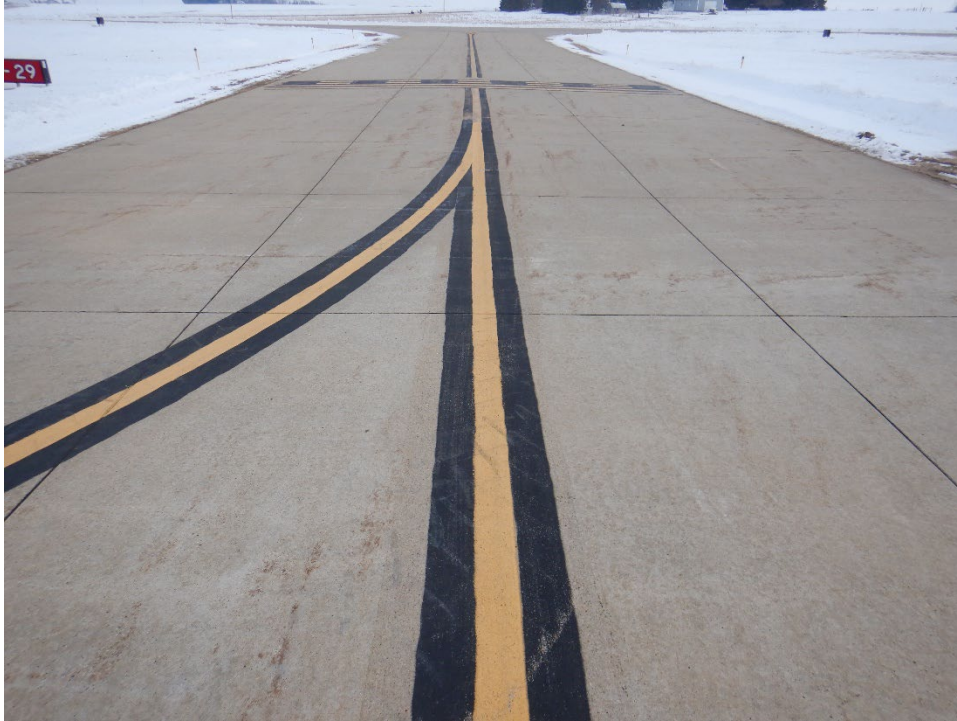
TAWV-01. Overview.

Taxiway A was defined by one section. Section 01 contained areas of medium-severity joint seal damage and low- and medium-severity corner spalling and joint spalling.

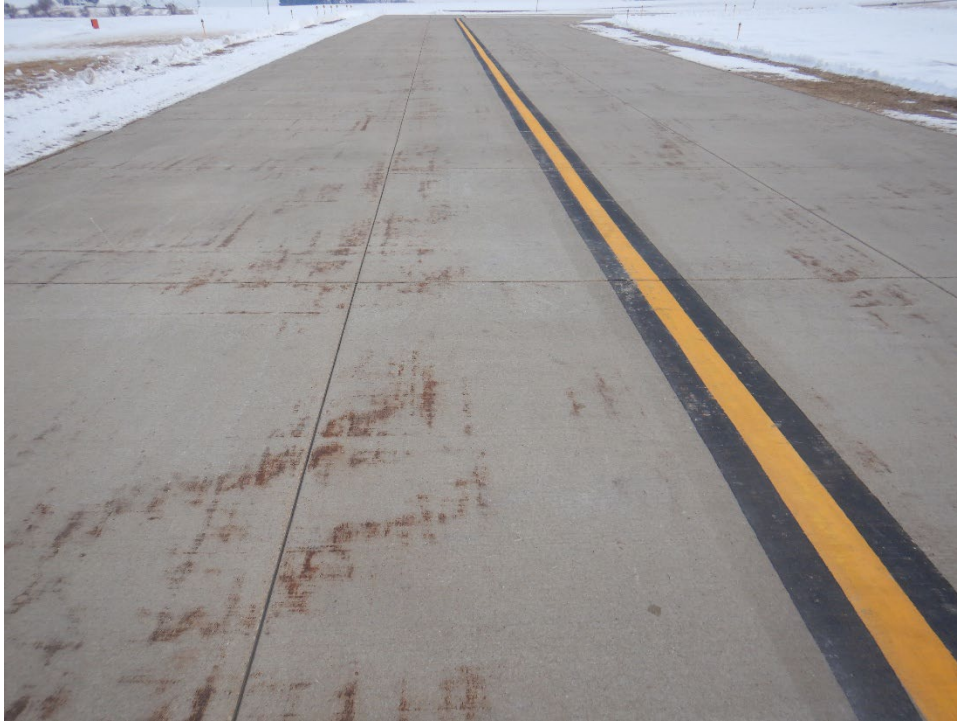
TBWV-01. Overview.

Taxiway B consisted of two sections. Section 01 and 02 were both in *Excellent* condition with no distress noted at the time of inspection.

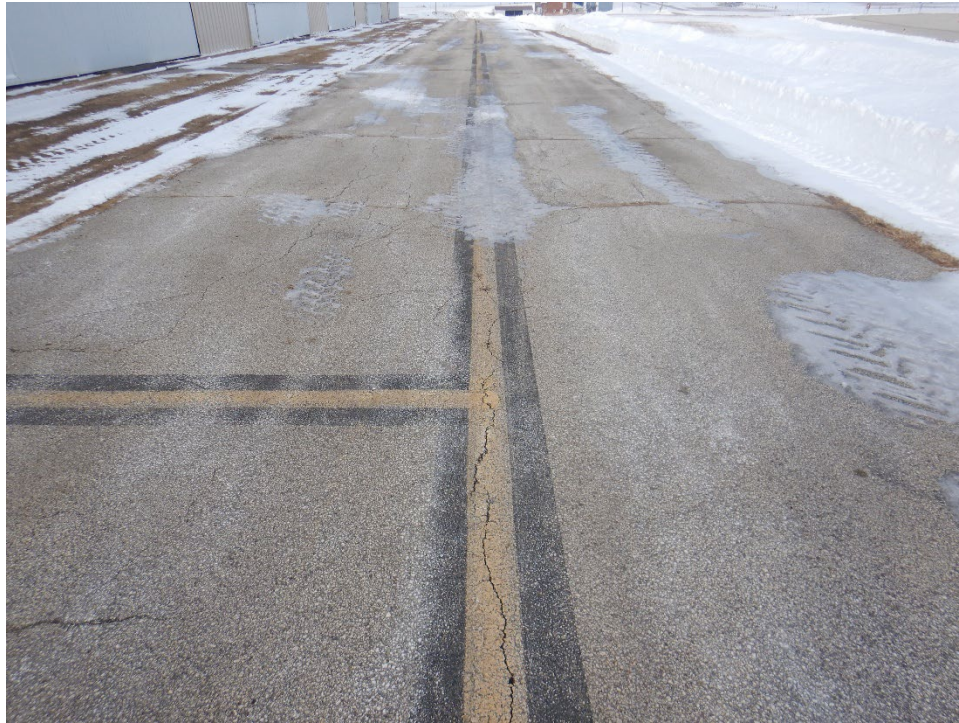
TH01WV-01. Overview.

The T-hangar area consisted of three sections. Section 01 was in *Poor* condition and contained medium-severity alligator cracking and weathering, low- and medium-severity longitudinal and transverse (L&T) cracking, and low-severity rutting. The low-severity L&T cracking was unsealed, and the medium-severity L&T cracking was due to unsealed crack widths greater than ¼ inch. Medium-severity joint seal damage, low- and medium-severity joint spalling, and low-severity LTD cracking were identified in Section 02. Section 03 was in *Excellent* condition with no distress noted at the time of inspection.
