# Webster City Municipal Airport

## Pavement Management Report

**AUGUST 2026**

# WEBSTER CITY MUNICIPAL AIRPORT PAVEMENT MANAGEMENT REPORT

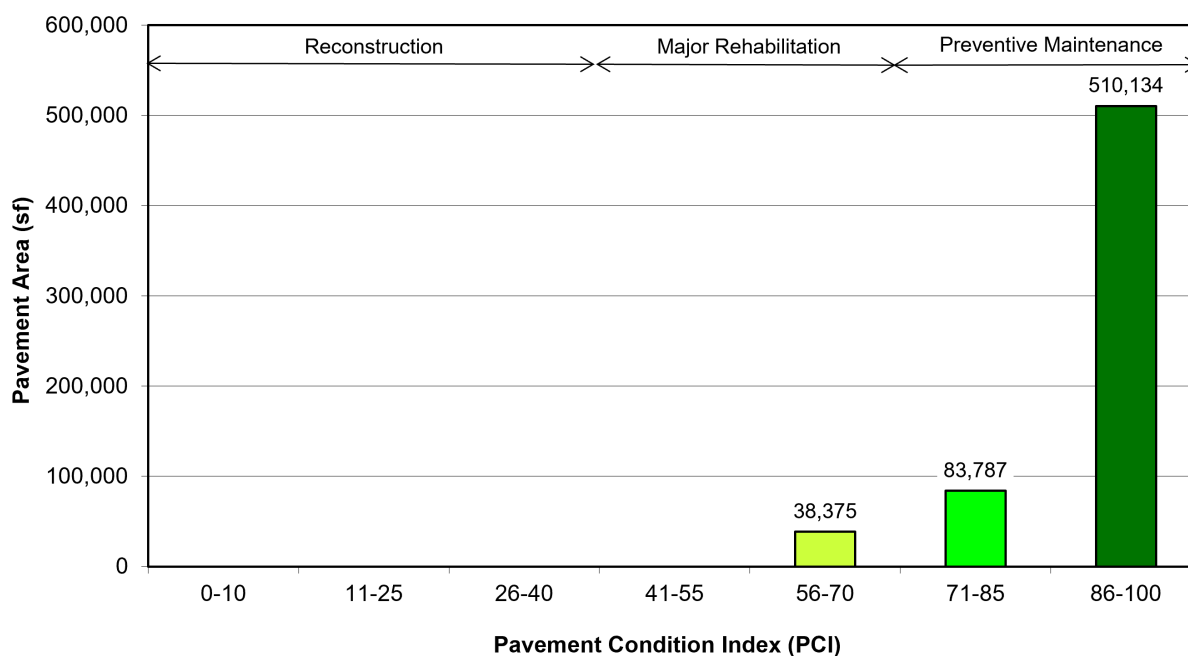
Figure 6. Pavement area by PCI range at Webster City Municipal Airport.

Figure 6 summarizes the overall condition of the pavements at Webster City Municipal Airport, and Figure 7 presents area-weighted condition (average PCI adjusted to account for the relative size of the pavement sections) by branch use. Figure 8 is a map that displays the condition of the evaluated pavements. Table 1 summarizes the results of the pavement evaluation. Appendix B presents photographs taken during the PCI inspection, and Appendix C contains detailed information on the distress types observed during the visual survey. Appendix D includes detailed work history information that was collected during the record review process.

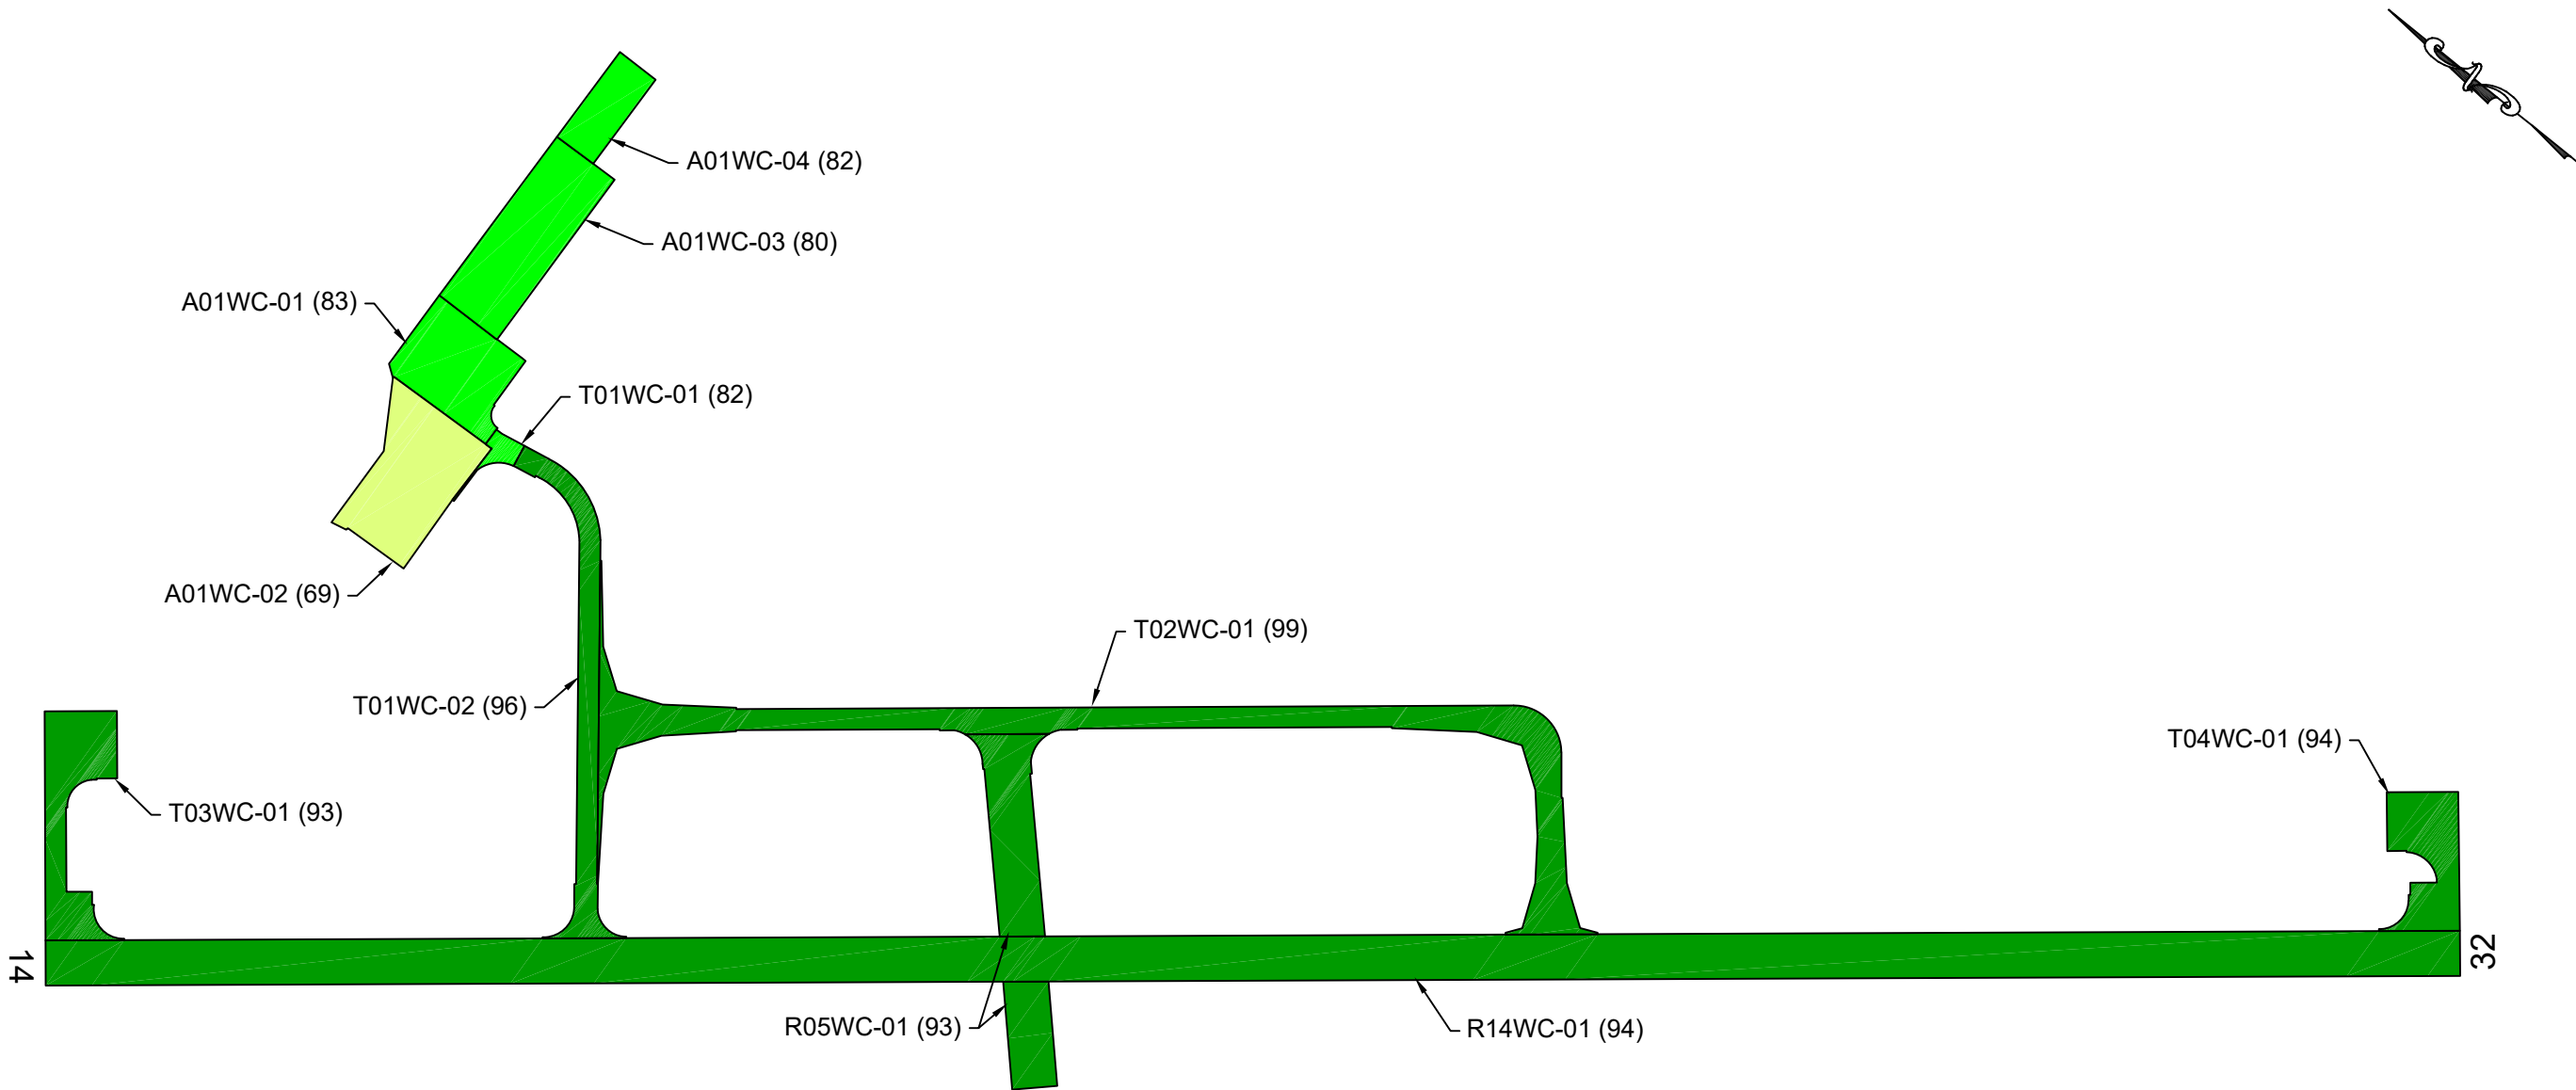
FIGURE 8. PCI MAP.

The pavements at Webster City Municipal Airport were inspected in March 2026. The 2026 area-weighted condition of Webster City Municipal Airport is 91, with conditions ranging from 69 to 99 (on a scale of 0 [Failed] to 100 [Excellent]). During the previous pavement inspection in 2022, the area-weighted PCI of the airport was 95.
