REVISION	1	2022 Edition
	<b>8010.107</b>		
	SHEET 1 of 1		
SUDAS Standard Specifications			
<b>WOOD POST SPAN ASSEMBLY</b>

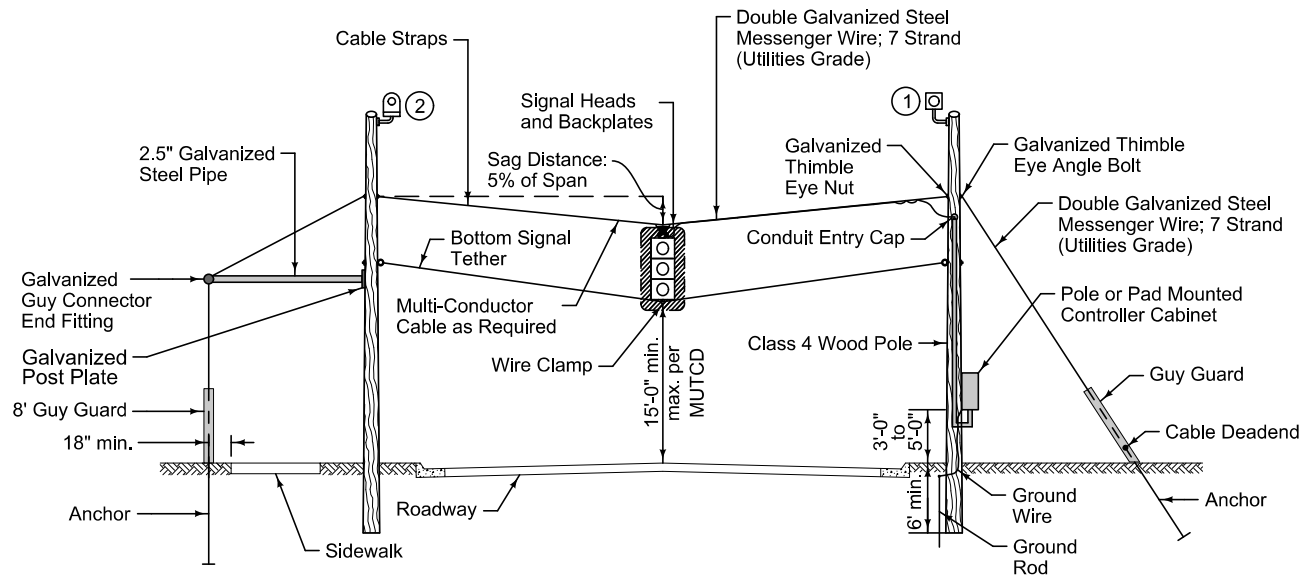
① Possible video camera location.

② Possible EVP detector location.
