# Ames Municipal Airport

## Pavement Management Report

**AUGUST 2026**

# AMES MUNICIPAL AIRPORT PAVEMENT MANAGEMENT REPORT

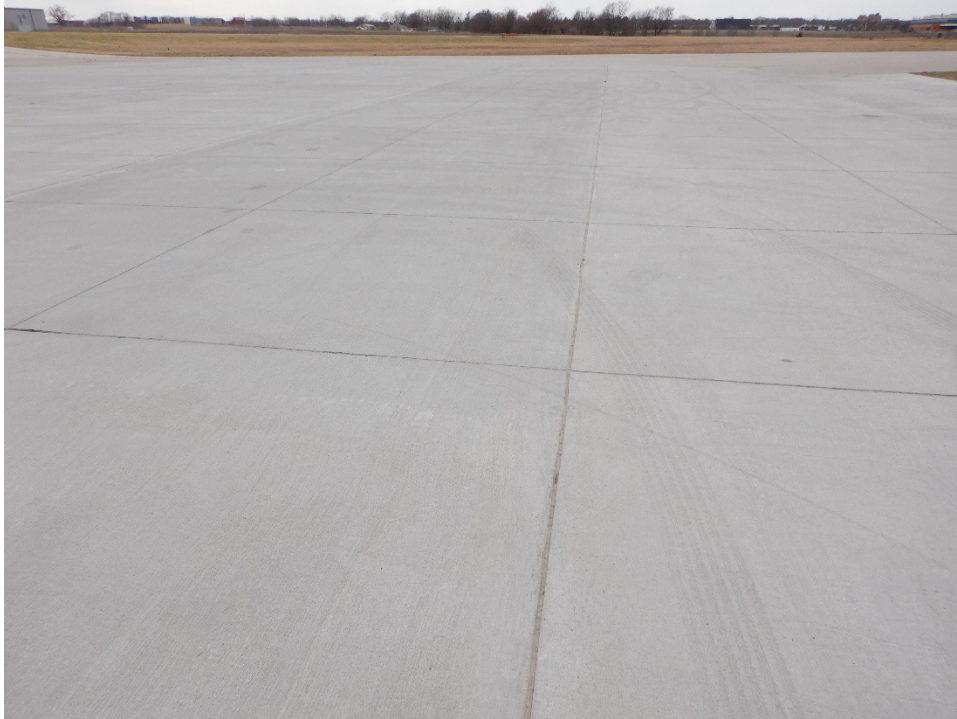
A01AM-01. Overview.

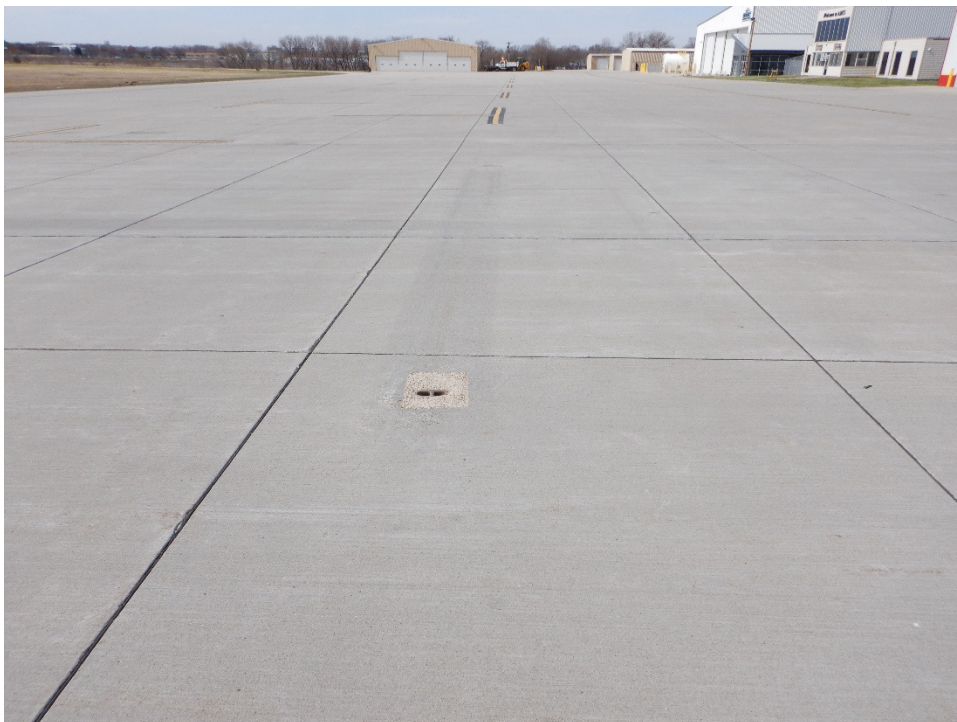
A01AM-02. Overview.

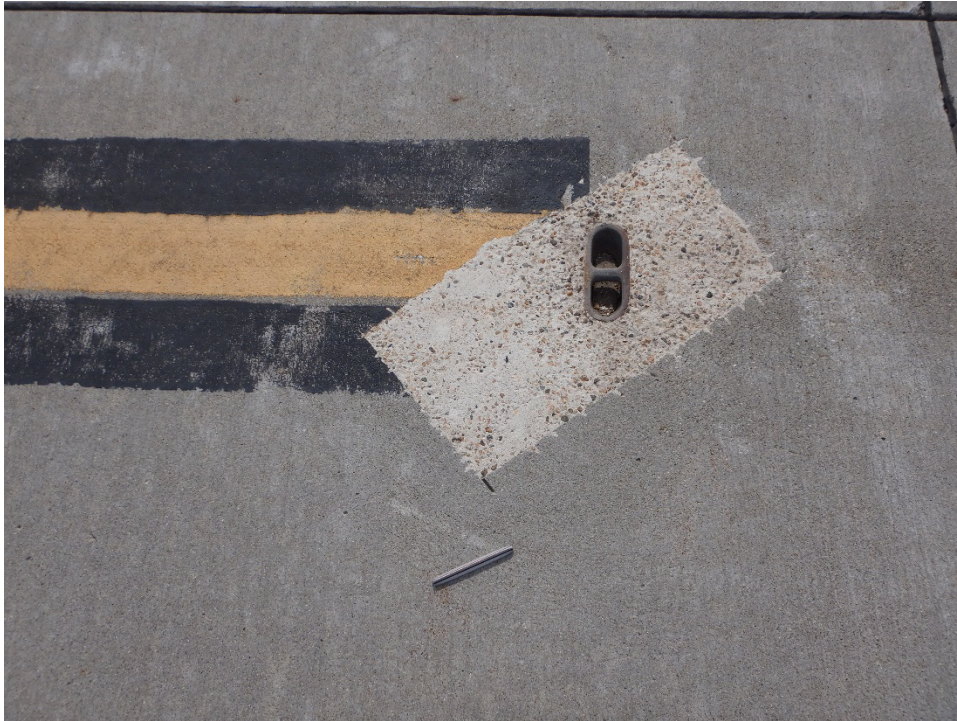
A01AM-02. Small Patching (Sample Unit No. 23).

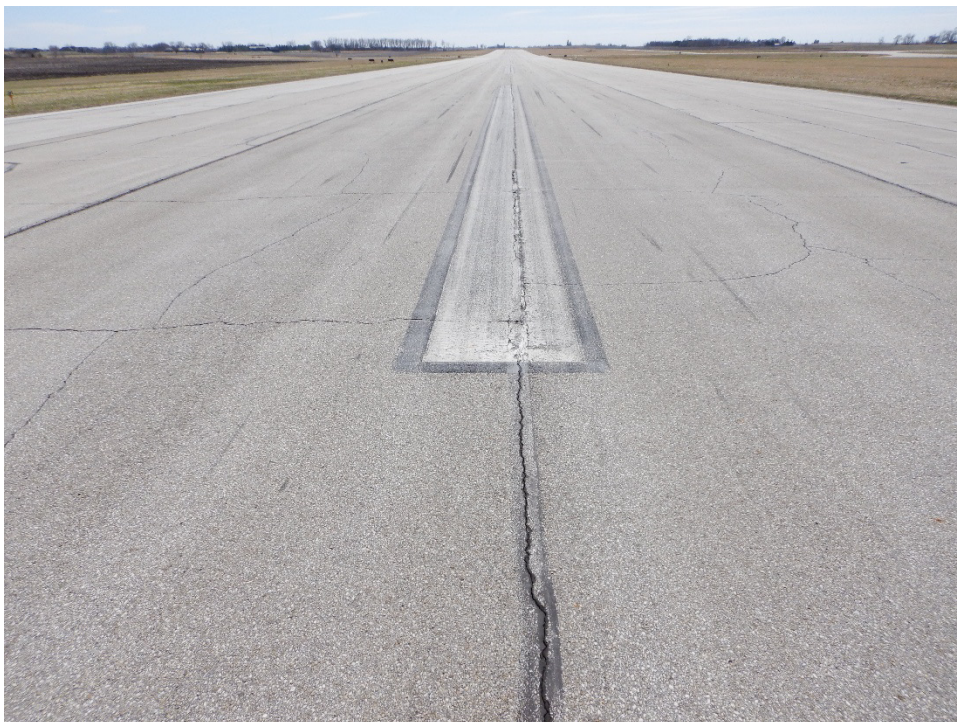
R01AM-01. Overview.

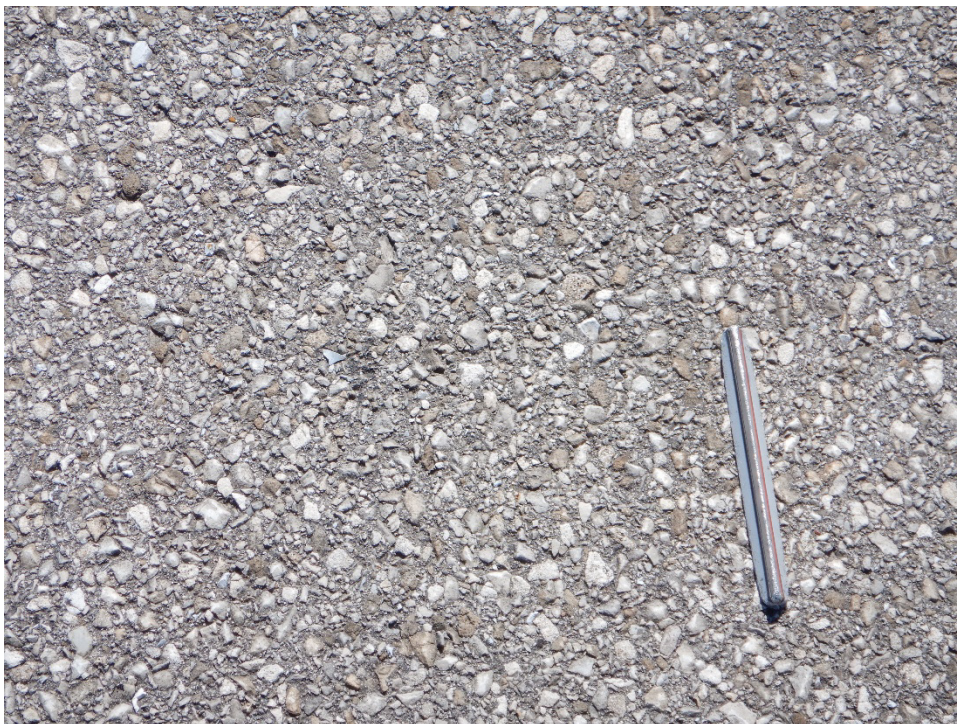
R01AM-01. Weathering (Sample Unit No. 109).

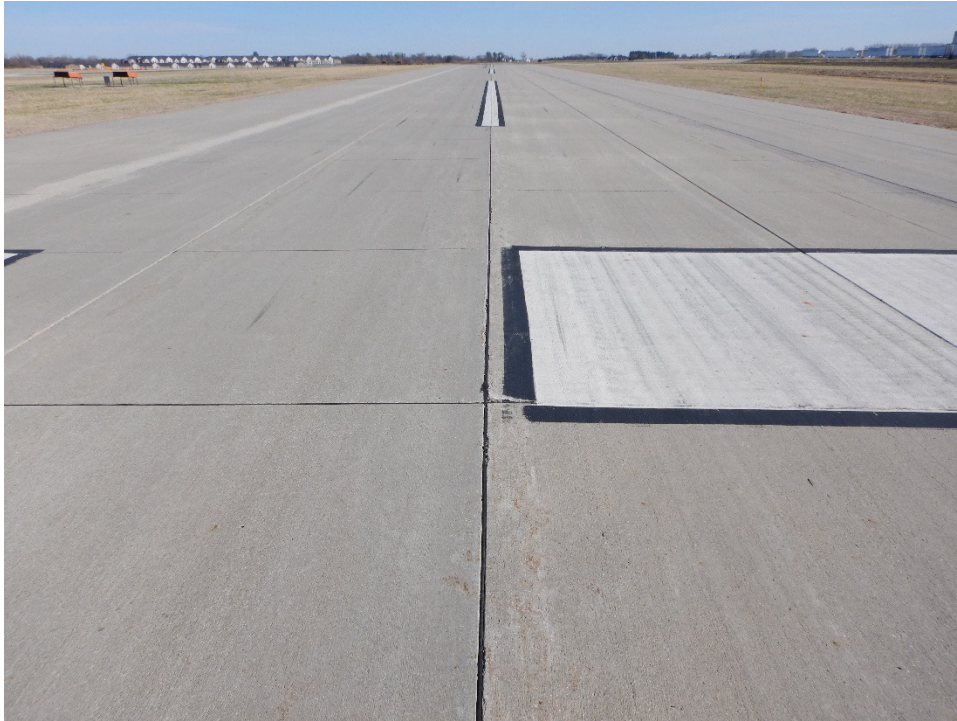
R13AM-01. Overview.

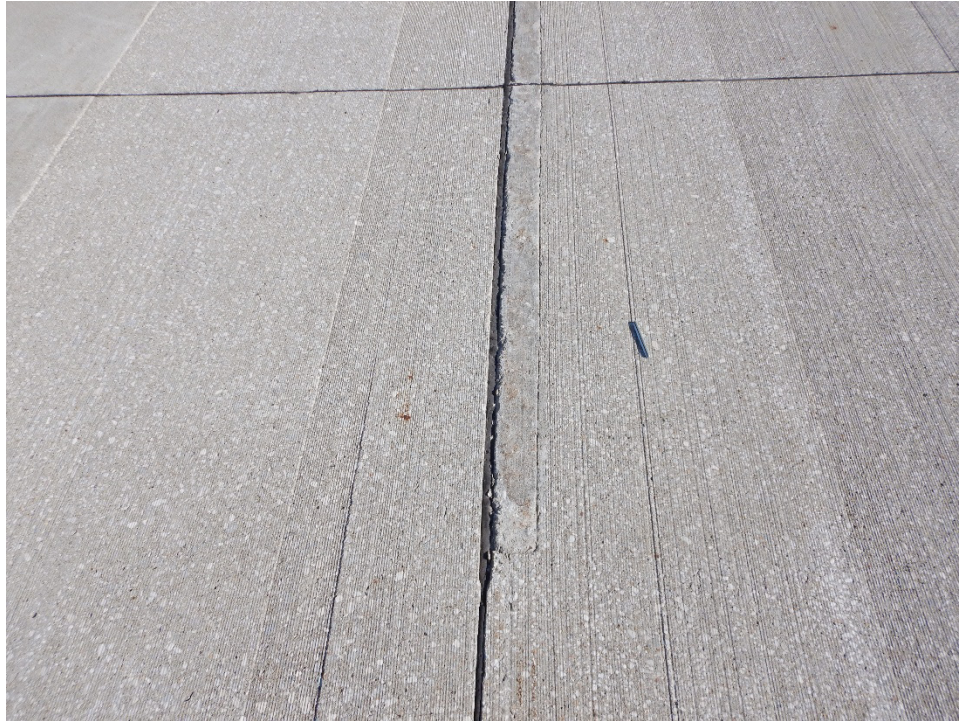
R13AM-01. Small Patching (Sample Unit No. 75).

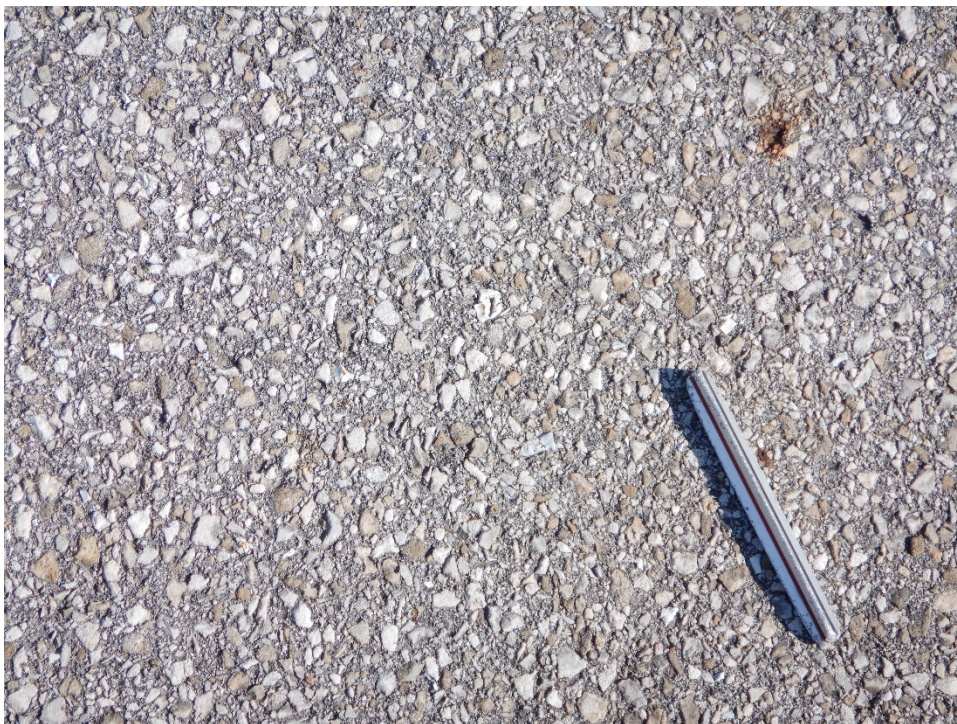
R13AM-02. Weathering (Sample Unit No. 04).

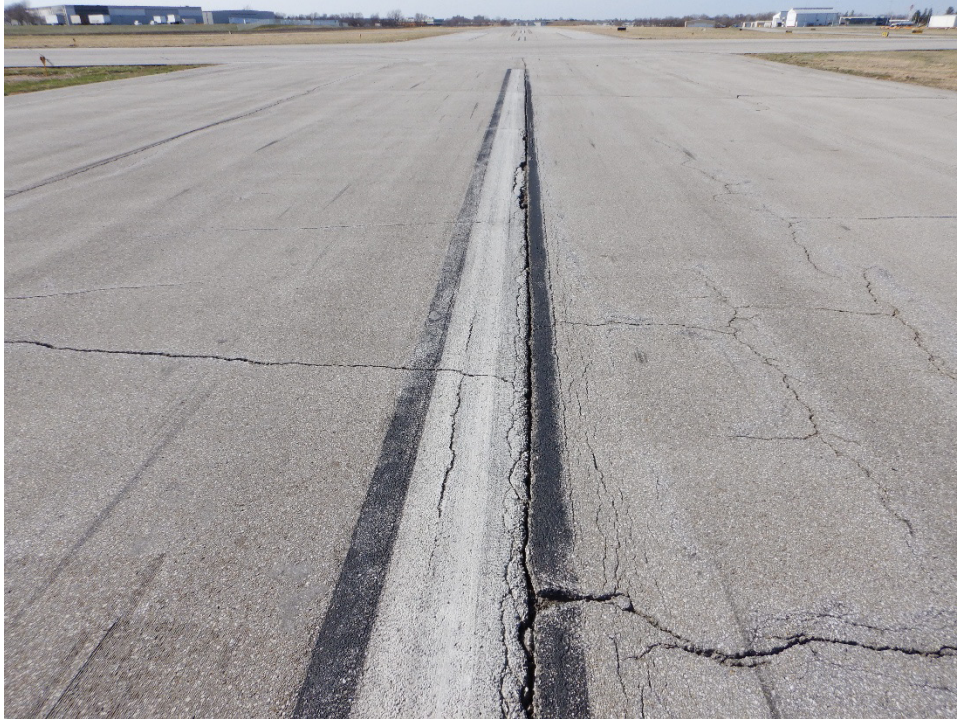
R13AM-03. Overview.

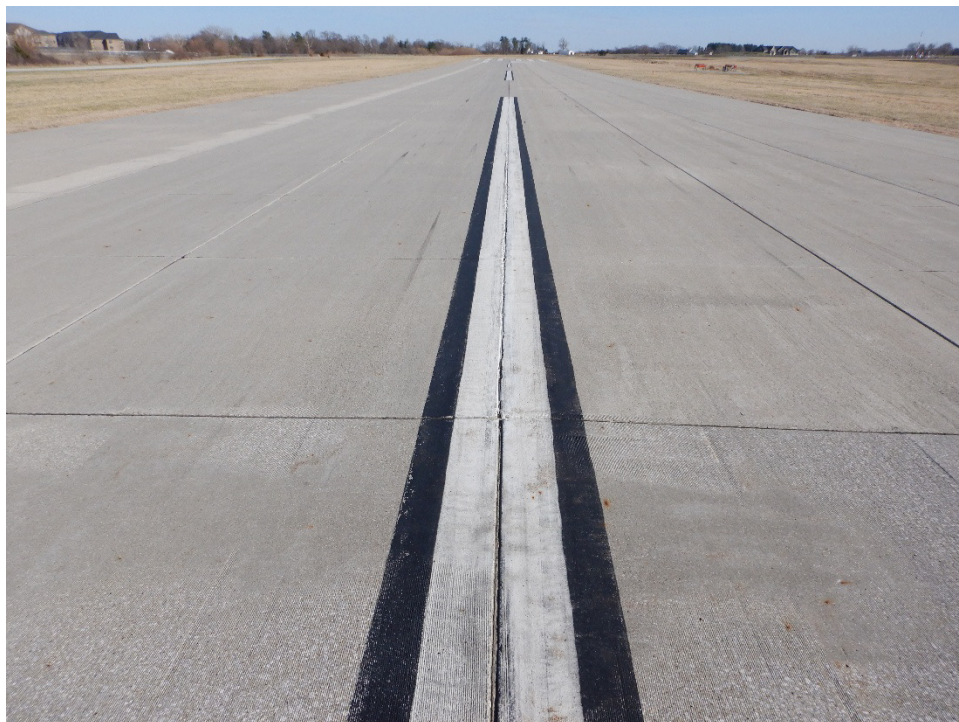
R13AM-04. Overview.

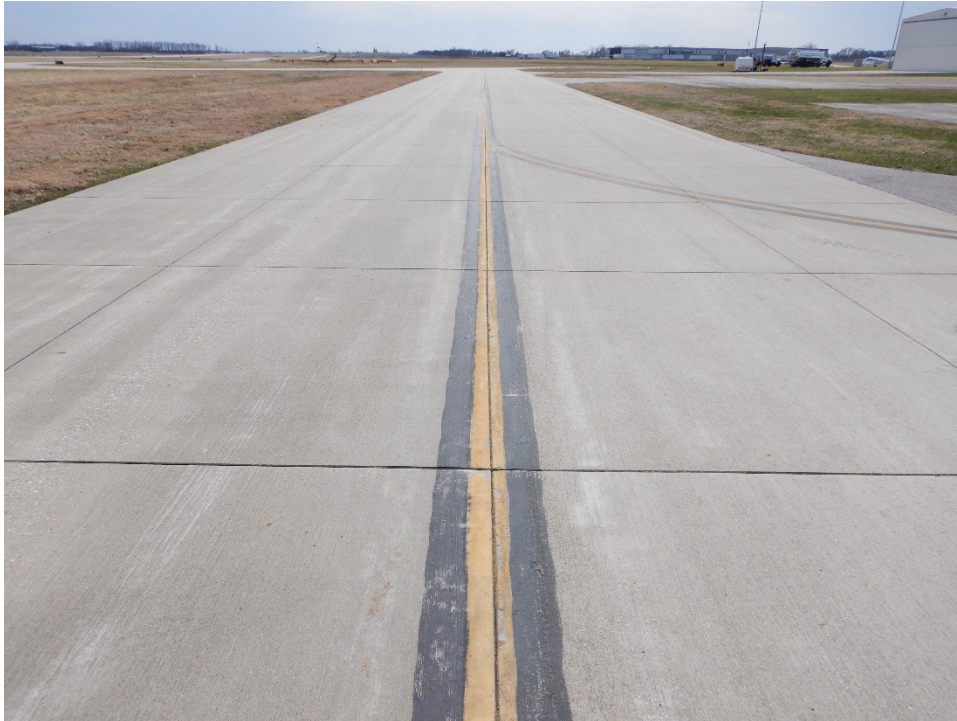
T13AM-01. Overview.

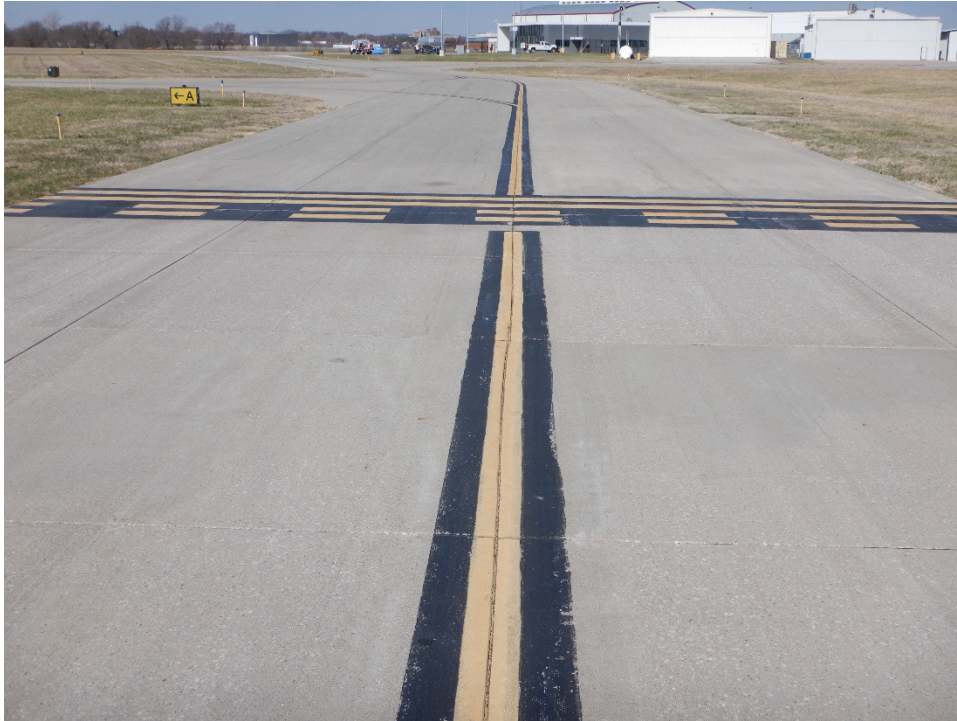
TA1AM-01. Overview.

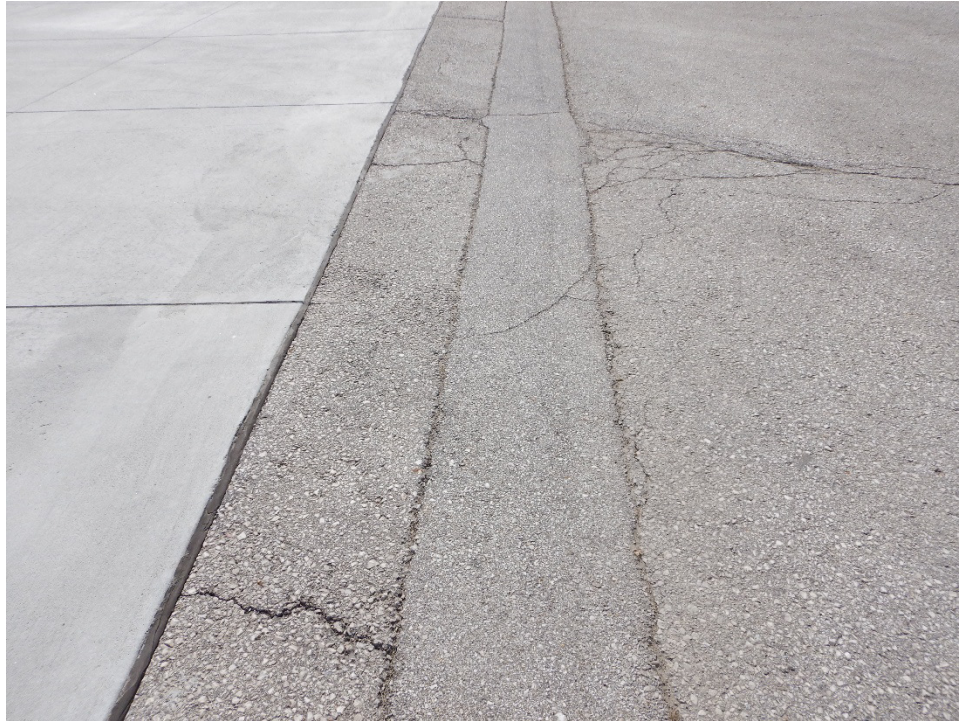
TA1AM-02. Patching (Sample Unit No. 03).

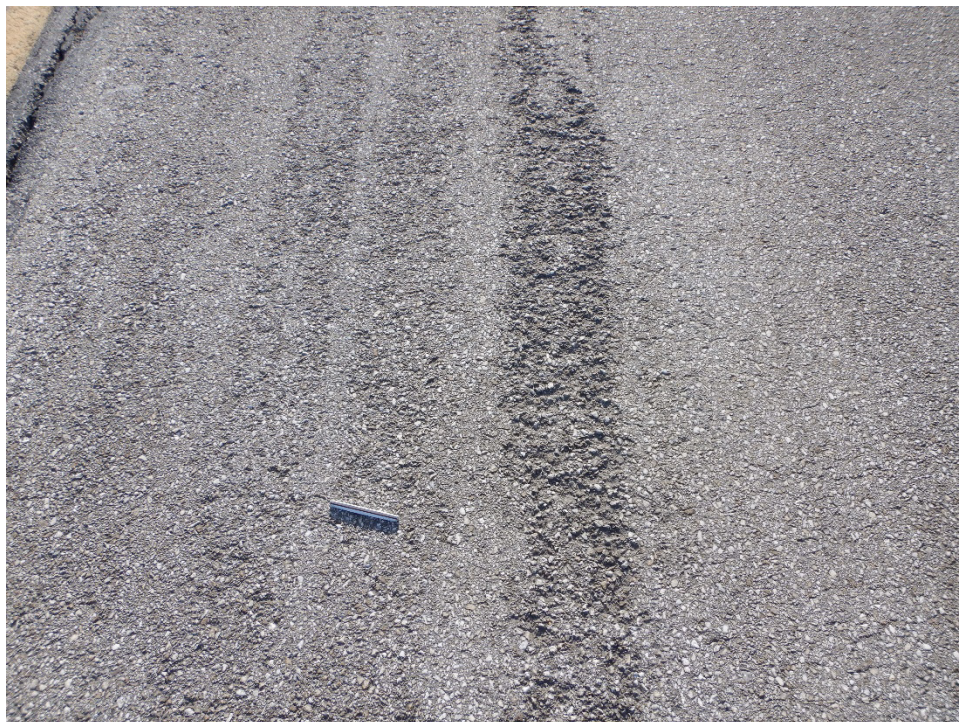
TA2AM-01. Raveling (Sample Unit No. 03).

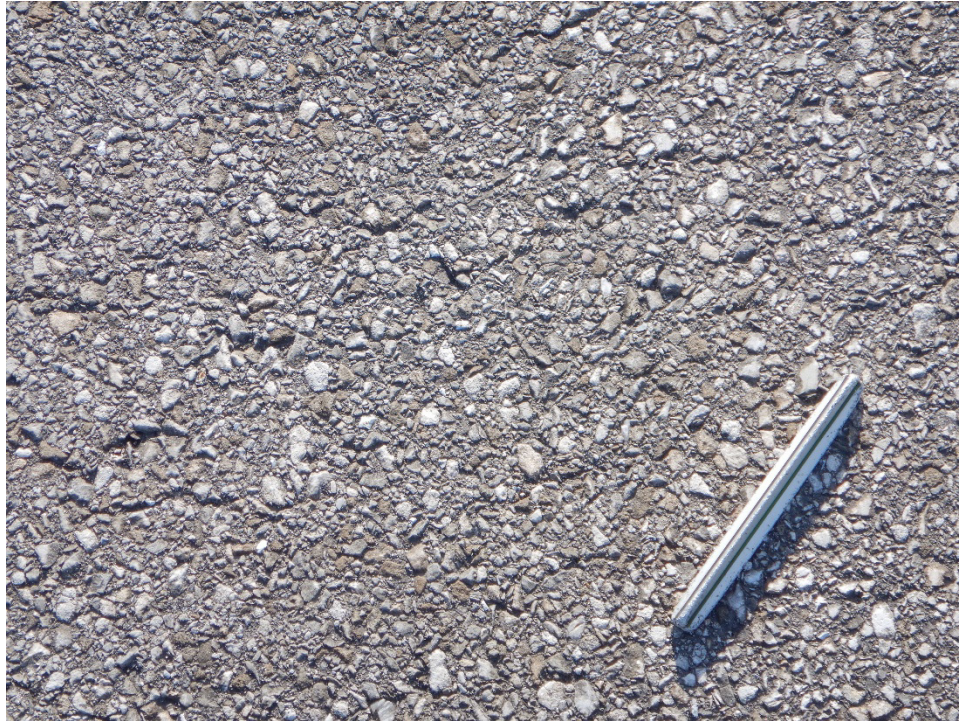
TA2AM-01. Weathering (Sample Unit No. 01).

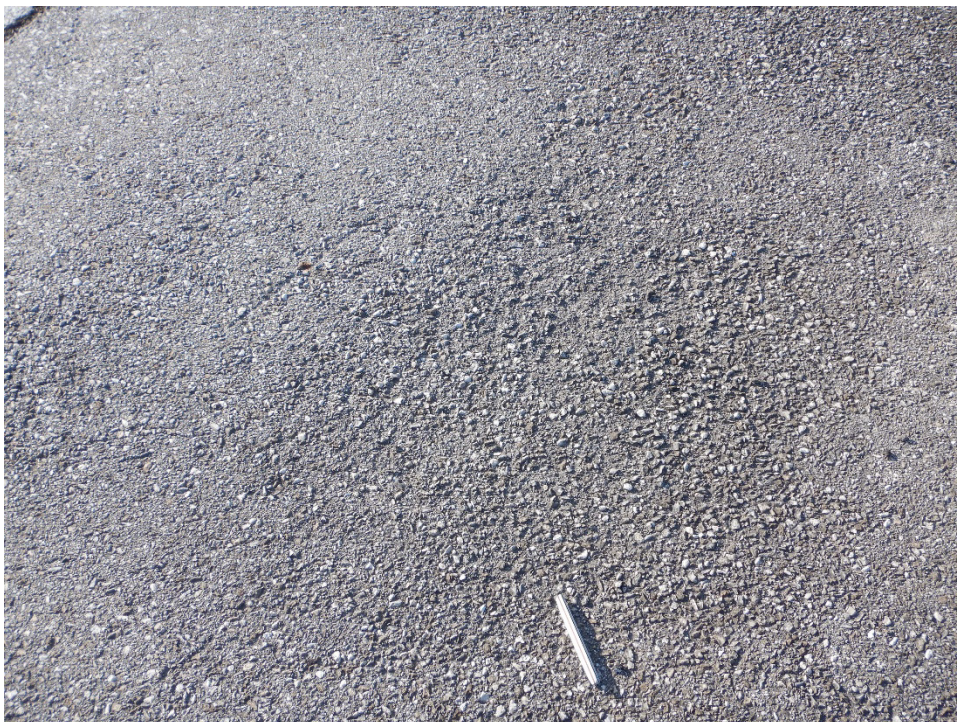
TA2AM-02. Raveling (Sample Unit No. 01).

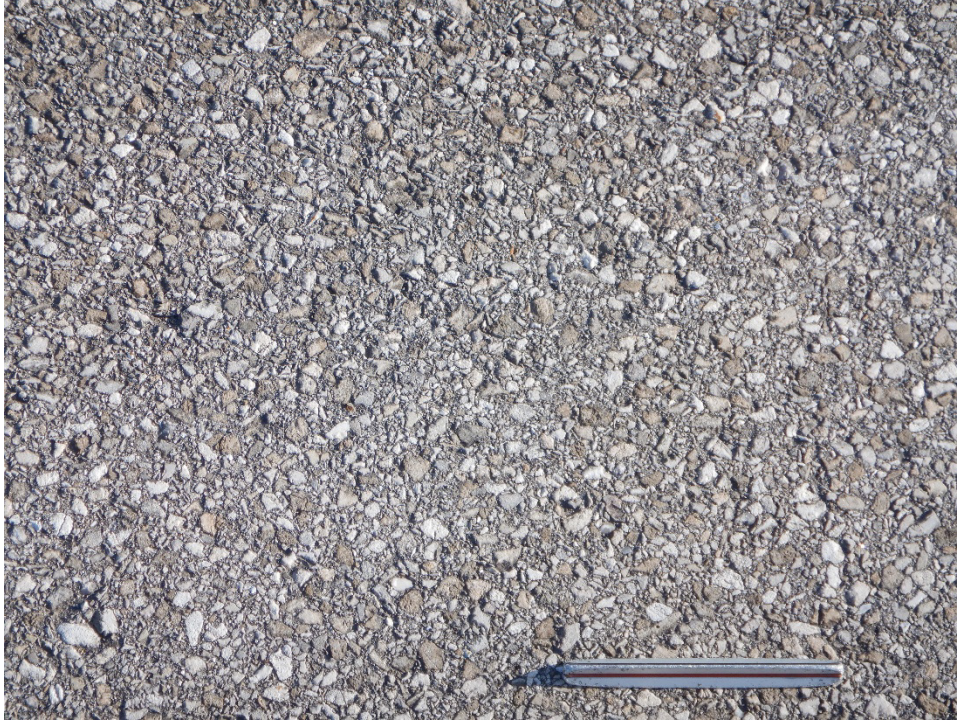
TA2AM-02. Weathering (Sample Unit No. 01).

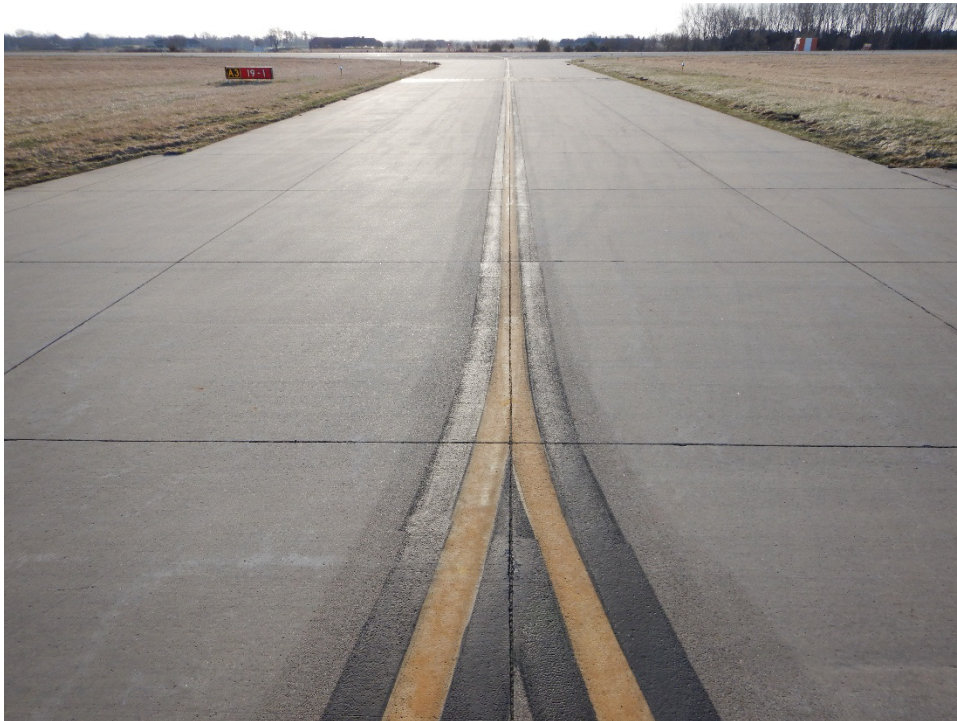
TA3AM-01. Overview.

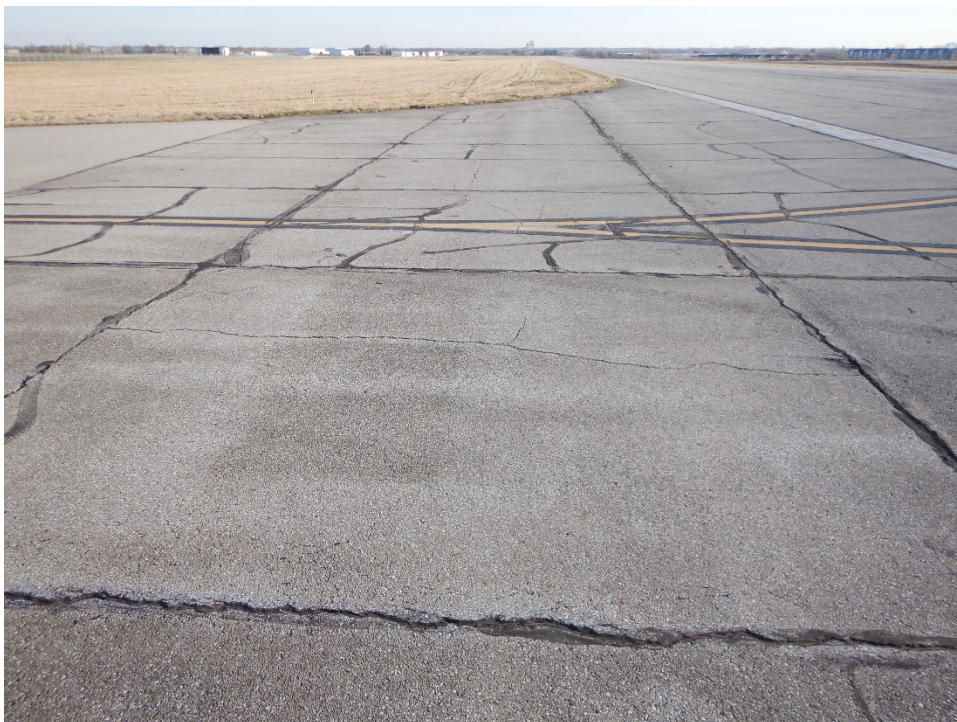
TA3AM-02. Overview.

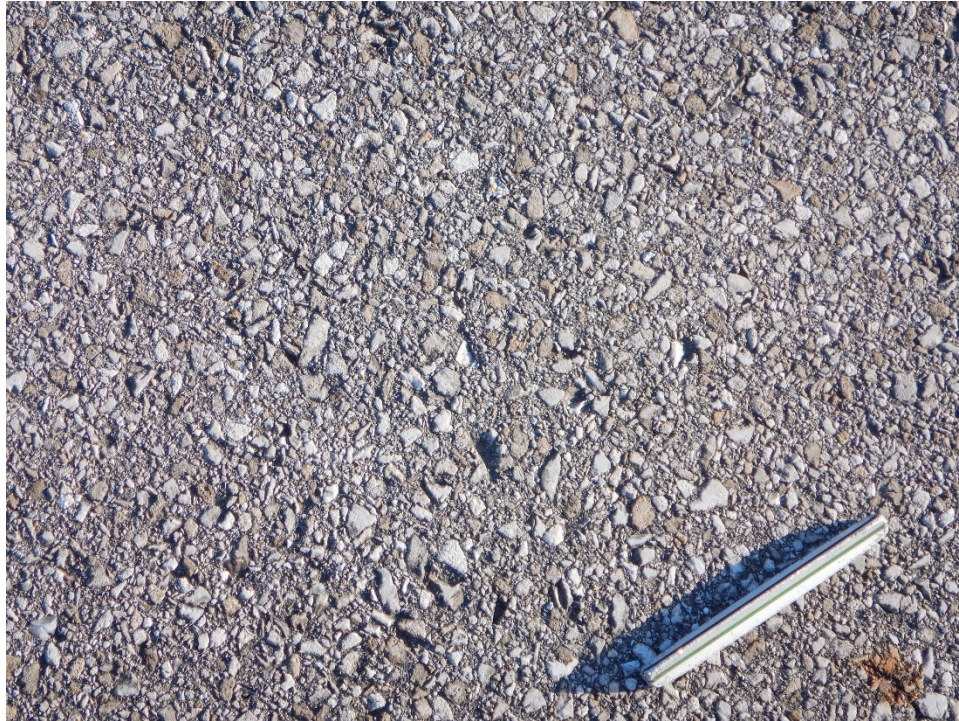
TA3AM-02. Weathering (Sample Unit No. 01).

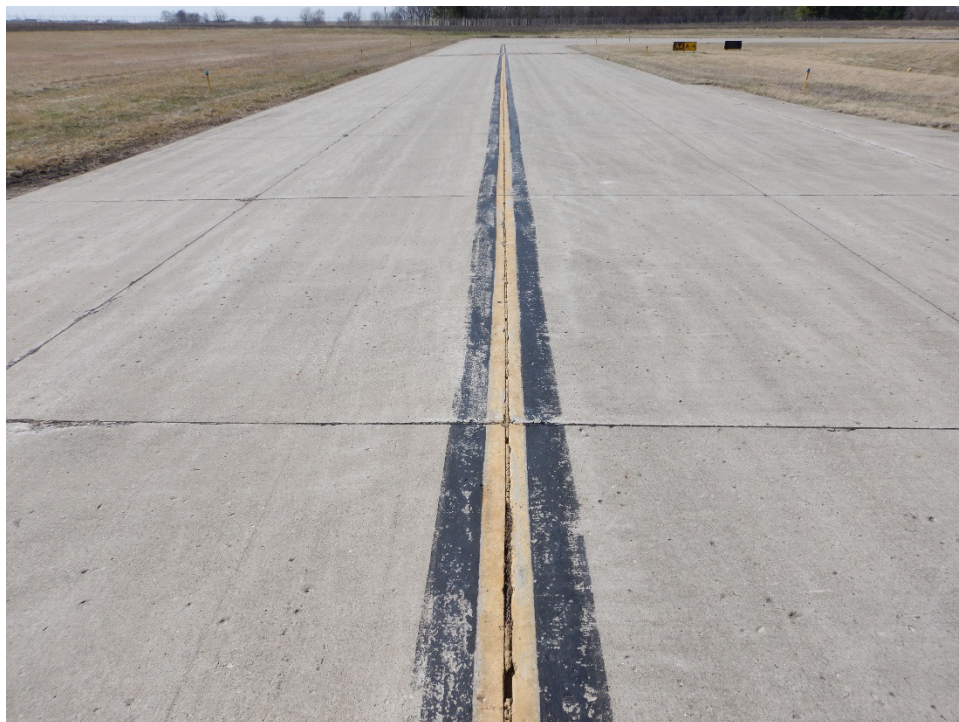
TA4AM-01. Overview.

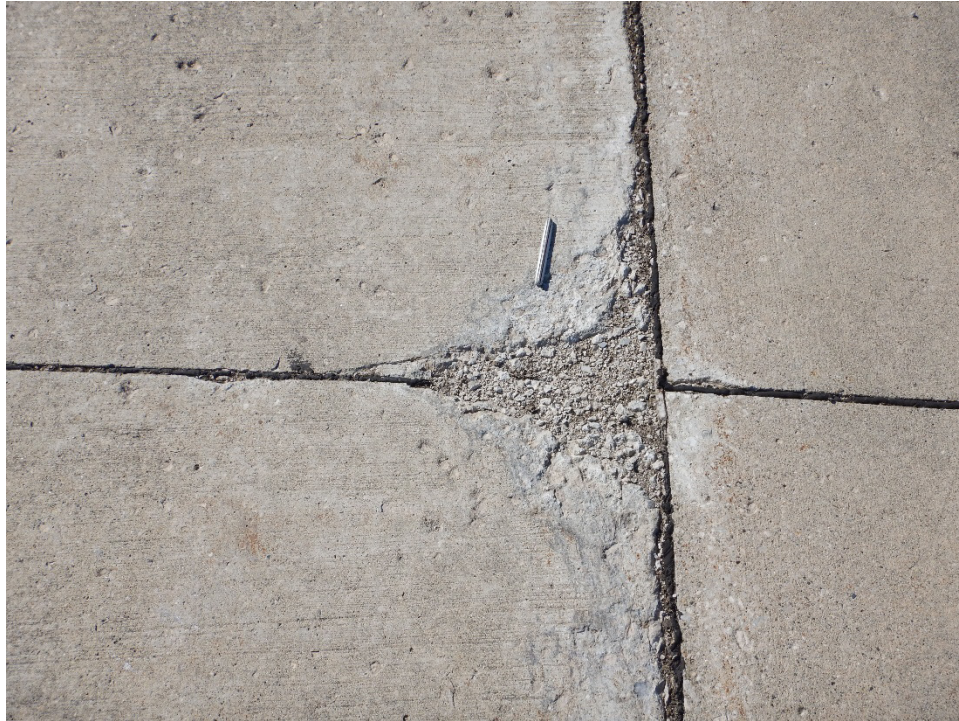
TA4AM-01. ASR (Sample Unit No. 05).

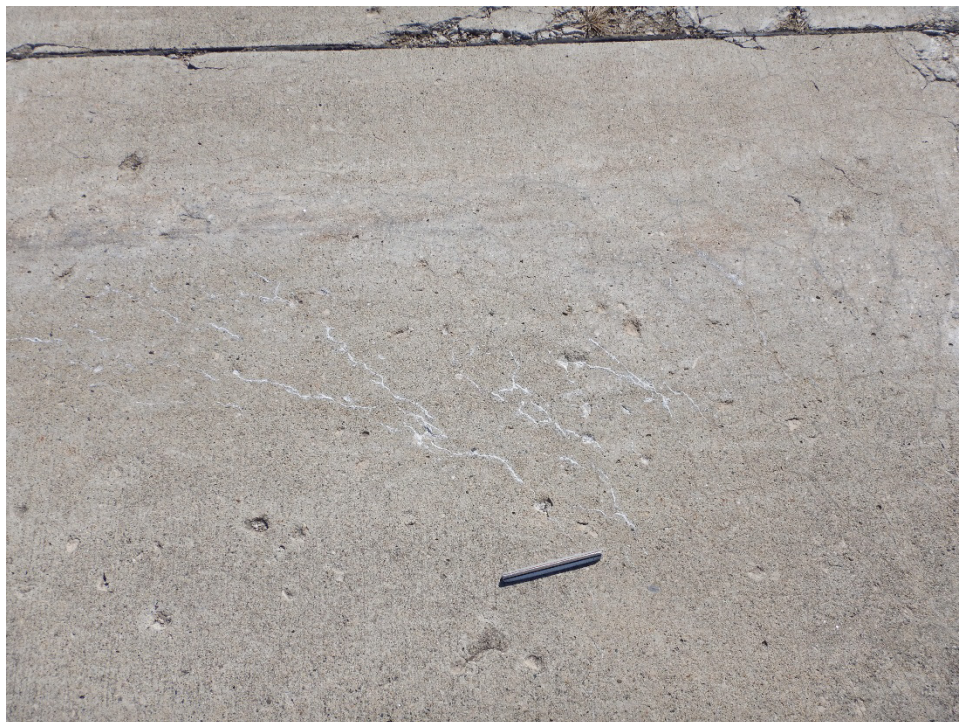
TA4AM-01. Popouts (Sample Unit No. 05).

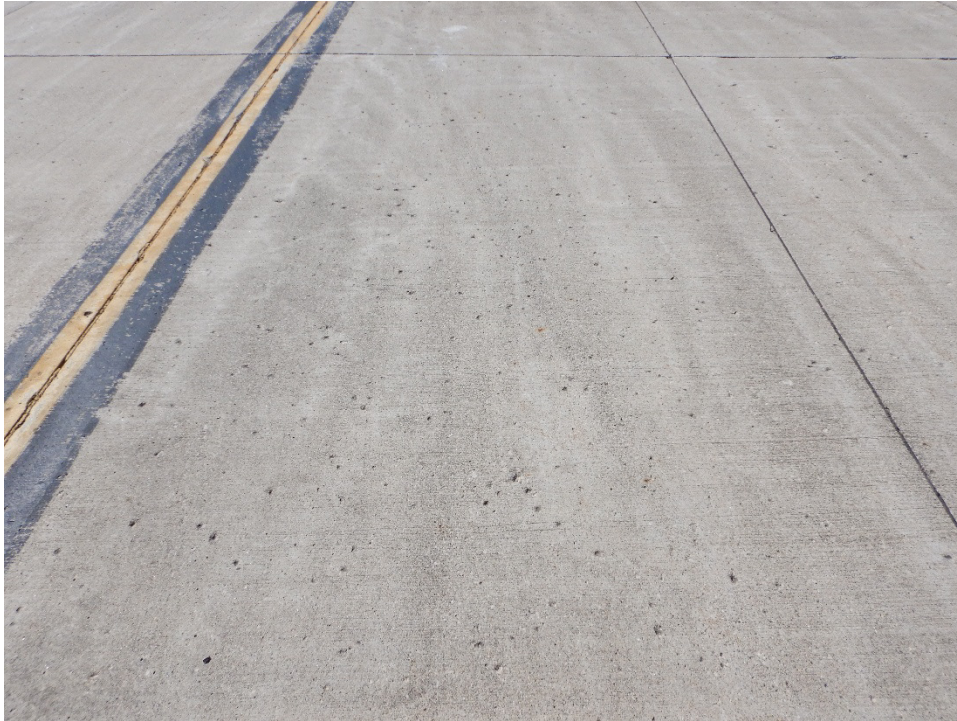
TA4AM-02. Overview.

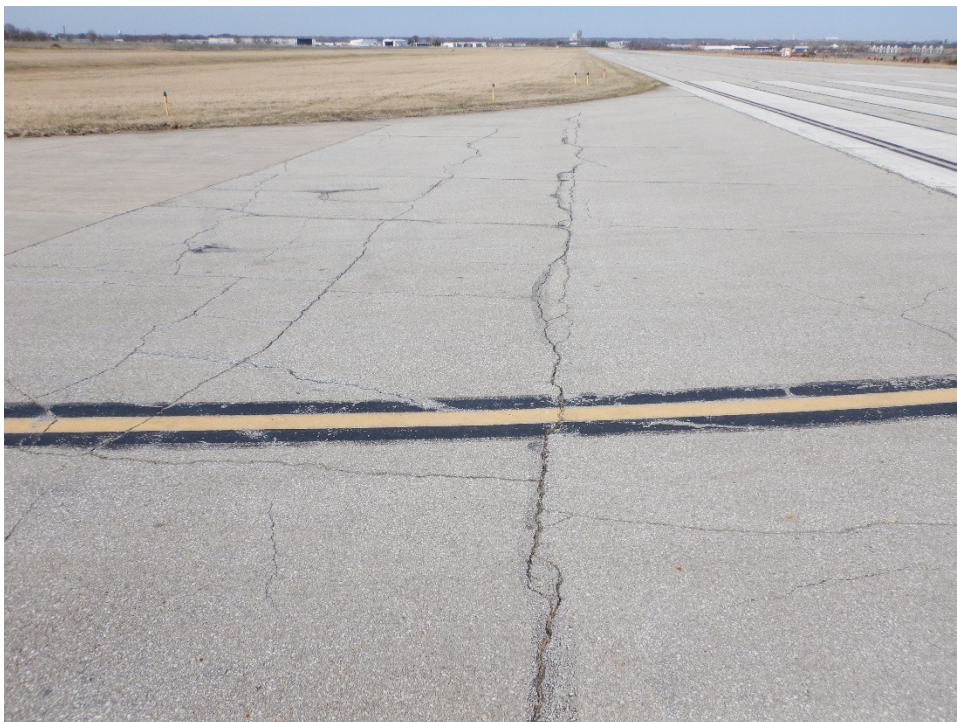
TA4AM-02. Block Cracking (Sample Unit No. 01).

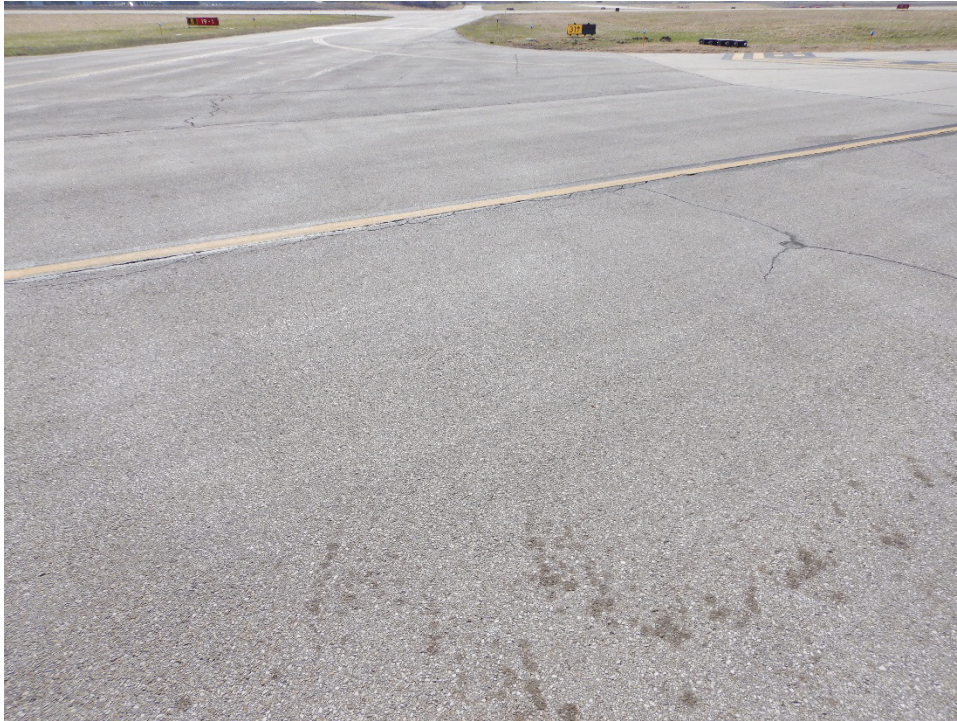
TAAM-03. L&T Cracking (Sample Unit No. 01).

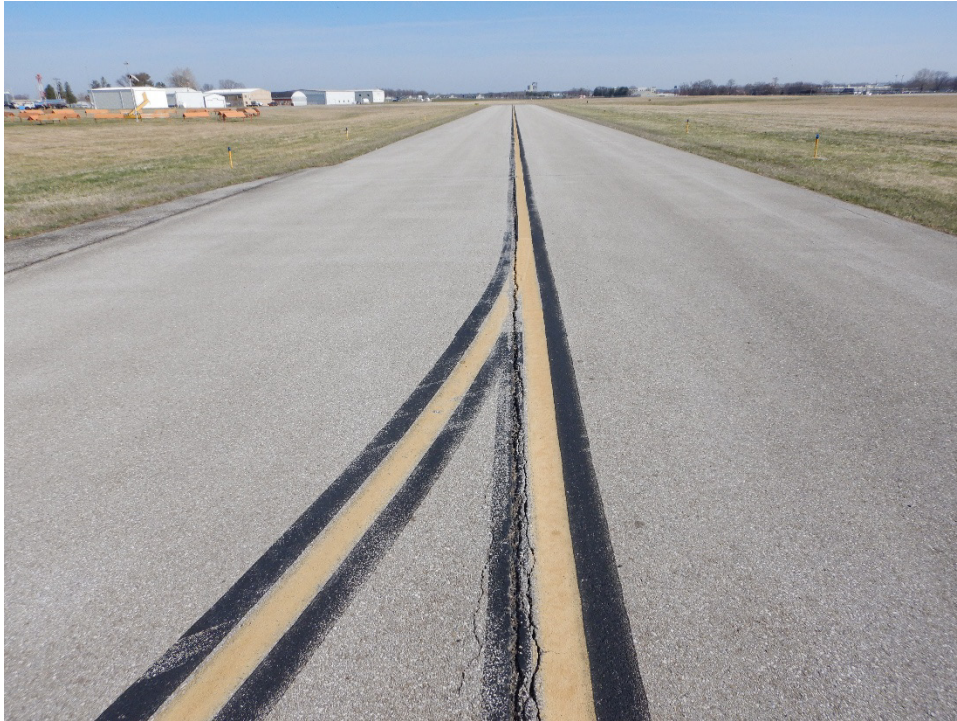
TAAM-04. Alligator Cracking (Sample Unit No. 05).

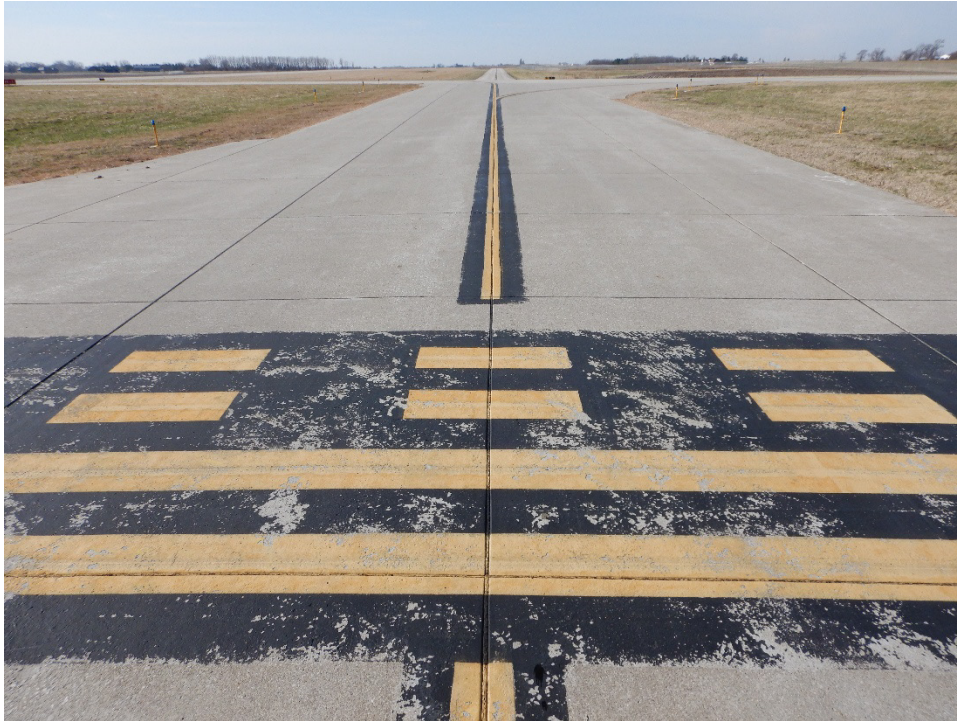
TAAM-06. LTD Cracking (Sample Unit No. 05).

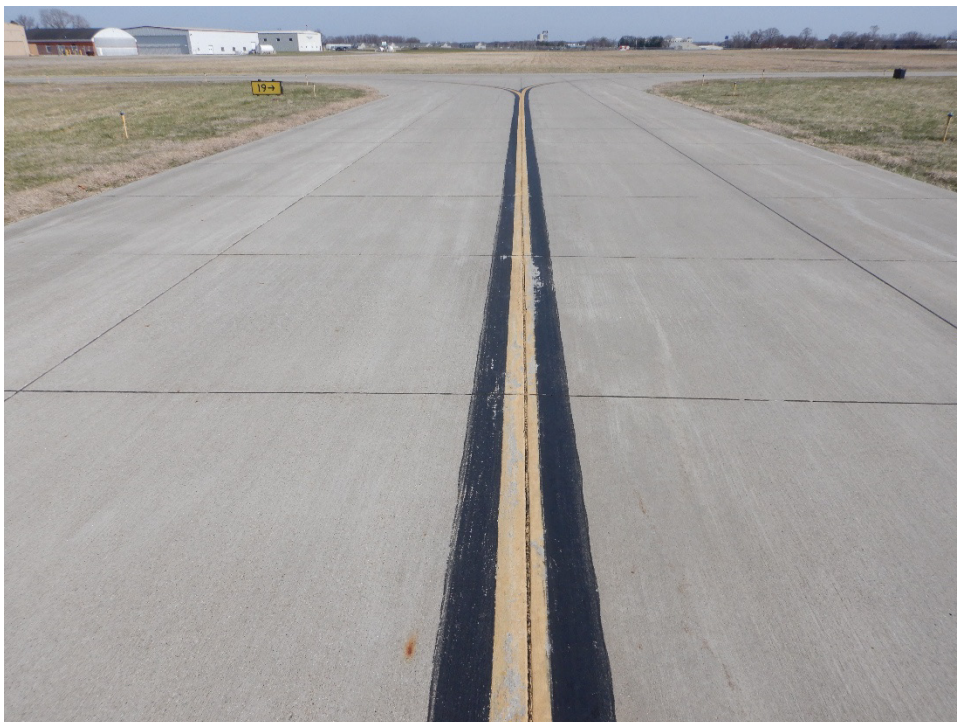
TAAM-07. Joint Seal Damage (Sample Unit No. 03).

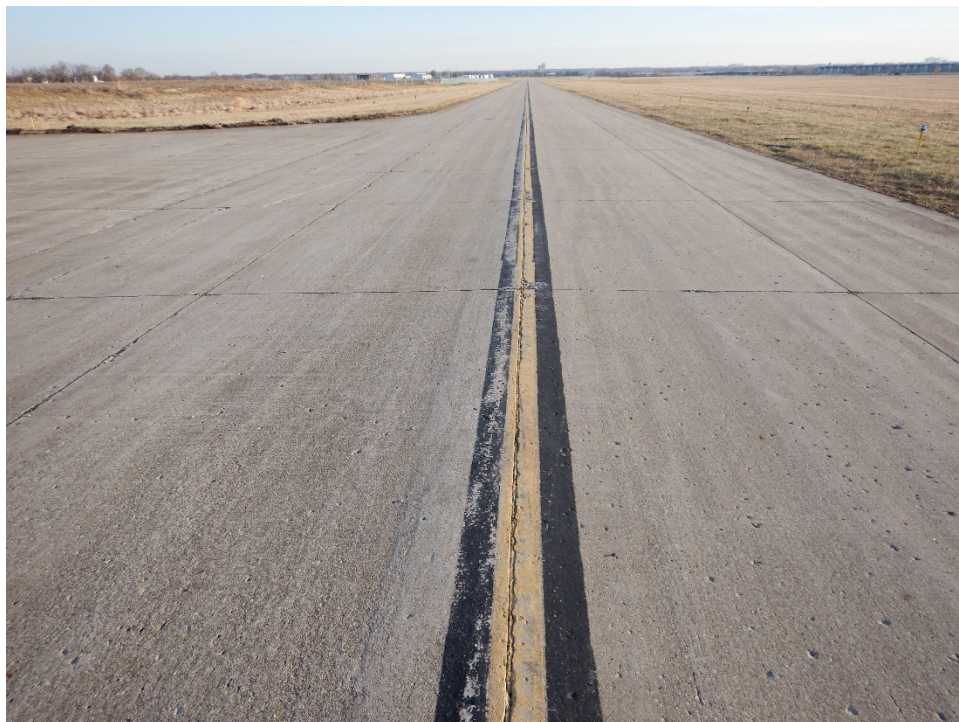
TAAM-09. ASR (Sample Unit No. 24).

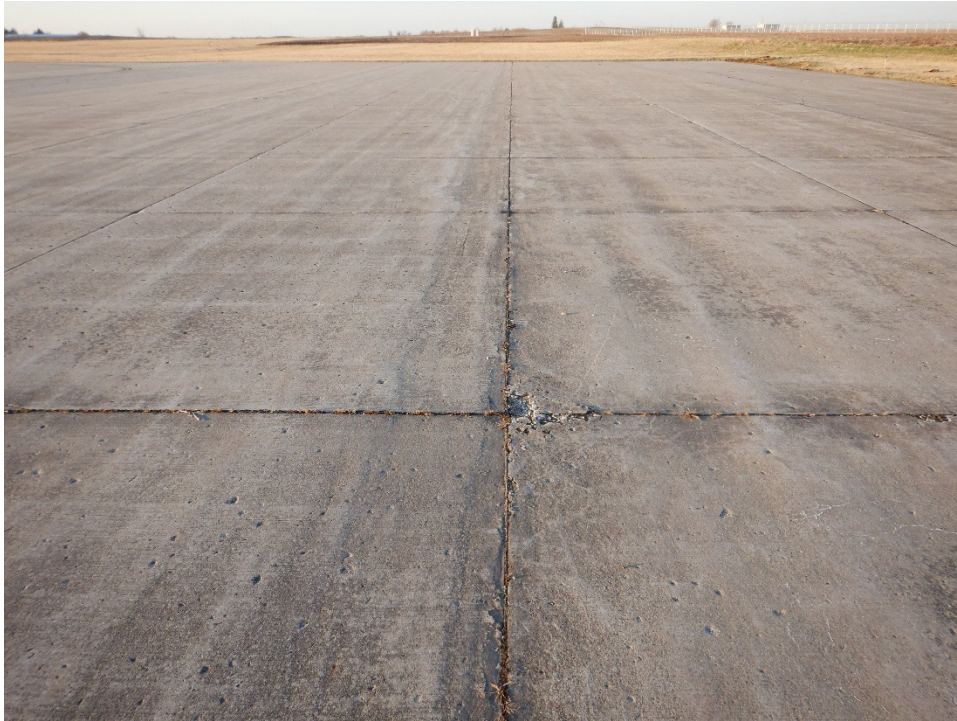
TAAM-10. ASR (Additional Sample Unit No. 07) (1).

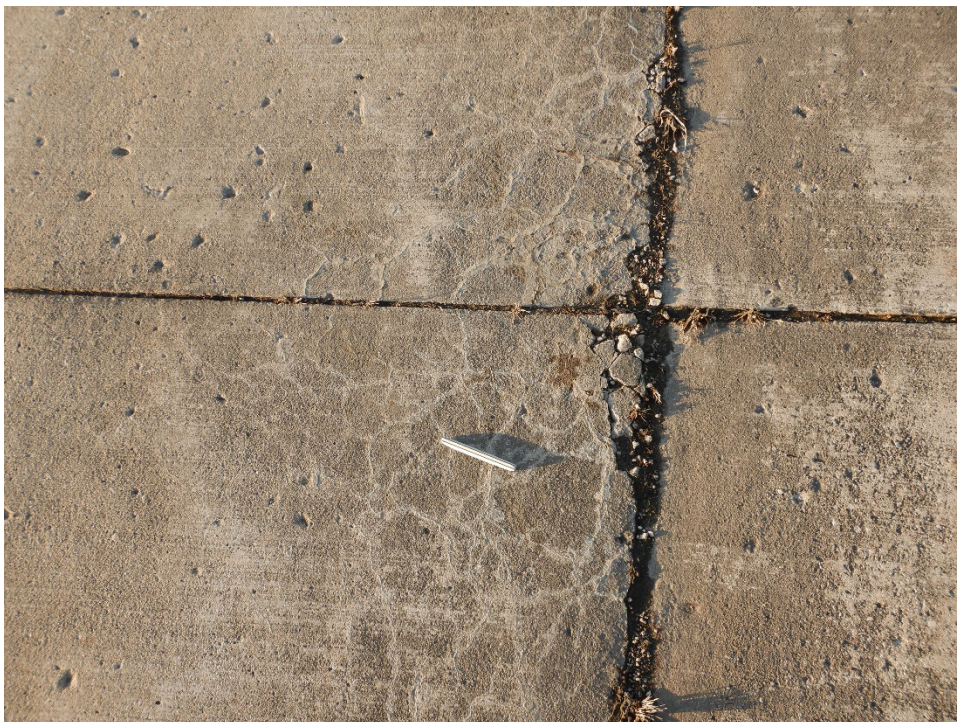
TAAM-10. ASR (Additional Sample Unit No. 07) (2).

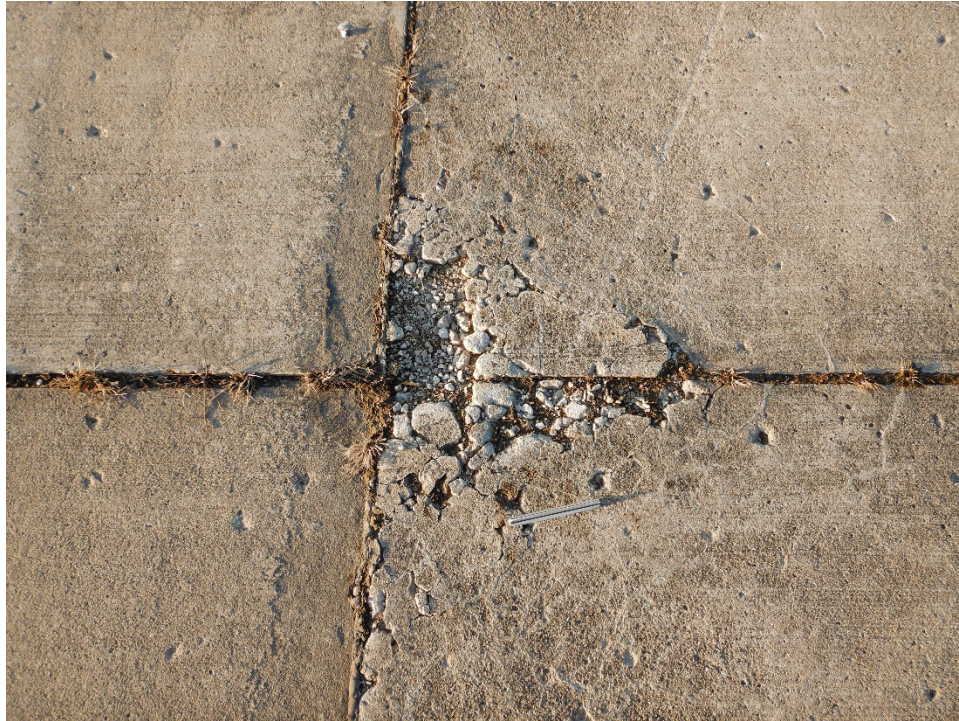
TAAM-10. ASR (Sample Unit No. 06) (1).
