# Ames Municipal Airport

## Pavement Management Report

**AUGUST 2026**

# AMES MUNICIPAL AIRPORT PAVEMENT MANAGEMENT REPORT

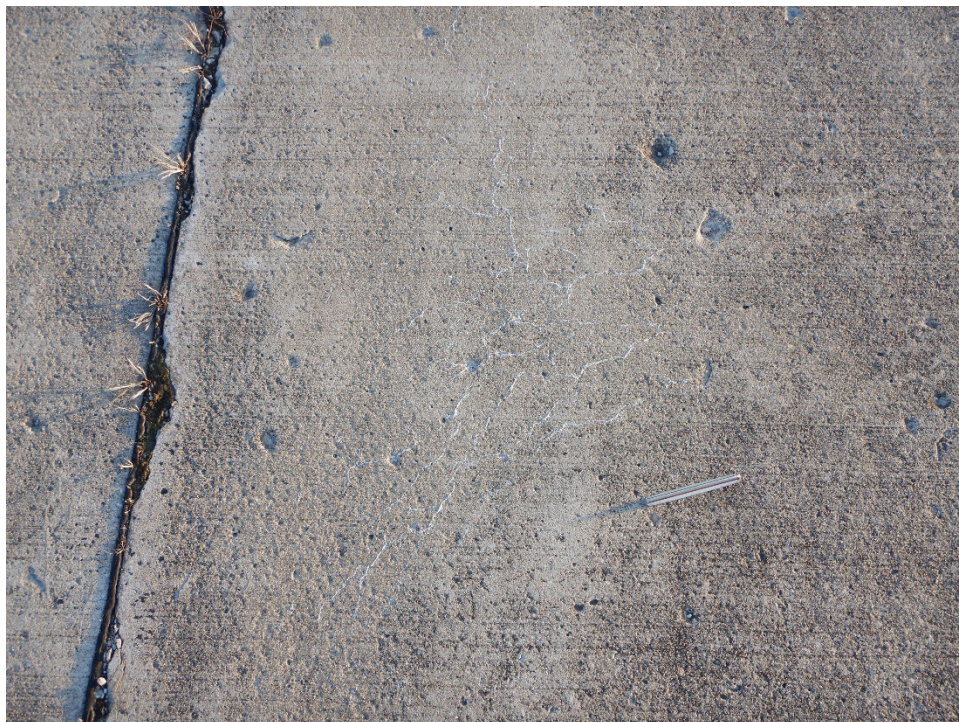
TAAM-10. ASR (Sample Unit No. 06) (2).

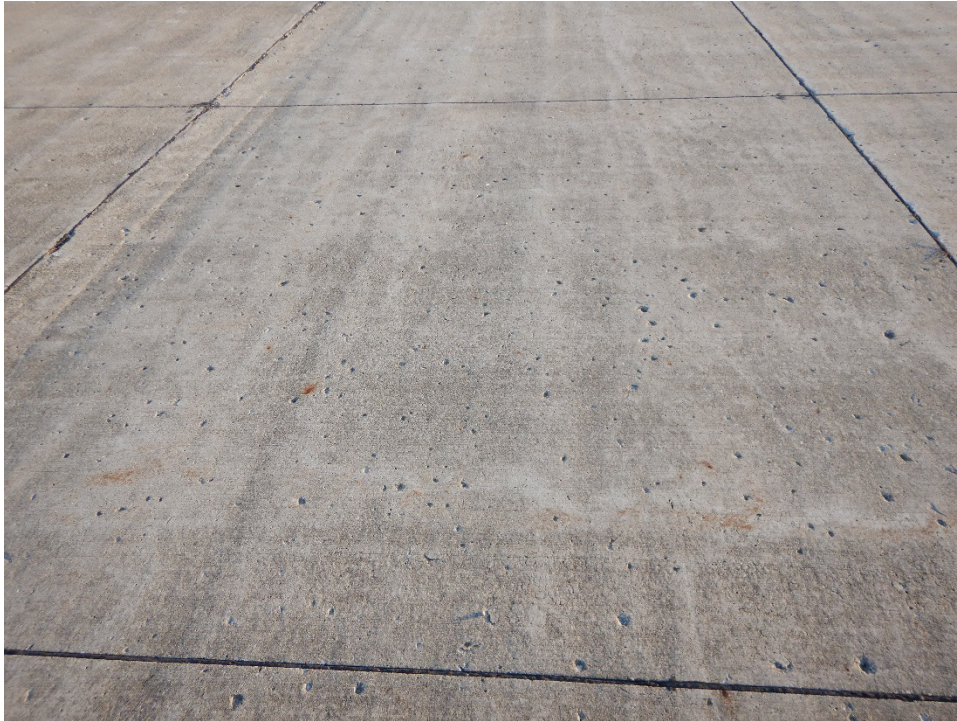
TAAM-10. Shattered Slab (Additional Sample Unit No. 07) (1).

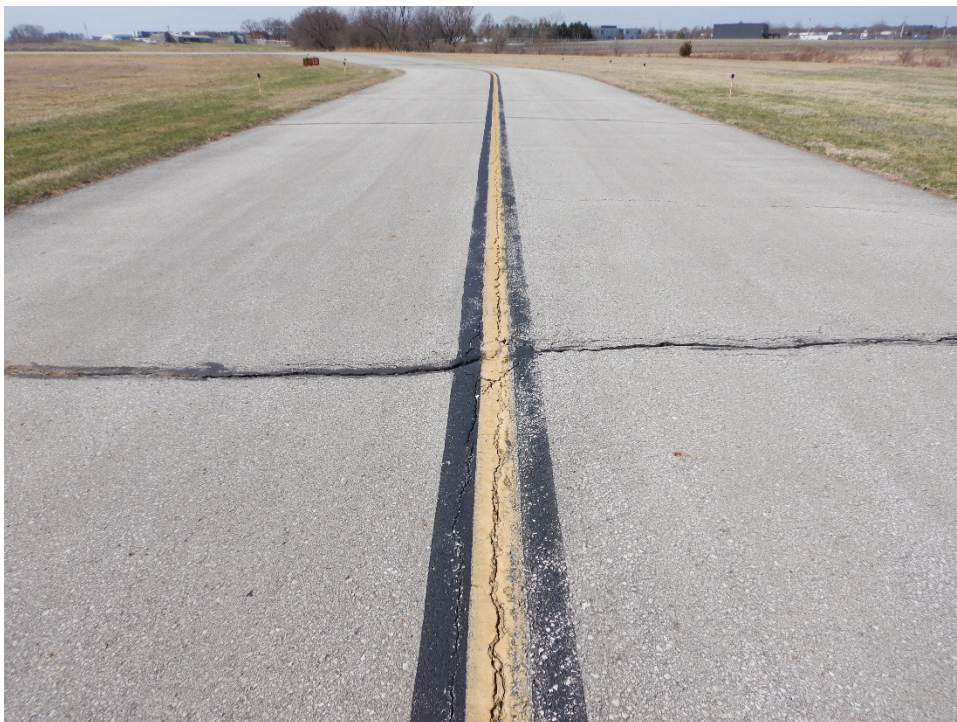
TB1AM-01. L&T Cracking (Sample Unit No. 02).

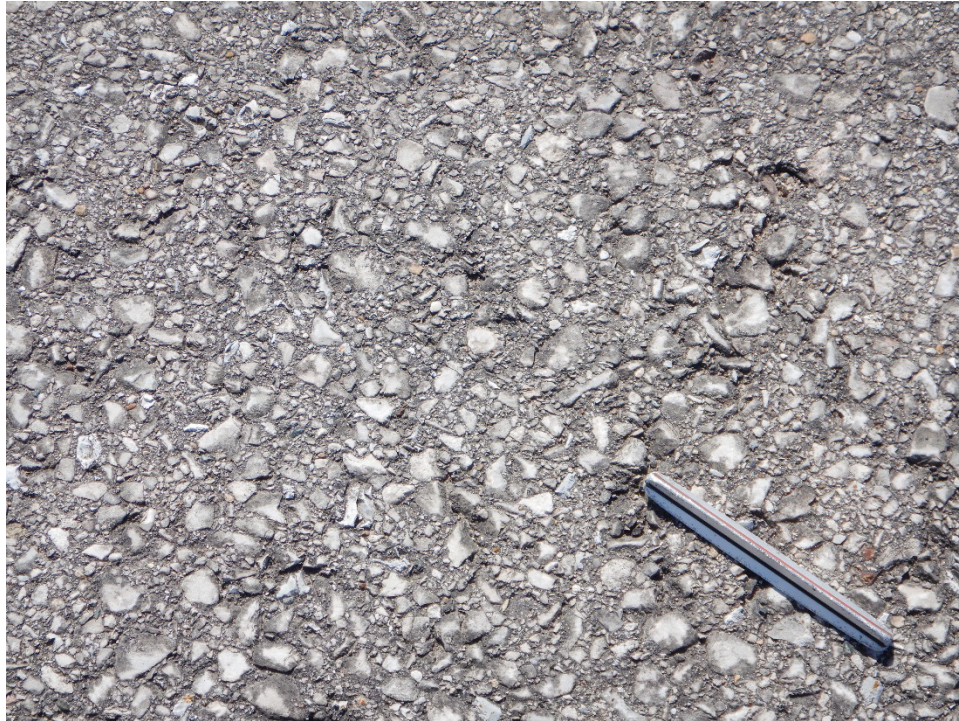
TB1AM-02. Overview.

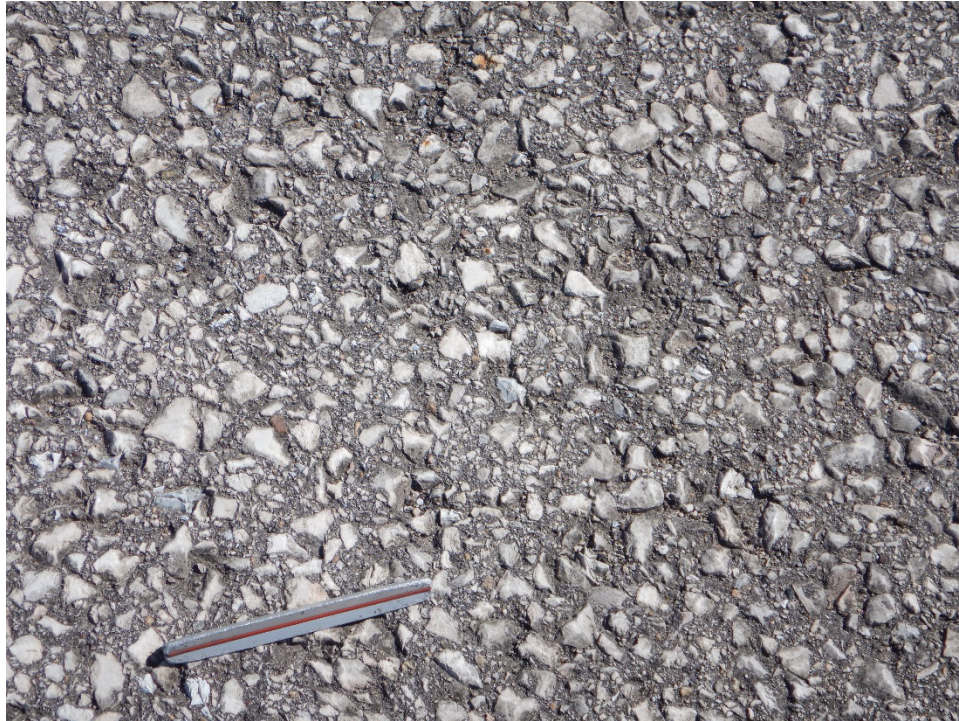
TB2AM-02. Overview.

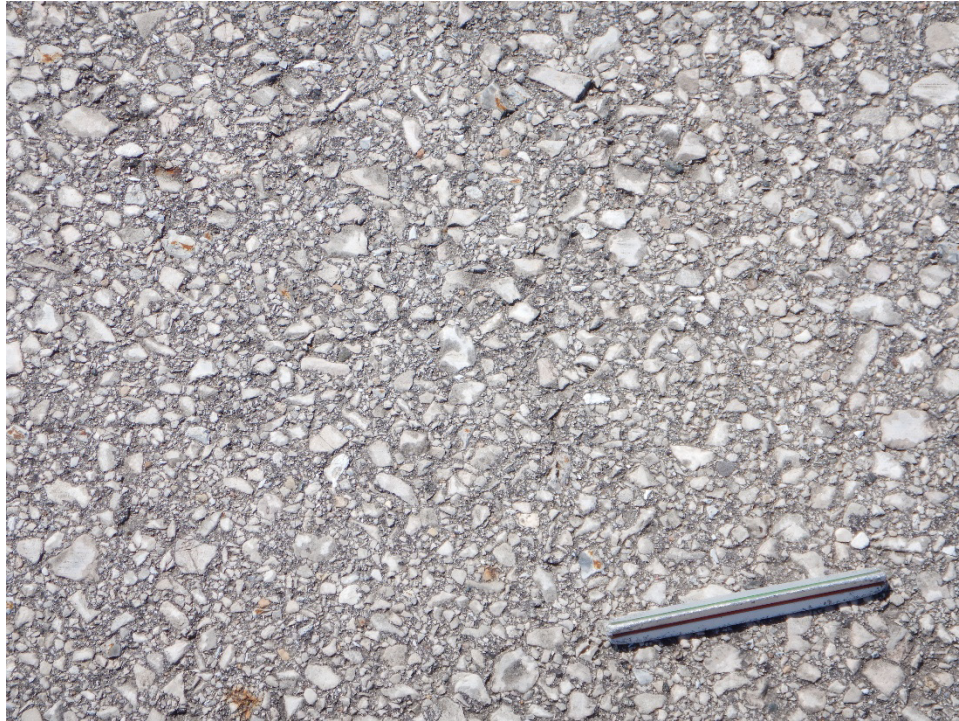
TBAM-01. Weathering (Sample Unit No. 09).

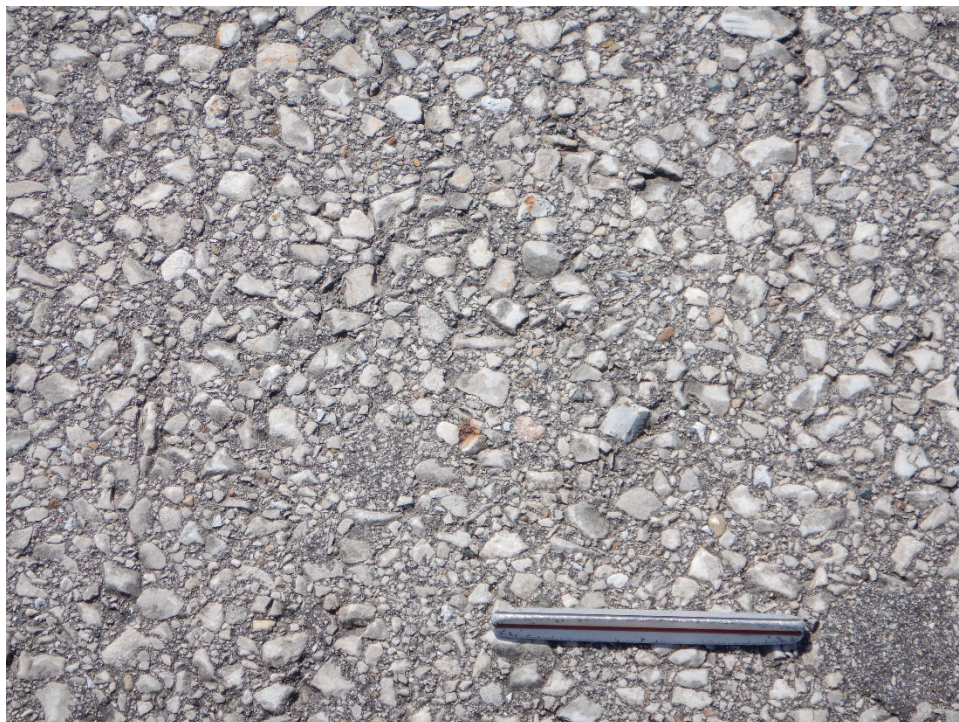
TBAM-02. Overview.

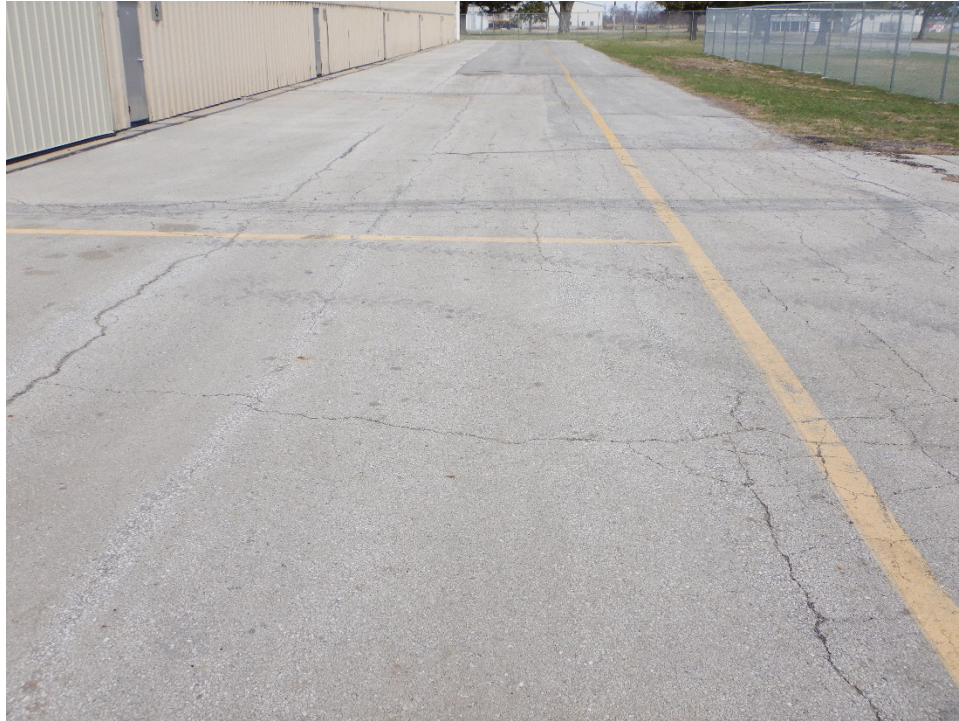
TH01AM-01. Alligator Cracking (Sample Unit No. 02).
