# Ankeny Regional Airport

## Pavement Management Report

**AUGUST 2025**

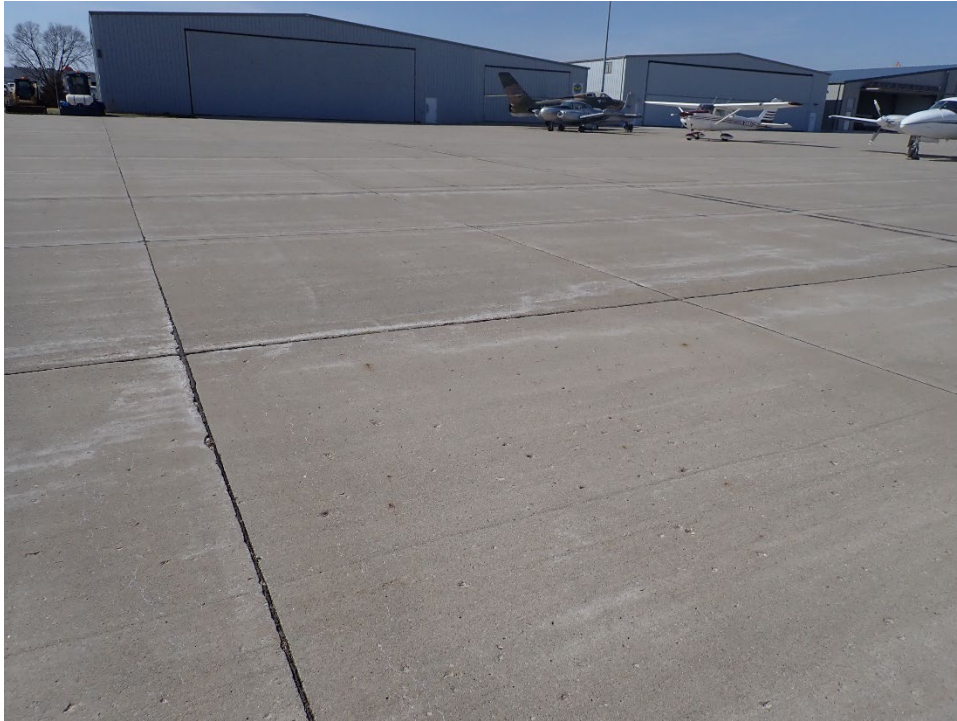
A01AN-01. Overview.

| Branch | Section | Surface Type | Section Area (sf) | LCD | 2025 PCI | % Distress Due to Load | % Distress Due to Climate/Durability | % Distress Due to Other | Type of Distress |
|---|---|---|---|---|---|---|---|---|---|
| A01AN | 01 | PCC | 159,078 | 10/31/1993 | 40 | 18 | 15 | 67 | Large Patch, LTD Cracking, Popouts, Shattered Slab, Shrinkage Cracking, Small Patch, ASR, Corner Spalling, Faulting, Joint Spalling, Joint Seal Damage |

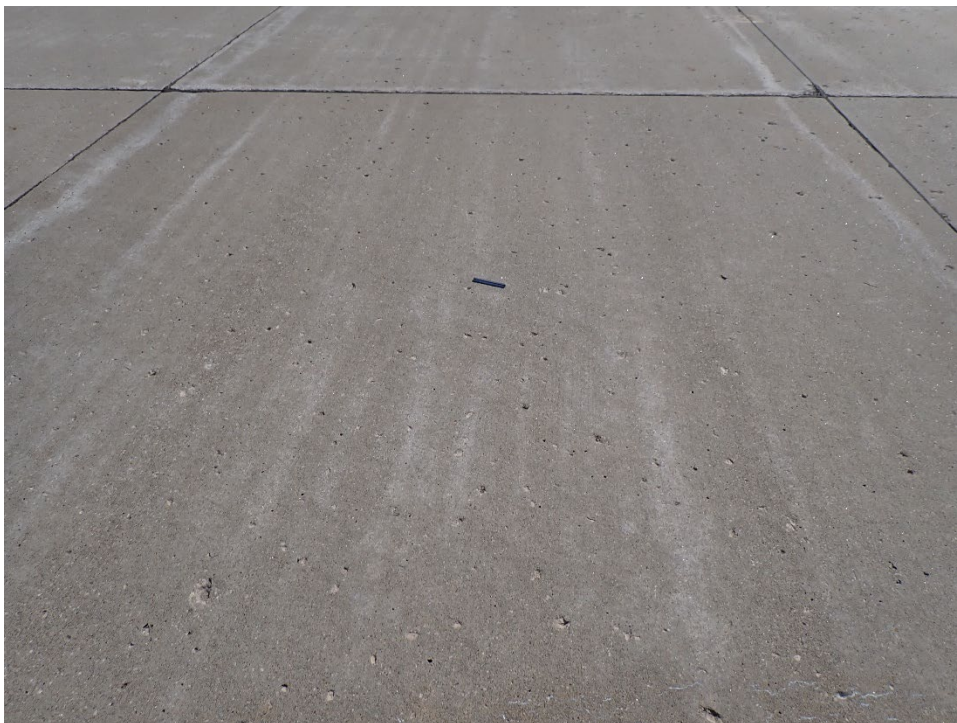
A01AN-01. Popouts (Sample Unit No. 33).

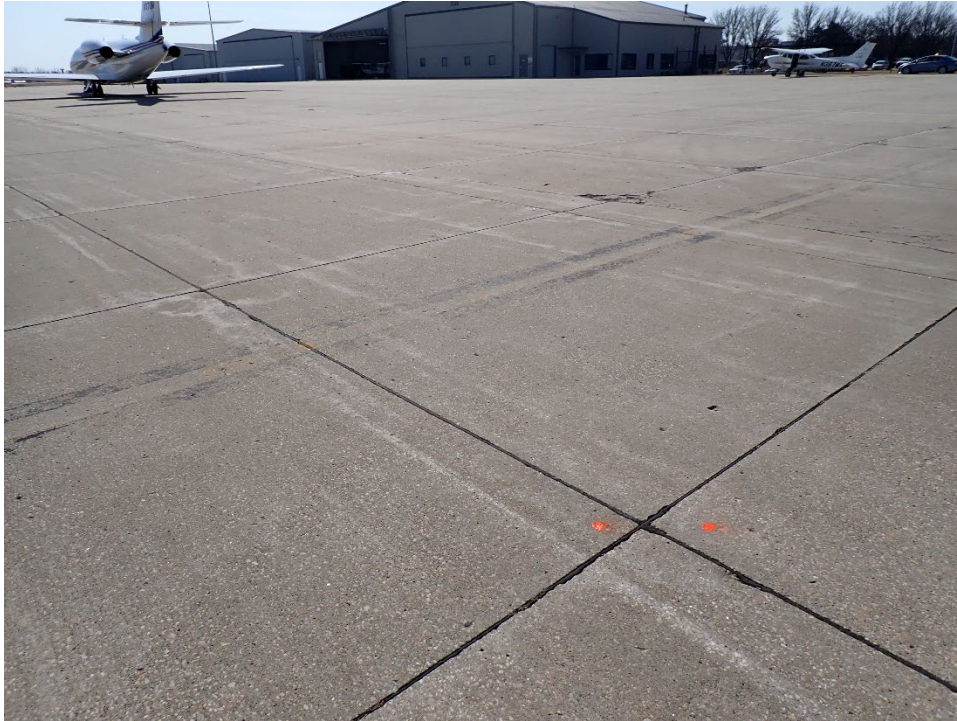
A01AN-02. Overview.

| Branch | Section | Surface Type | Section Area (sf) | LCD | 2025 PCI | % Distress Due to Load | % Distress Due to Climate/Durability | % Distress Due to Other | Type of Distress |
|---|---|---|---|---|---|---|---|---|---|
| A01AN | 02 | PCC | 97,192 | 6/1/2006 | 61 | 5 | 18 | 77 | ASR, Joint Spalling, Joint Seal Damage, LTD Cracking, Popouts, Shrinkage Cracking |

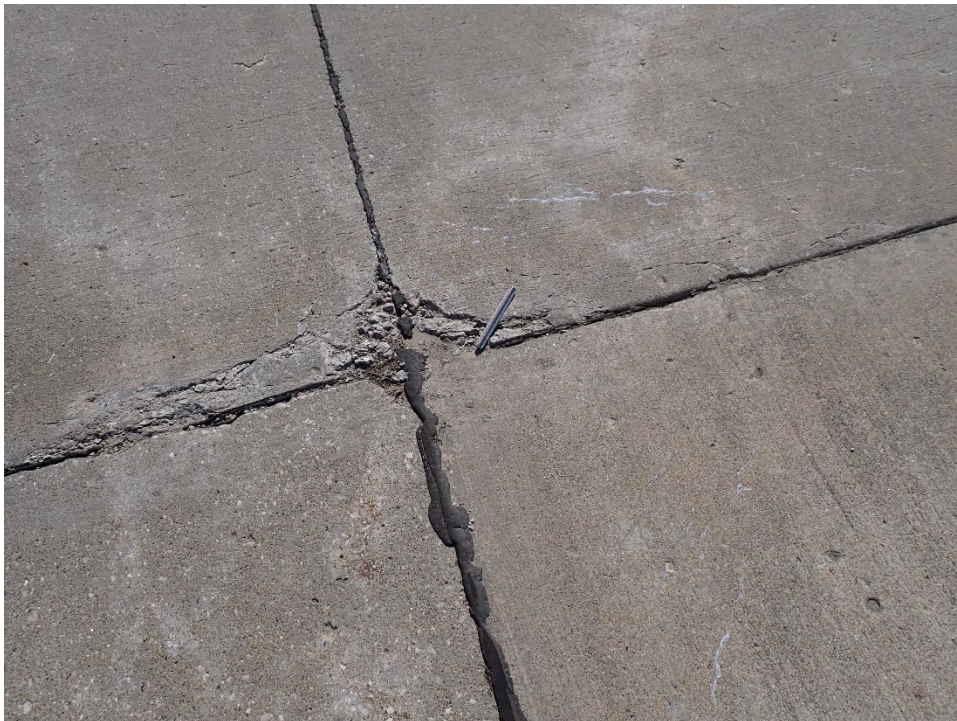
A01AN-02. ASR (Sample Unit No. 05).

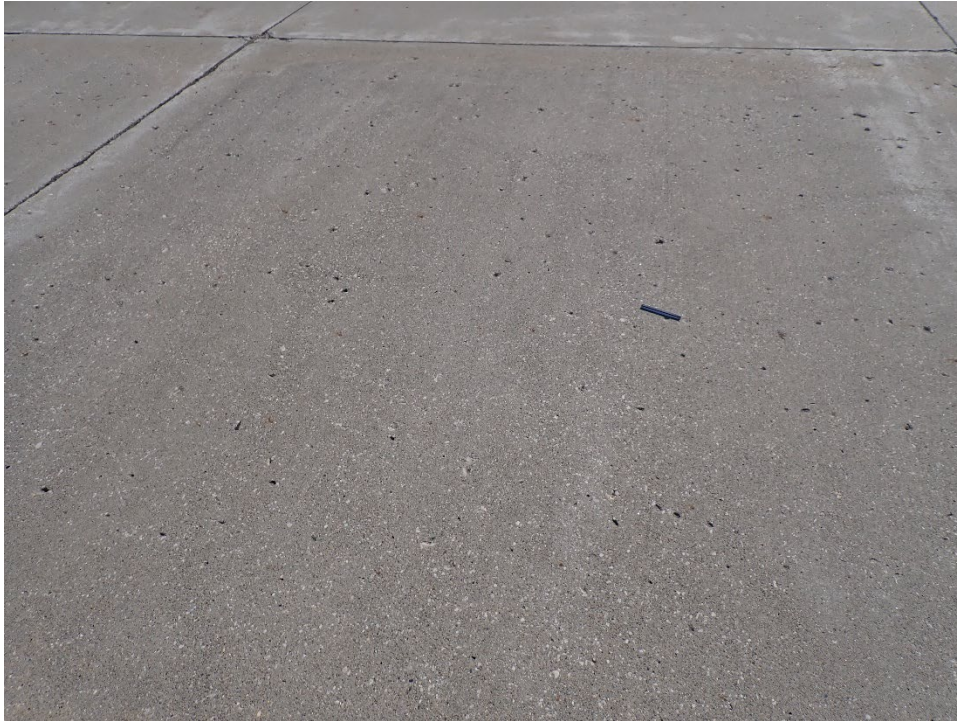
A01AN-02. Popouts (Sample Unit No. 05).

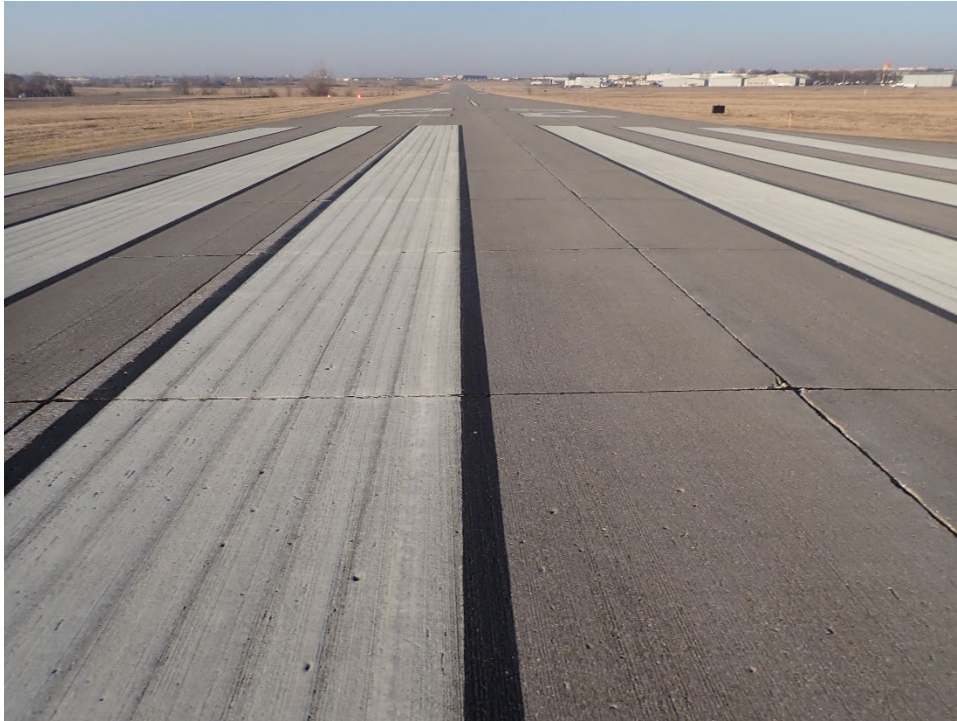
R04AN-01. Overview.

| Branch | Section | Surface Type | Section Area (sf) | LCD | 2025 PCI | % Distress Due to Load | % Distress Due to Climate/Durability | % Distress Due to Other | Type of Distress |
|---|---|---|---|---|---|---|---|---|---|
| R04AN | 01 | PCC | 98,351 | 10/30/1999 | 77 | 0 | 48 | 52 | ASR, Corner Spalling, Faulting, Joint Spalling, Joint Seal Damage, Large Patch, Small Patch |

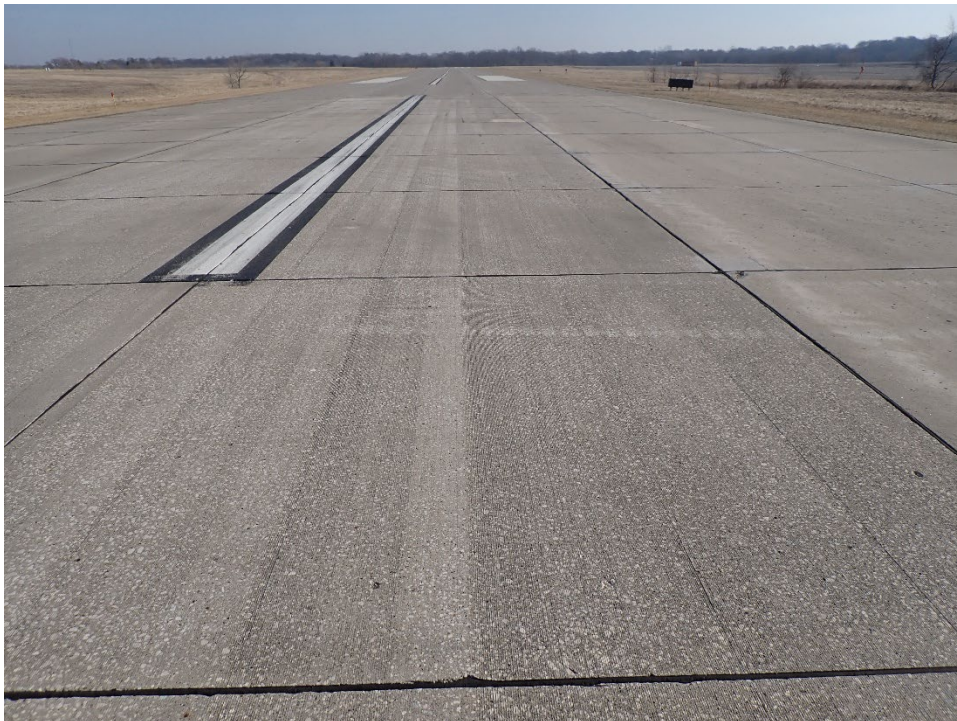
R04AN-02. Overview.

| Branch | Section | Surface Type | Section Area (sf) | LCD | 2025 PCI | % Distress Due to Load | % Distress Due to Climate/Durability | % Distress Due to Other | Type of Distress |
|---|---|---|---|---|---|---|---|---|---|
| R04AN | 02 | PCC | 20,118 | 10/31/1993 | 46 | 0 | 21 | 79 | ASR, Corner Spalling, Joint Spalling, Joint Seal Damage, Large Patch, Popouts, Small Patch |

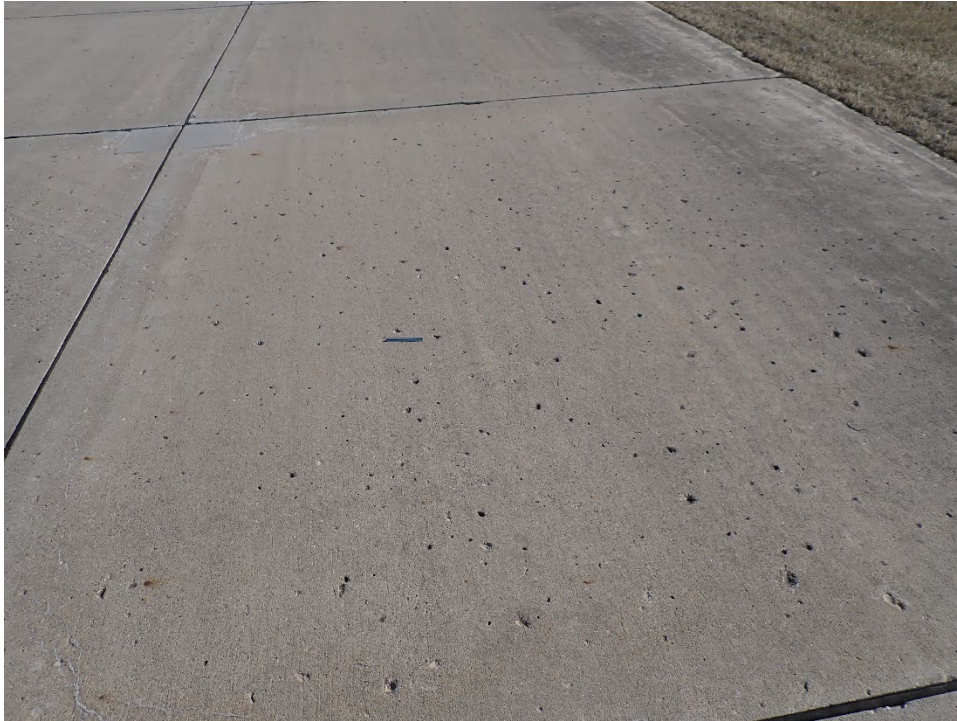
R04AN-02. Popouts (Sample Unit No. 03).

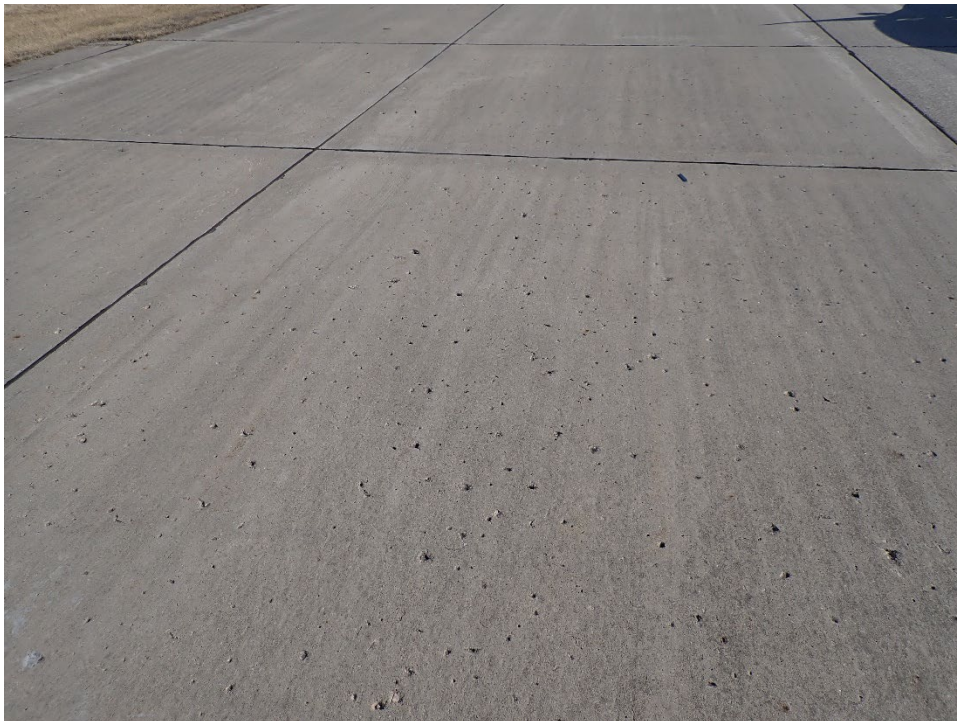
R04AN-02. Popouts (Sample Unit No. 04).

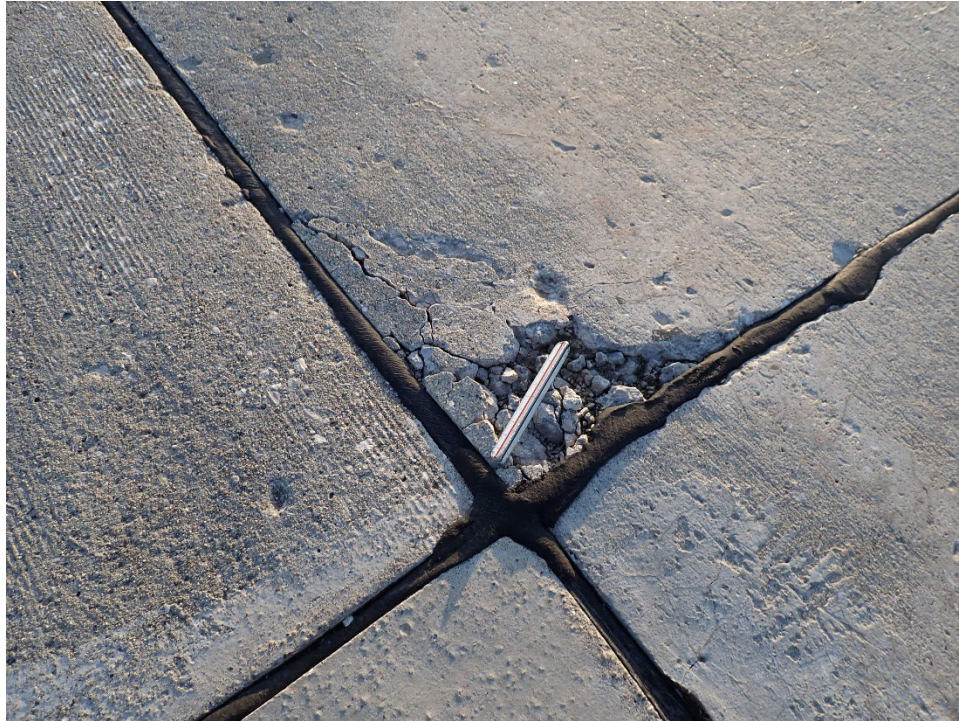
R04AN-03. ASR (Sample Unit No. 05).

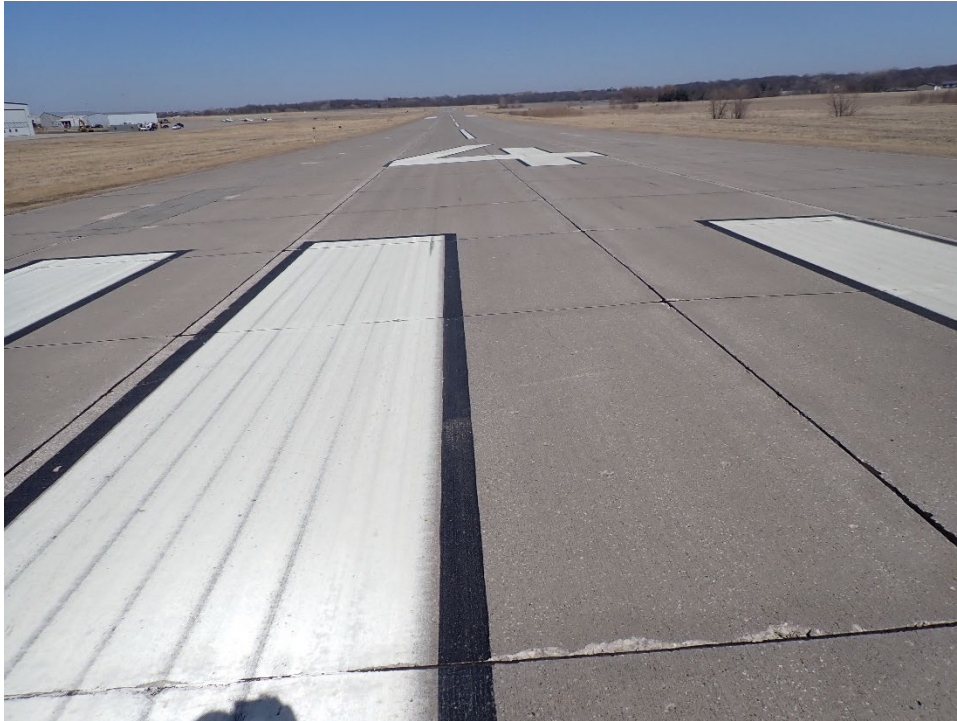
R04AN-04. Overview.

| Branch | Section | Surface Type | Section Area (sf) | LCD | 2025 PCI | % Distress Due to Load | % Distress Due to Climate/Durability | % Distress Due to Other | Type of Distress |
|---|---|---|---|---|---|---|---|---|---|
| R04AN | 04 | PCC | 168,335 | 10/30/1999 | 44 | 3 | 21 | 76 | ASR, Corner Spalling, Faulting, Joint Spalling, Joint Seal Damage, Large Patch, LTD Cracking, Small Patch |

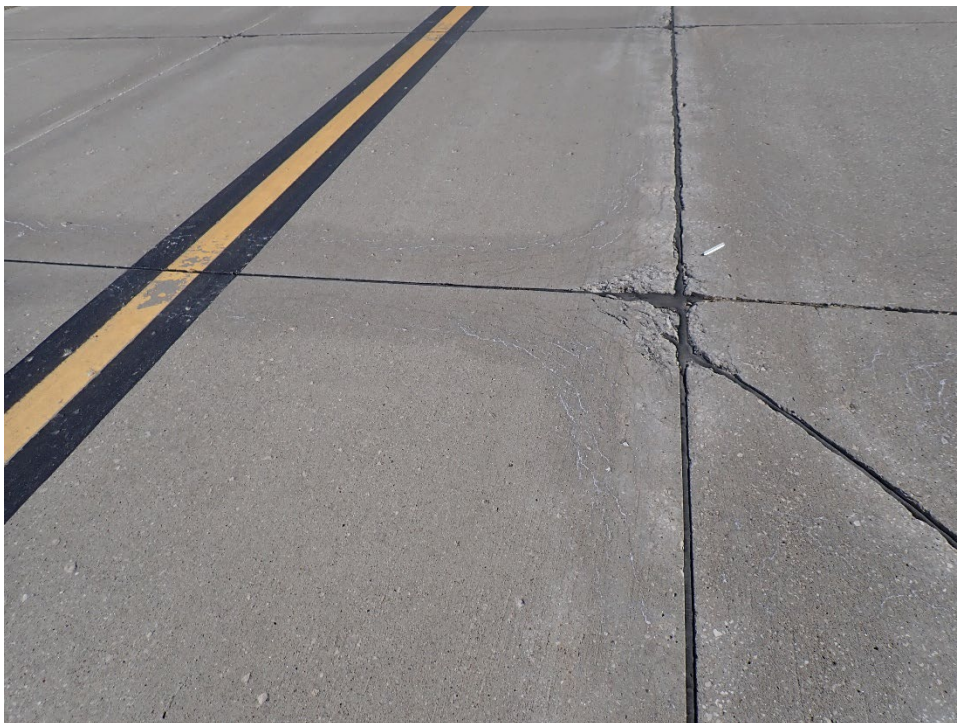
R04AN-04. ASR (Sample Unit No. 09).

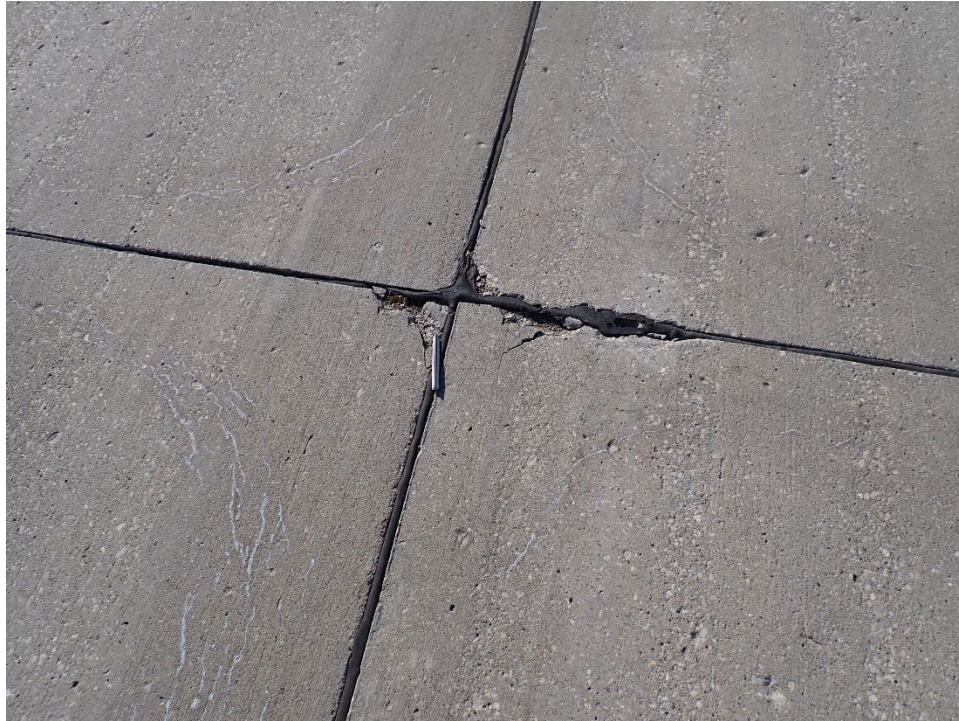
R18AN-01. ASR (Sample Unit No. 54).

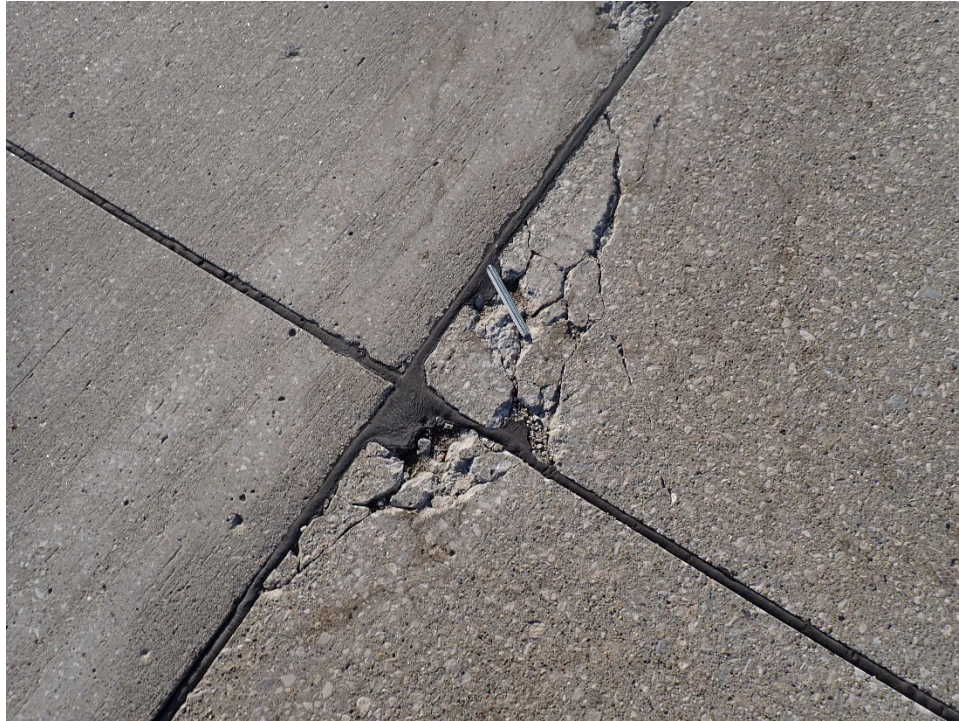
T02AN-01. ASR (Sample Unit No. 03).

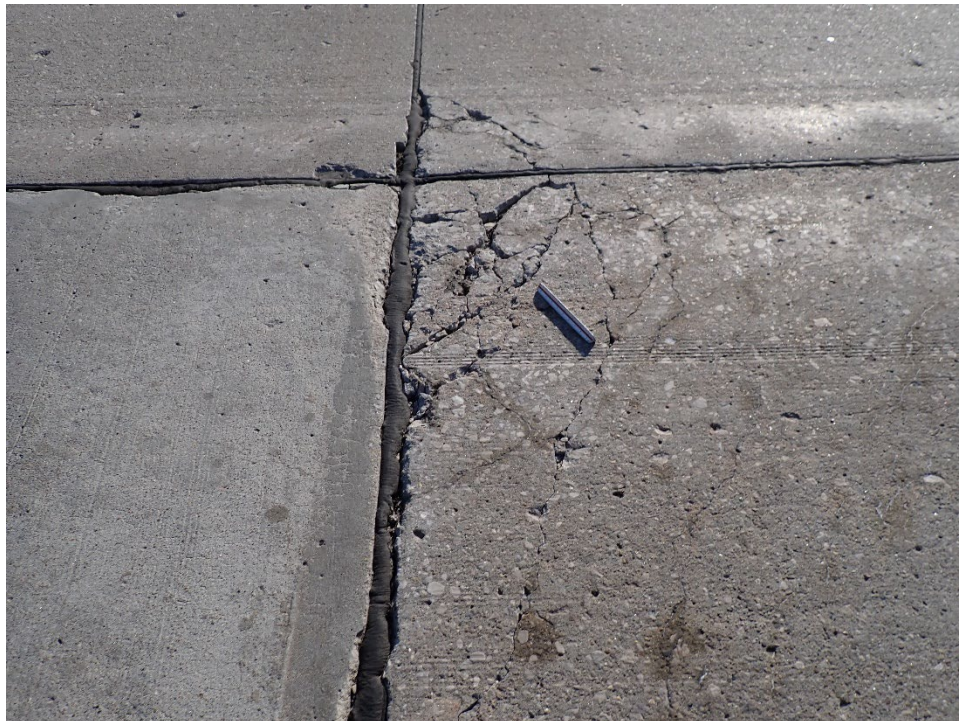
T02AN-01. ASR (Sample Unit No. 06).

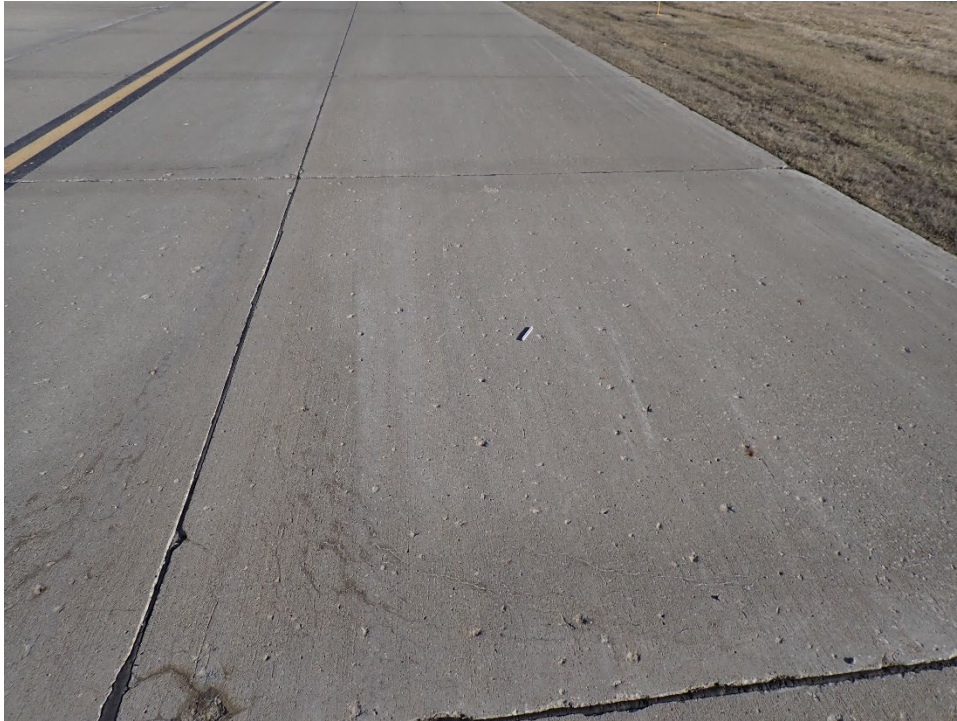
T02AN-01. Popouts (Sample Unit No. 06).

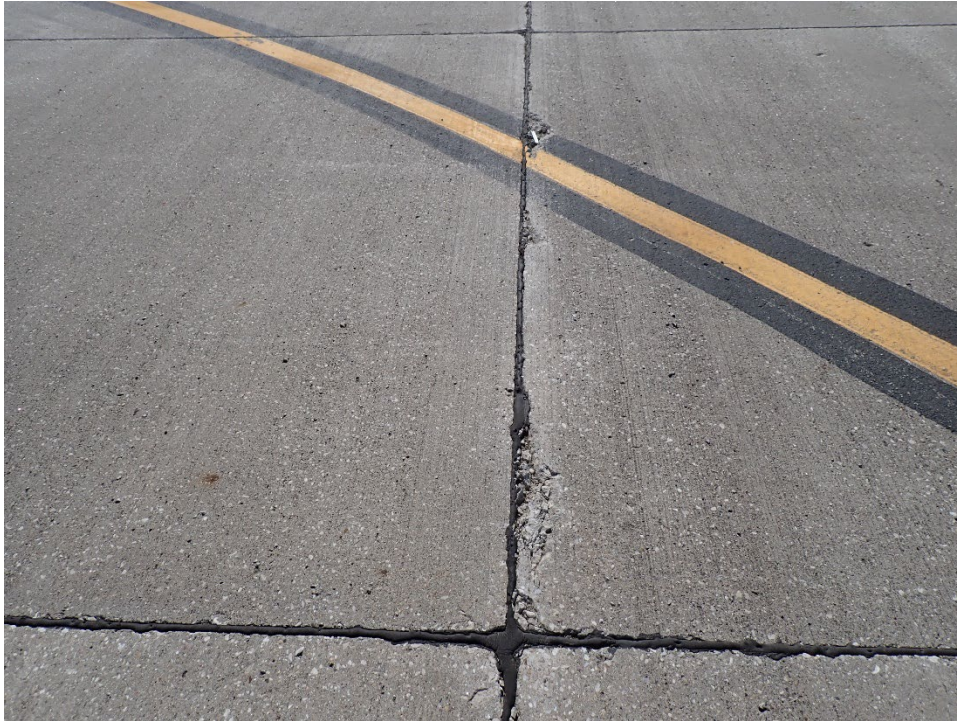
T03AN-01. ASR (Sample Unit No. 01).

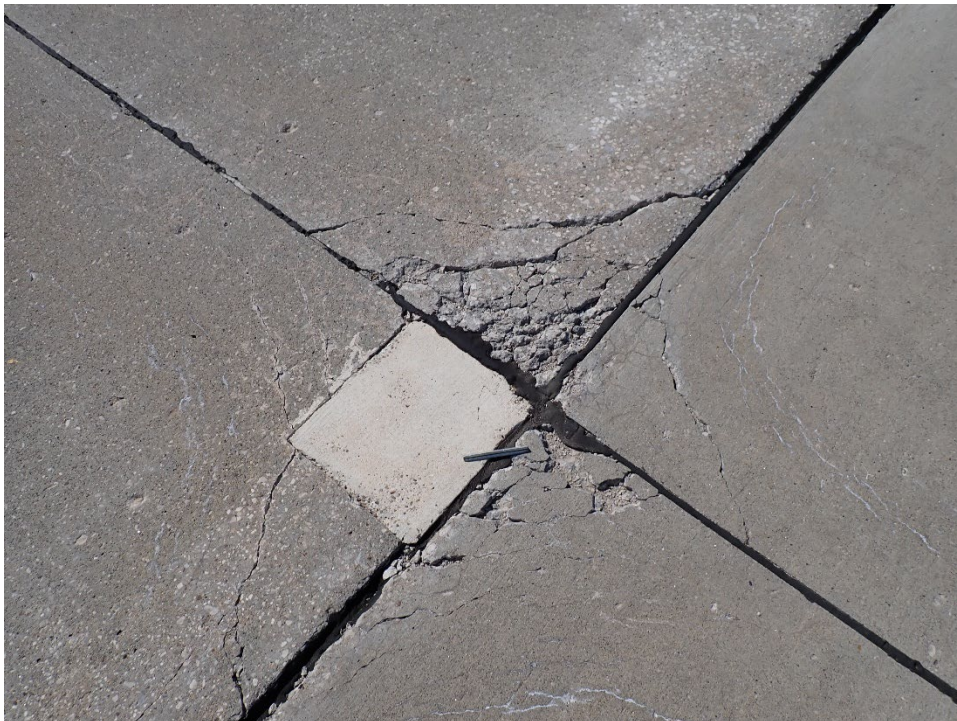
T03AN-01. ASR (Sample Unit No. 03).

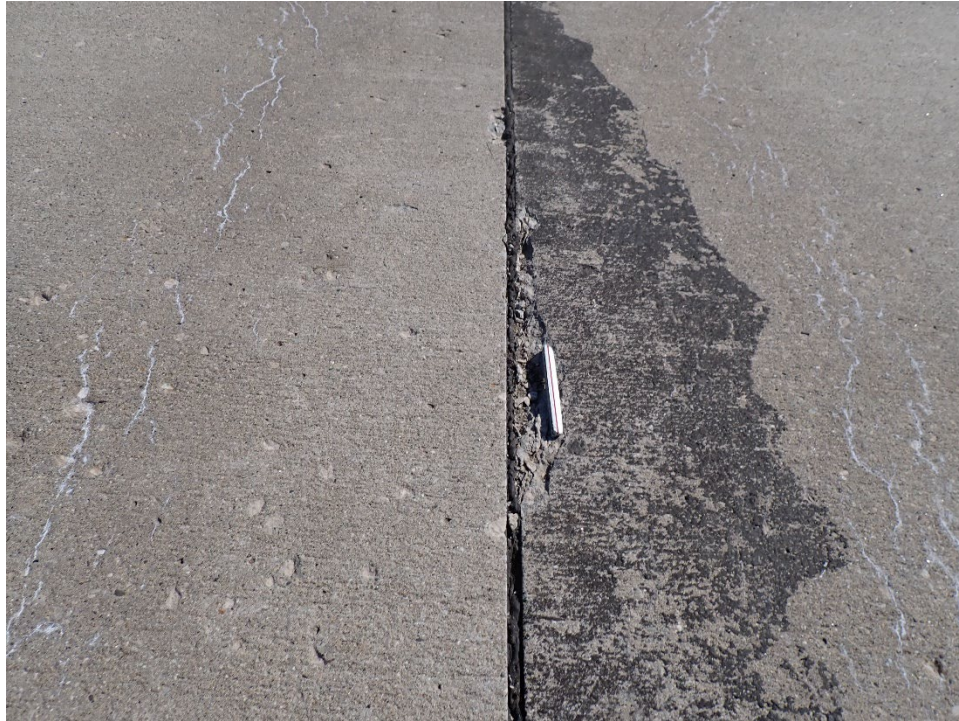
T05AN-01. ASR (Sample Unit No. 05).

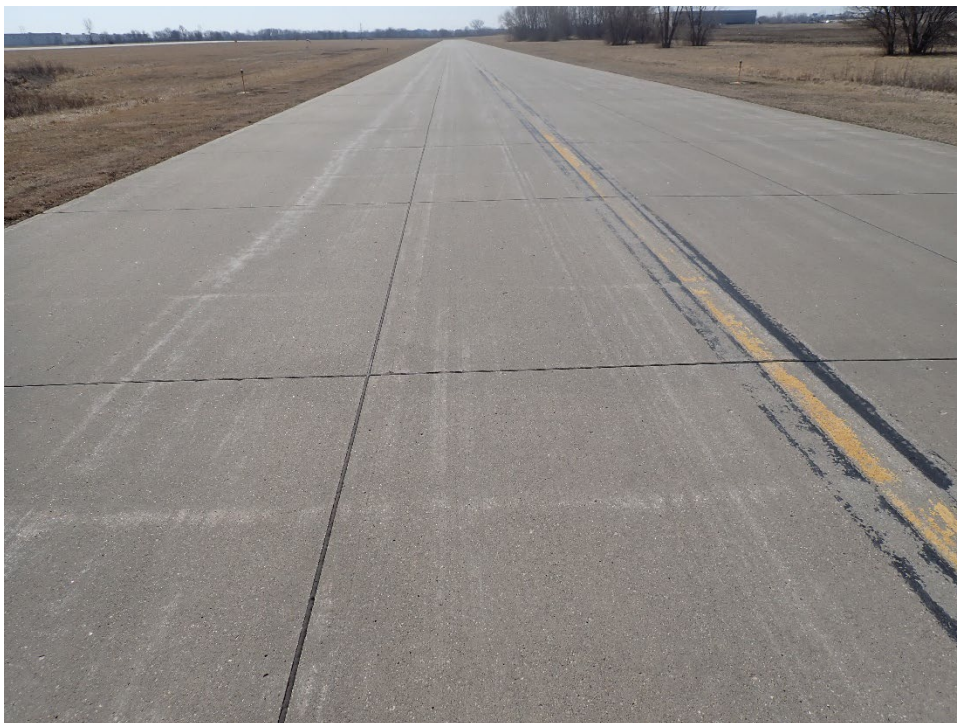
T06AN-01. ASR (Sample Unit No. 02).

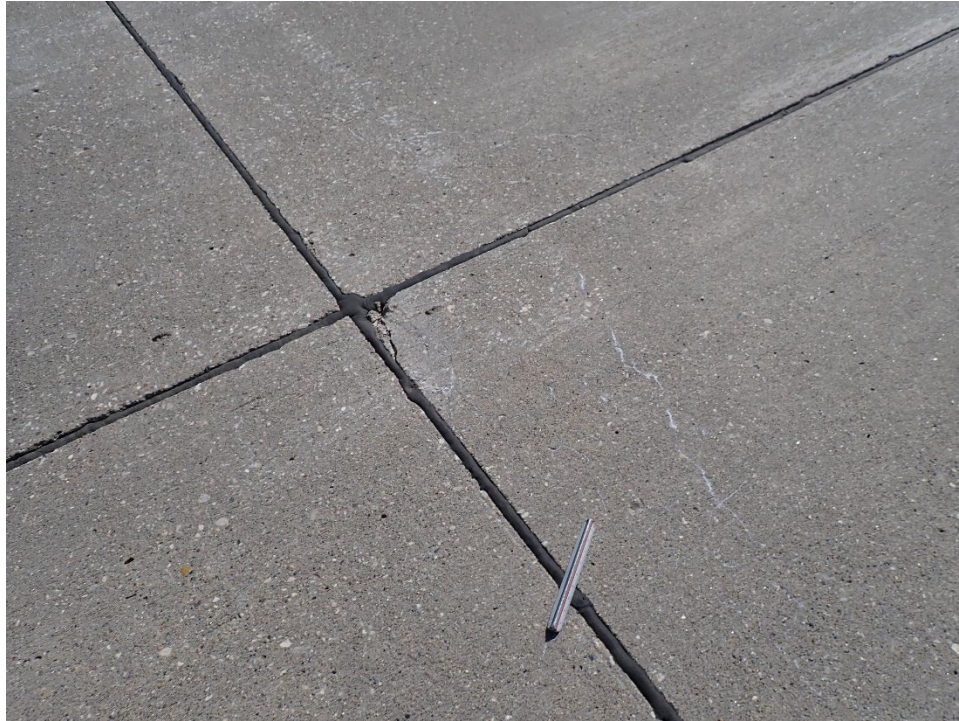
T06AN-01. Corner Break (Sample Unit No. 02).

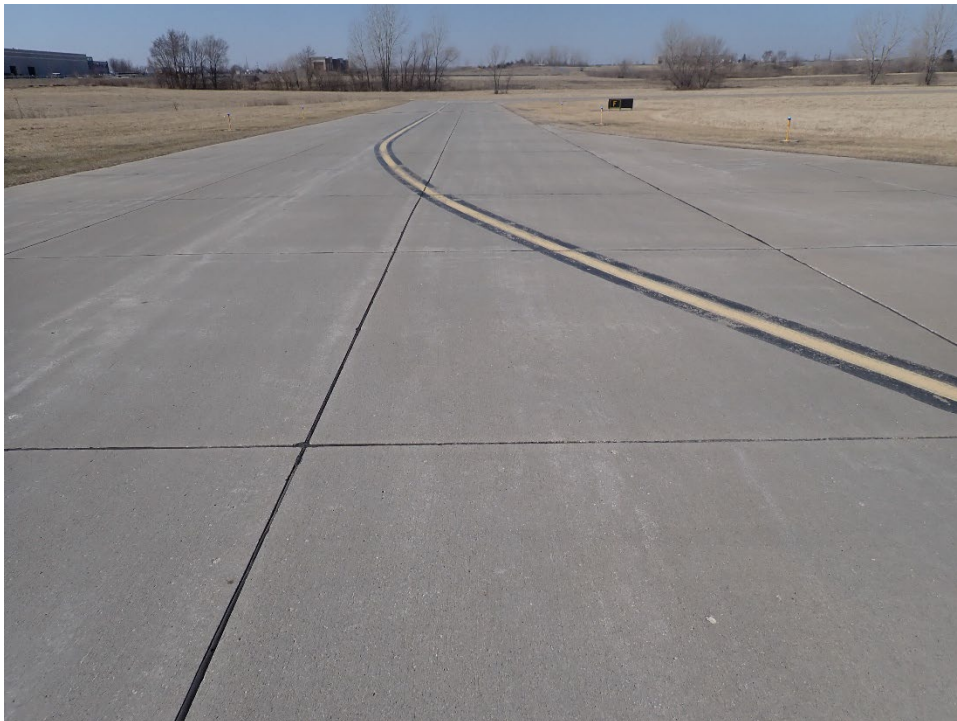
T07AN-01. Corner Break (Sample Unit No. 04).

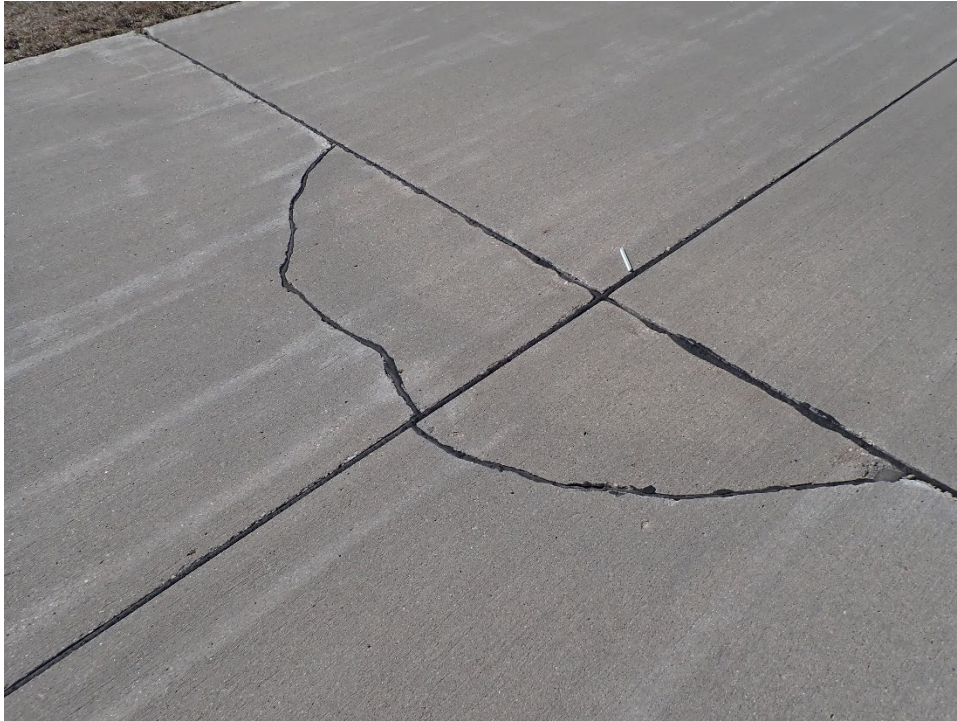
T07AN-01. Small Patching (Sample Unit No. 04).

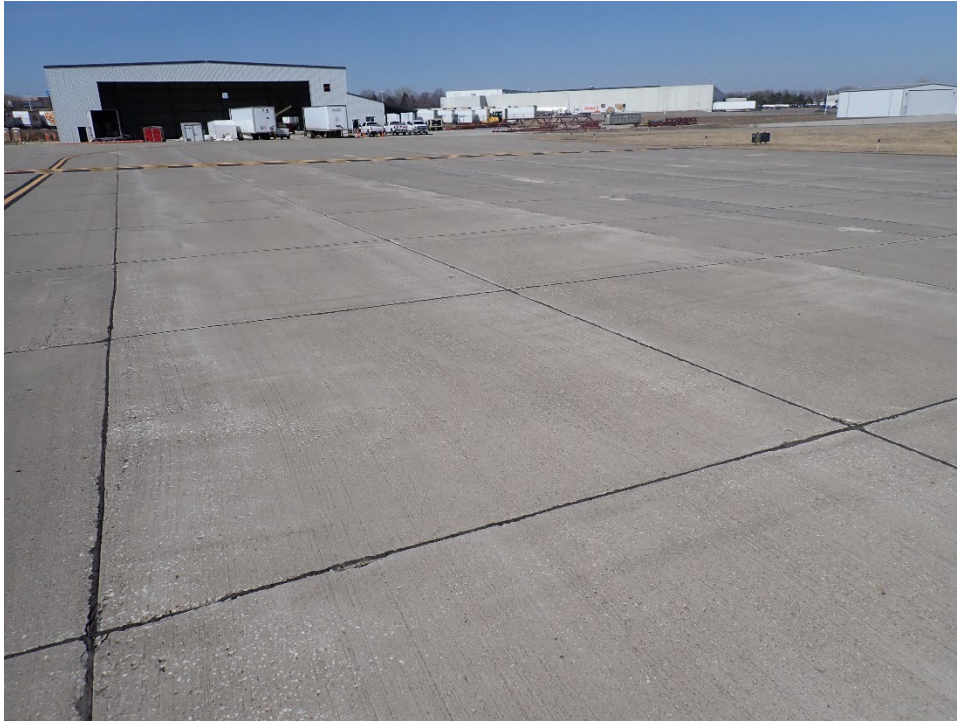
T08AN-01. ASR (Sample Unit No. 04).

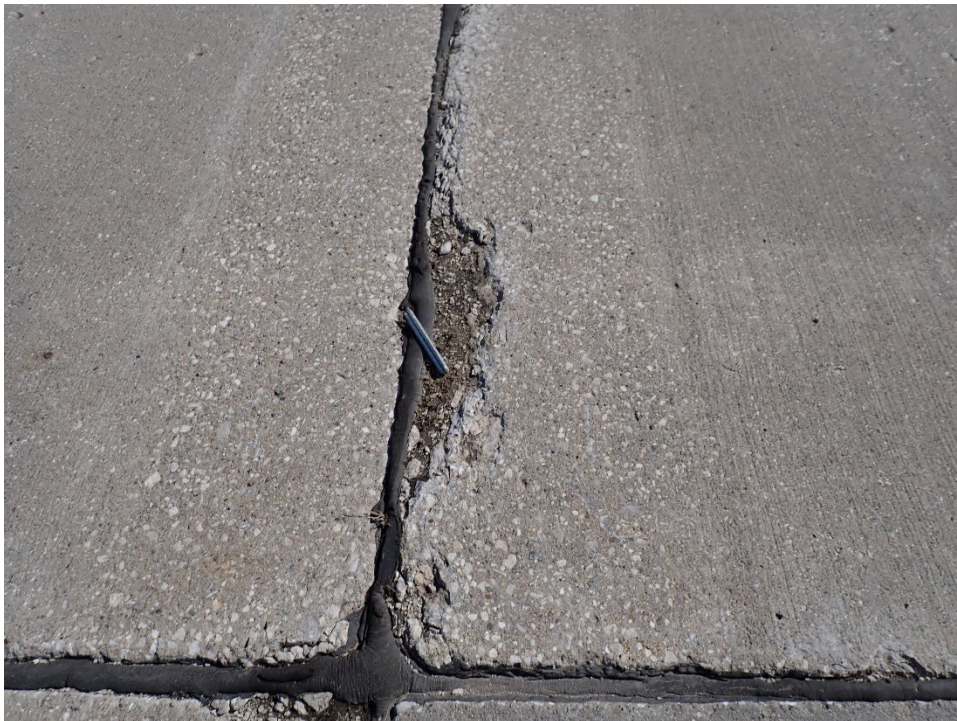
T08AN-01. ASR (Sample Unit No. 06).

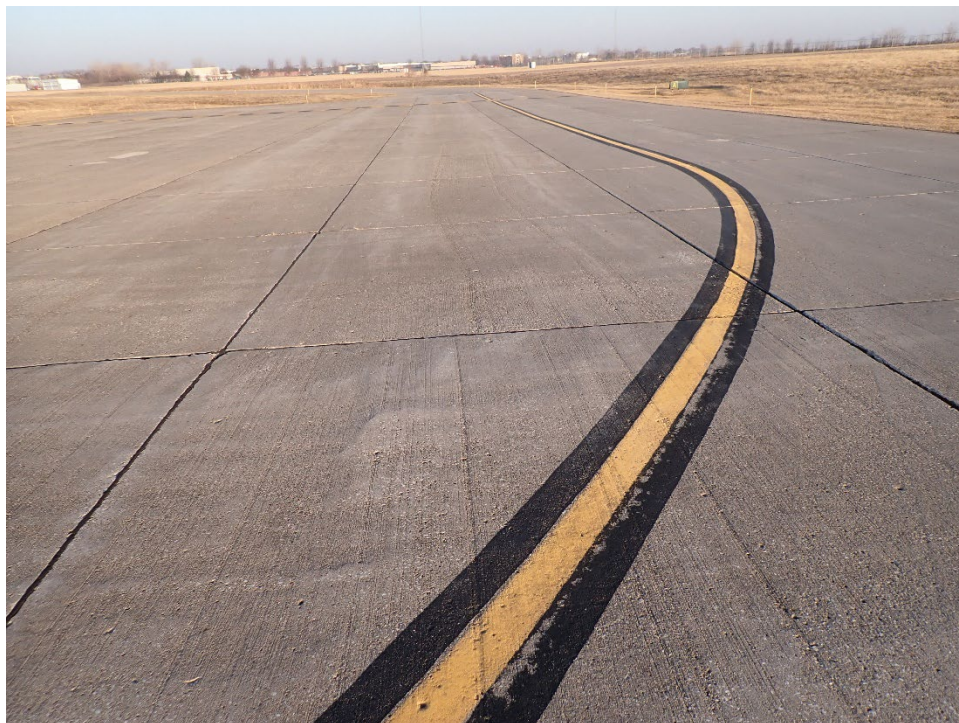
T09AN-01. ASR (Sample Unit No. 02).

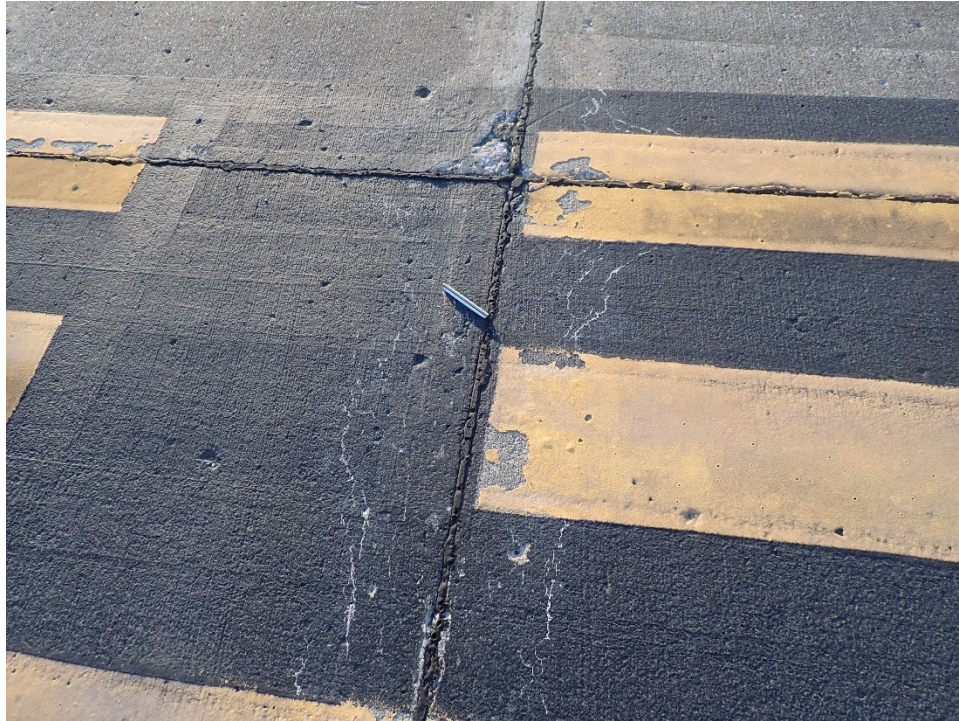
T09AN-01. Faulting (Sample Unit No. 04).

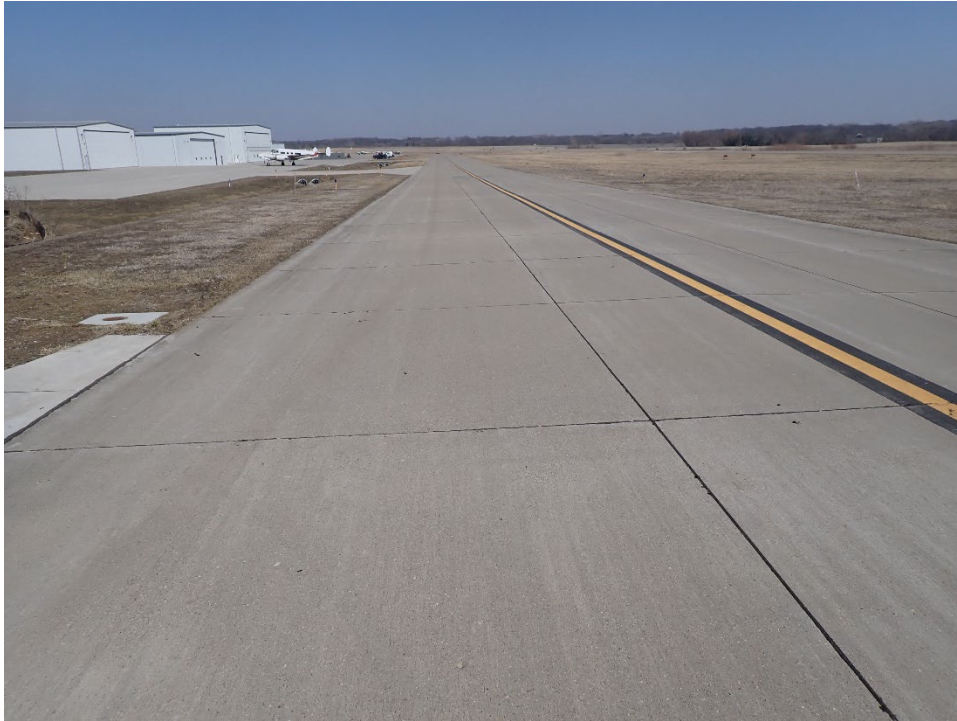
T12AN-01. Corner Spalling (Sample Unit No. 06).

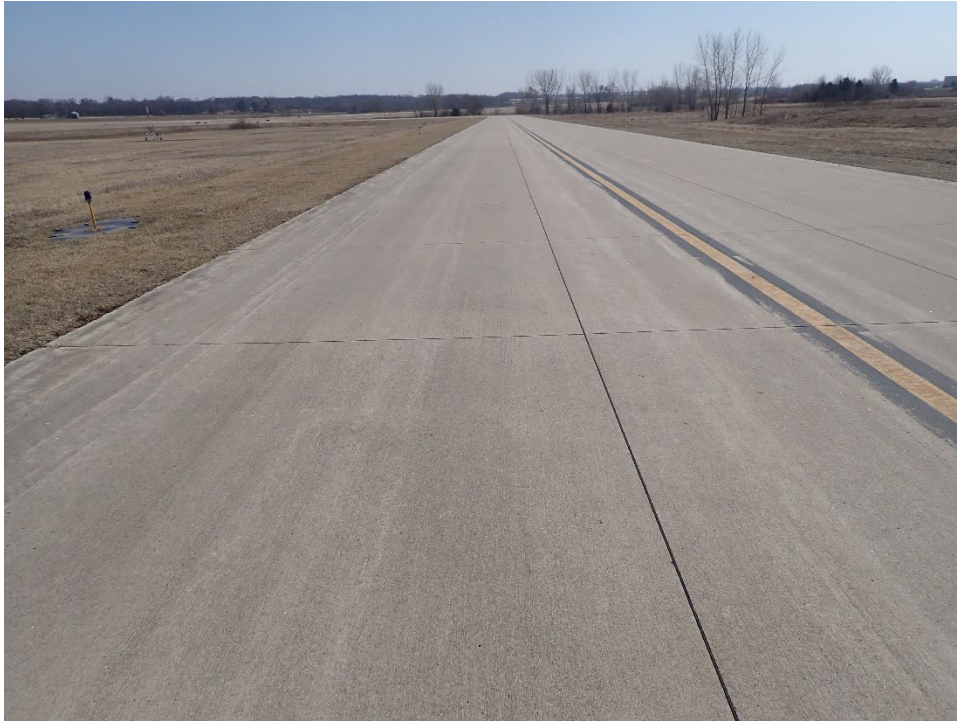
T13AN-01. ASR (Sample Unit No. 08) (1).

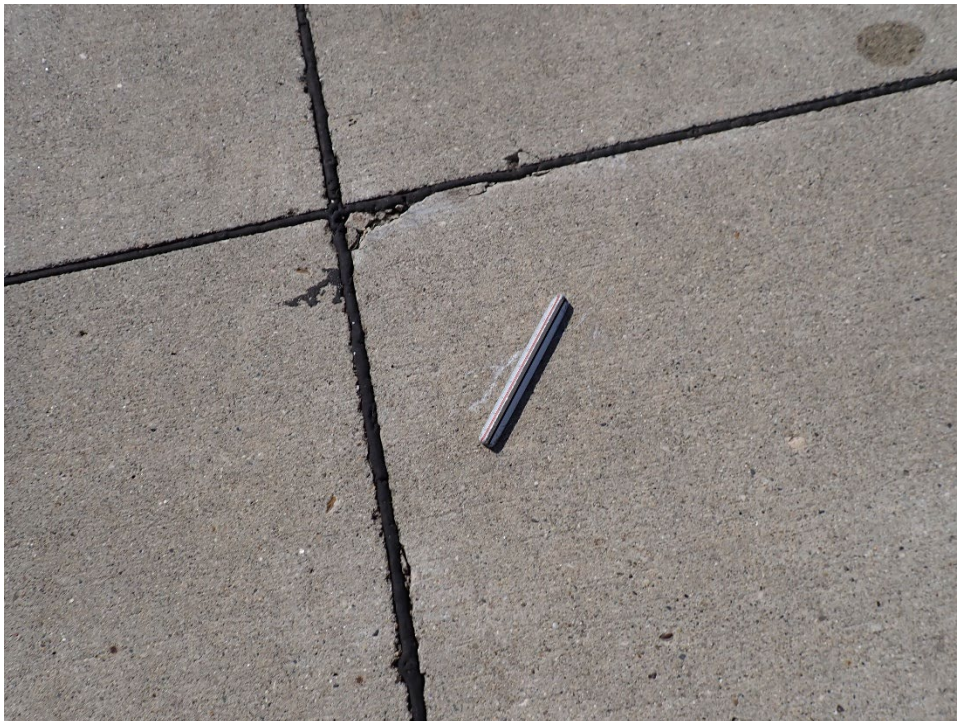
T13AN-01. ASR (Sample Unit No. 08) (2).

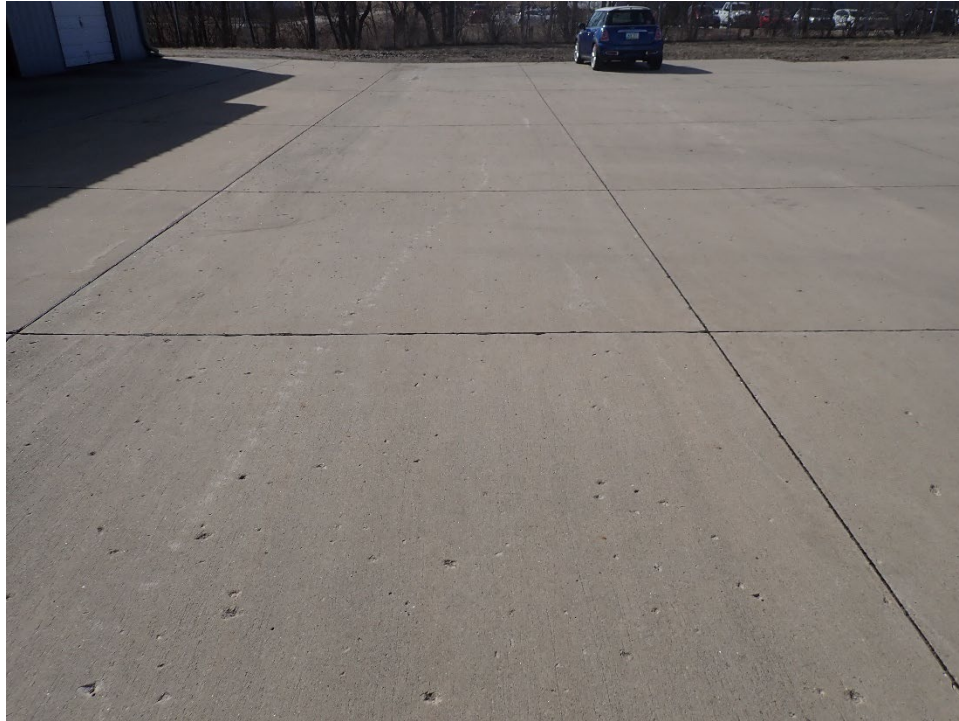
TH01AN-01. ASR (Sample Unit No. 01).

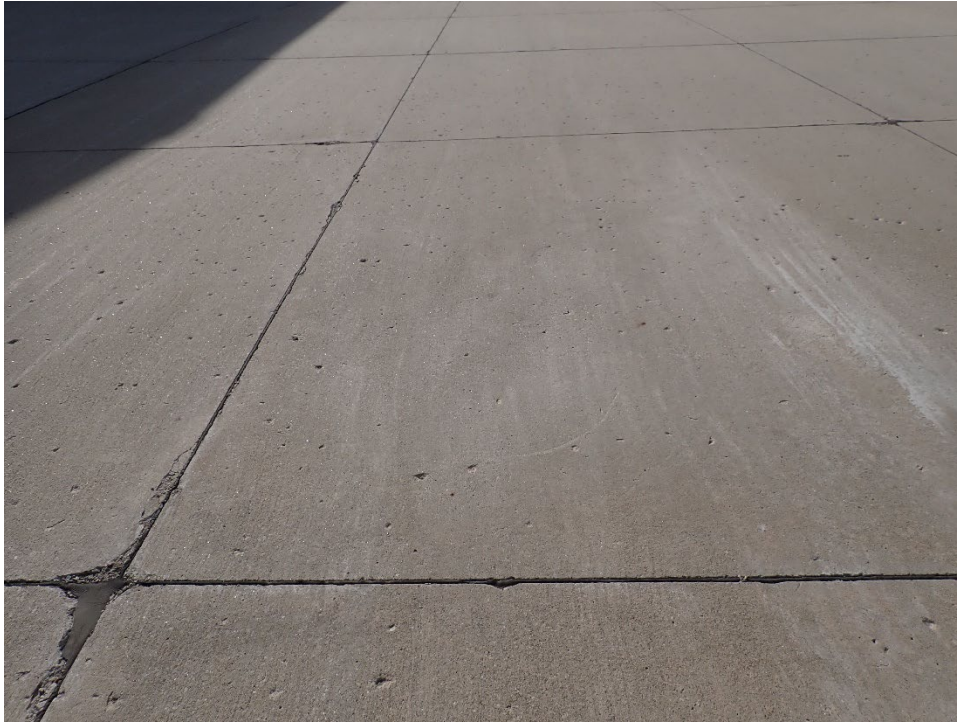
TH01AN-01. Popouts (Sample Unit No. 04).
