# Ankeny Regional Airport

## Pavement Management Report

**AUGUST 2025**

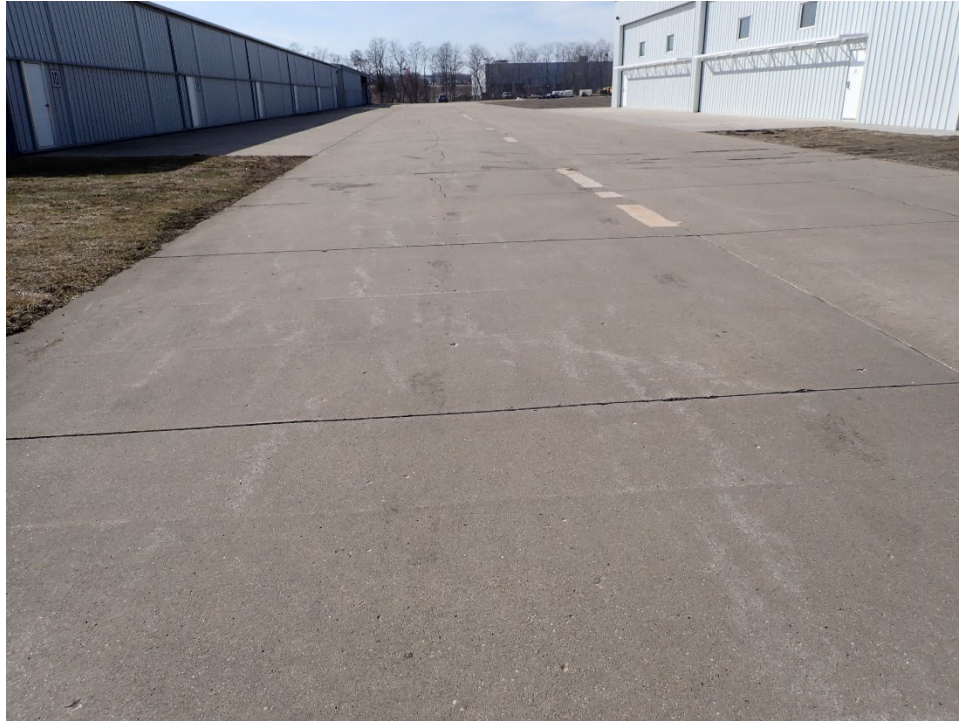
TH01AN-02. LTD Cracking (Sample Unit No. 18).

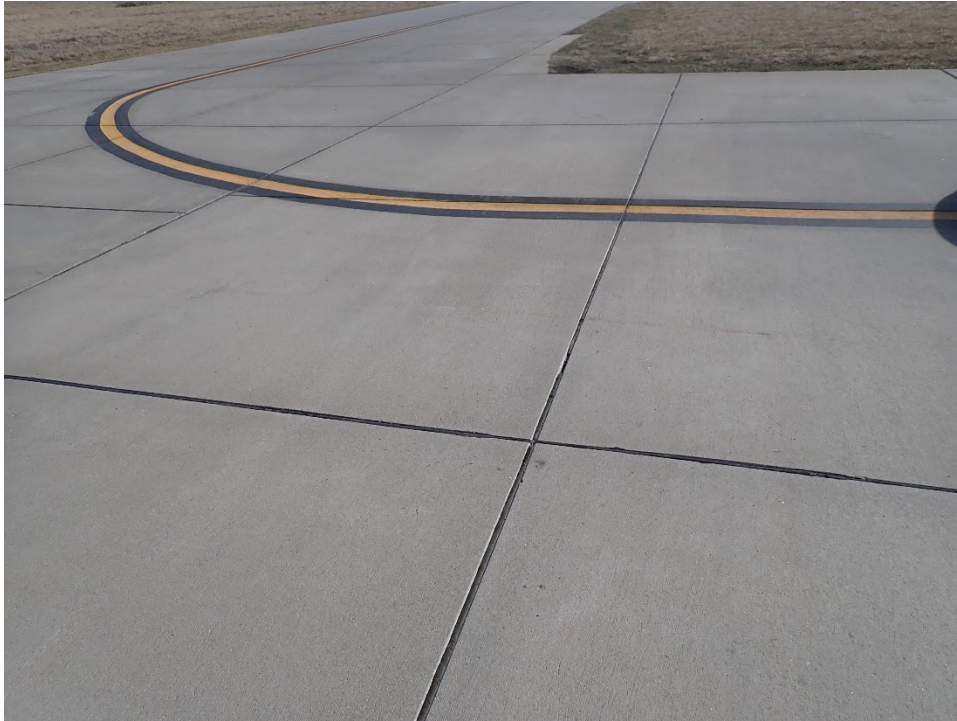
TH01AN-04. Joint Seal Damage (Sample Unit No. 07).
