Southeast Iowa Regional Airport

**Pavement Management Report**

#### AUGUST 2025

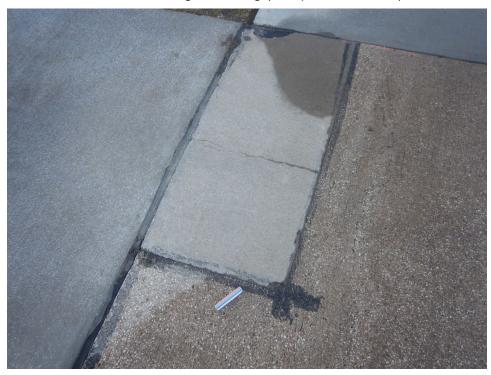
A01BR-02. Shattered Slab (Sample Unit No. 05).

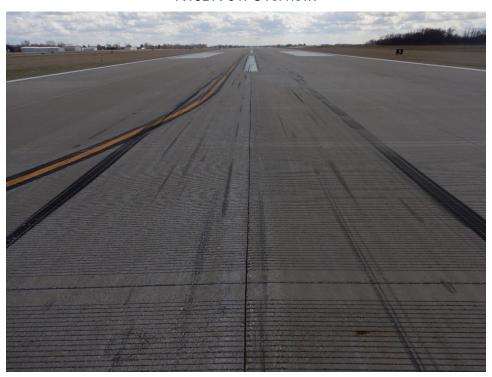
R18BR-01 Faulting. (Sample Unit No. 015).

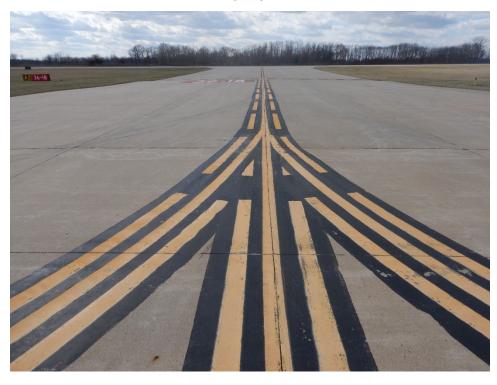
TA2BR-01. ASR (Sample Unit No. 04).

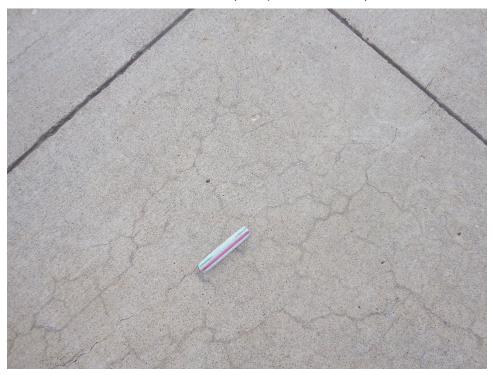
TA2BR-01. Small Patching (Sample Unit No. 04).

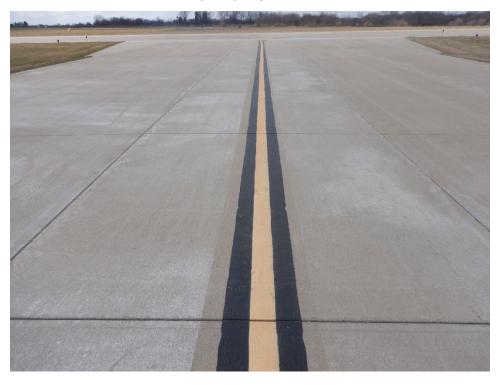
TA3BR-02. Joint Seal Damage (Sample Unit No. 02).

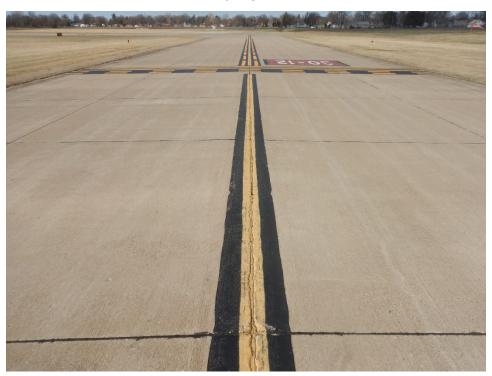
TABR-01. Corner Break (Sample Unit No. 03).

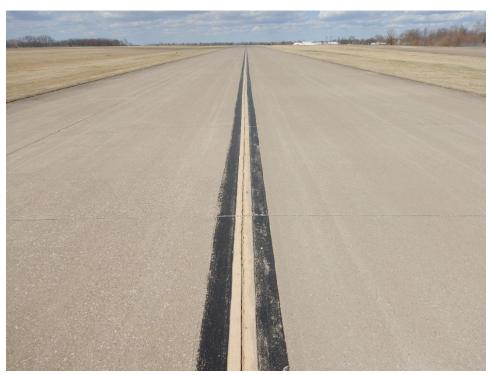
TABR-02. ASR (Sample Unit No. 94).

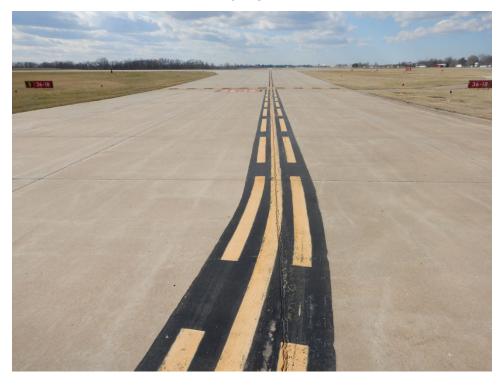
TBBR-02. Joint Seal Damage (Sample Unit No. 02).

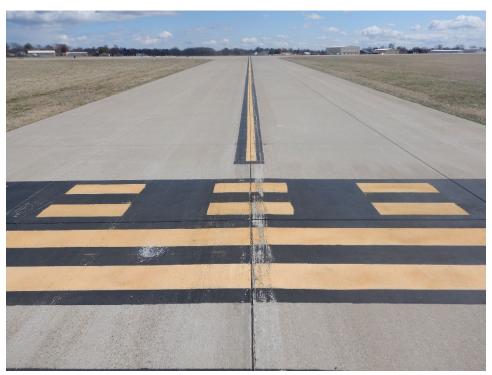
TBBR-03. Corner Spalling (Sample Unit No. 01).

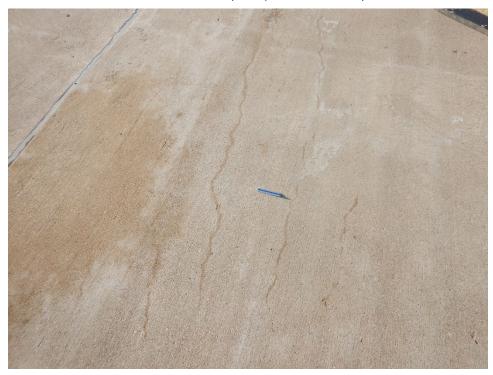
TCBR-01. Large Patching (Additional Sample Unit No. 11).

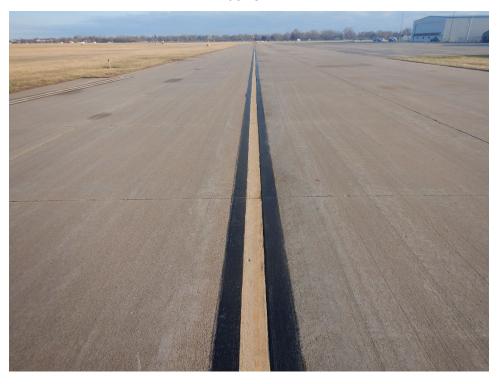
TDBR-03. Corner Spalling (Sample Unit No. 04).

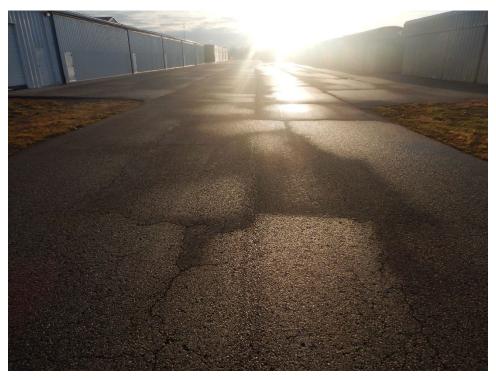
TH01BR-01. L&T Cracking (Sample Unit No. 02).

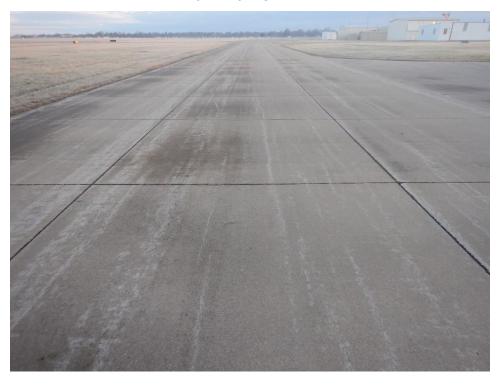
TH01BR-02. Corner Spalling (Sample Unit No. 04).
