# Clinton Municipal Airport

## Pavement Management Report

**AUGUST 2025**

# CLINTON MUNICIPAL AIRPORT PAVEMENT MANAGEMENT REPORT

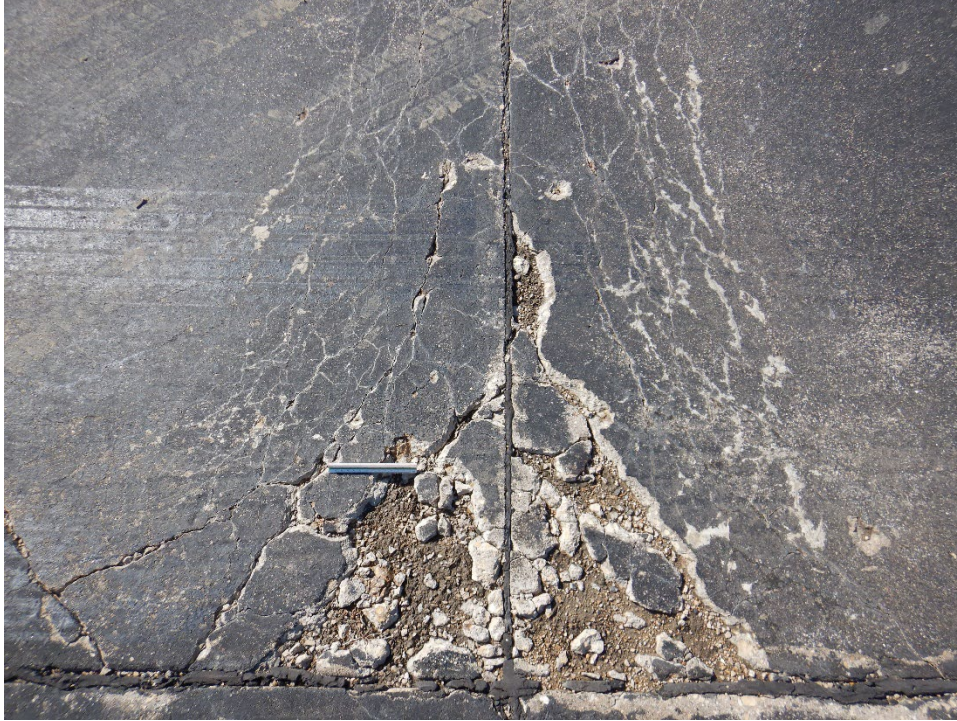
A01CN-01. ASR (Sample Unit No. 01) (1).

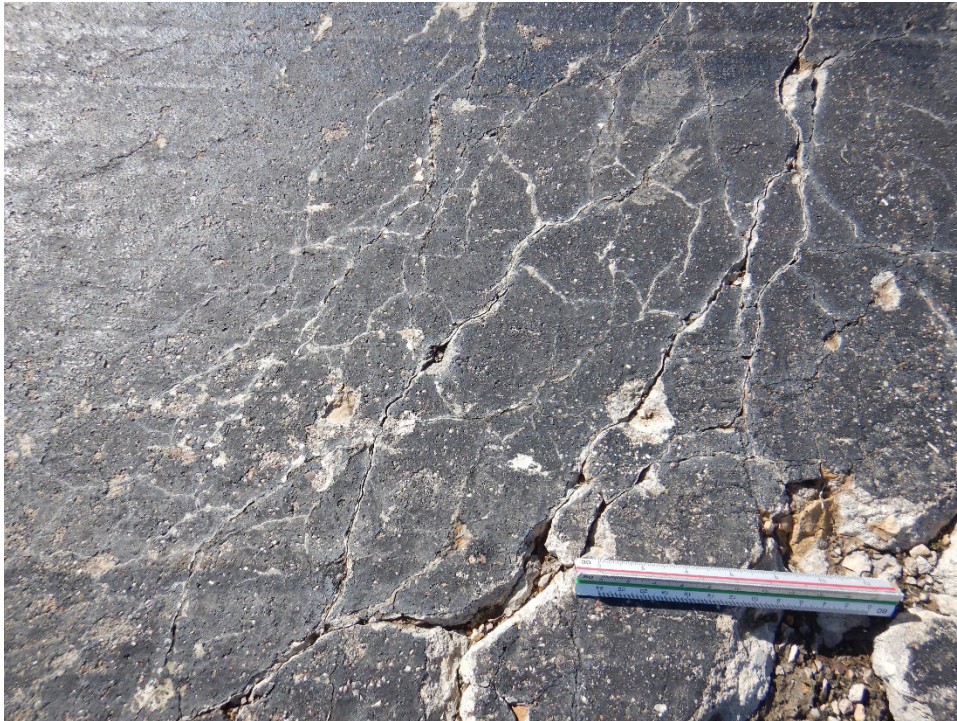
A01CN-01. ASR (Sample Unit No. 01) (2).

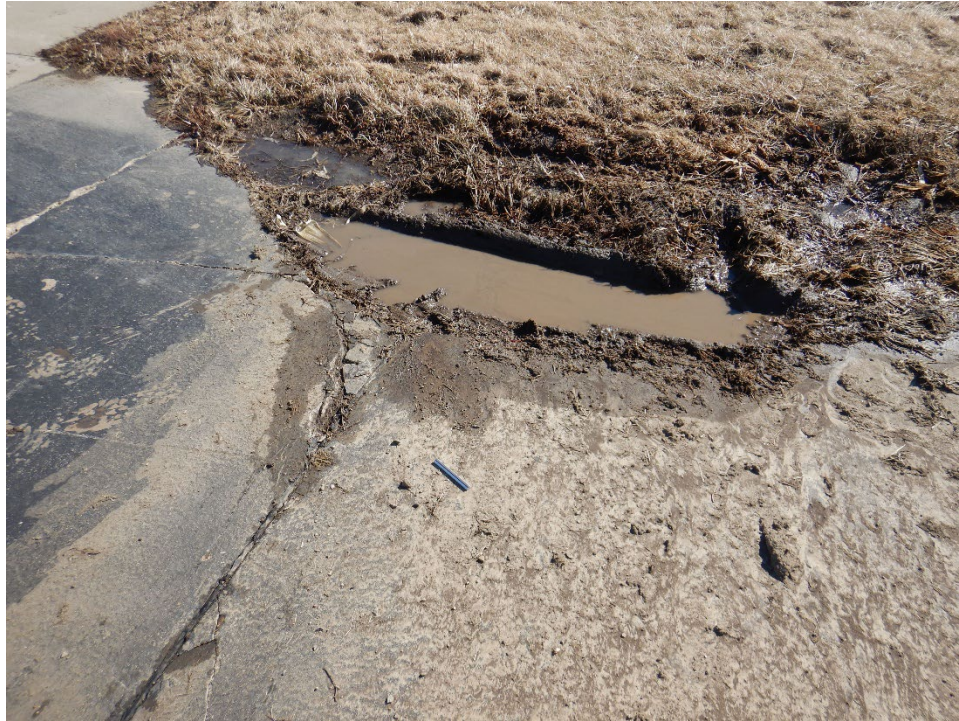
A01CN-01. ASR (Sample Unit No. 01) (3).

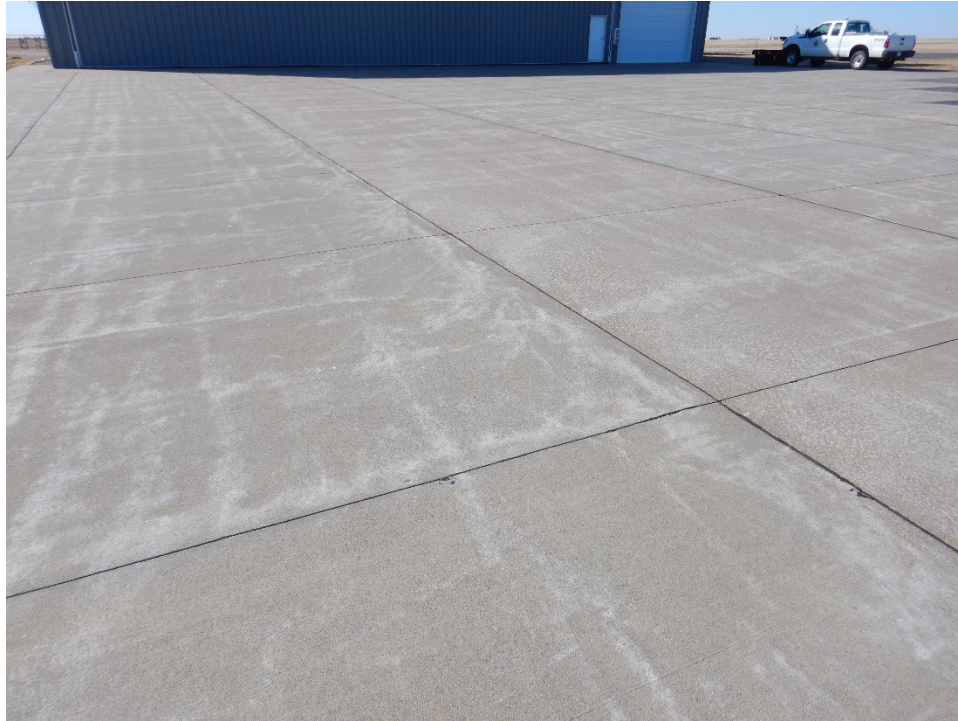
A01CN-02. Overview.

| Branch | Section | Surface Type | Section Area (sf) | LCD | 2025 PCI | % Distress Due to Load | % Distress Due to Climate/ Durability | % Distress Due to Other | Type of Distress |
|---|---|---|---|---|---|---|---|---|---|
| A01CN | 02 | PCC | 9,991 | 6/3/2014 | 88 | 39 | 58 | 3 | Corner Break, Joint Seal Damage, LTD Cracking, Shrinkage Cracking |

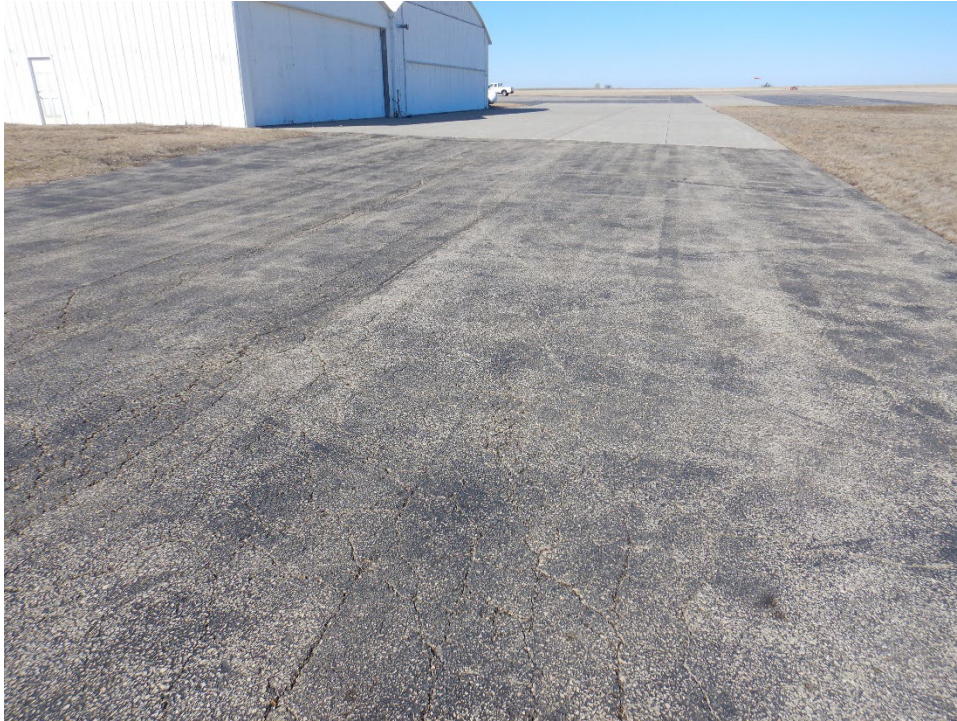
A01CN-03. Overview.

| Branch | Section | Surface Type | Section Area (sf) | LCD | 2025 PCI | % Distress Due to Load | % Distress Due to Climate/ Durability | % Distress Due to Other | Type of Distress |
|---|---|---|---|---|---|---|---|---|---|
| A01CN | 03 | AC | 2,415 | 1/1/1995 | 11 | 60 | 40 | 0 | Alligator Cracking, L&T Cracking, Raveling, Weathering |

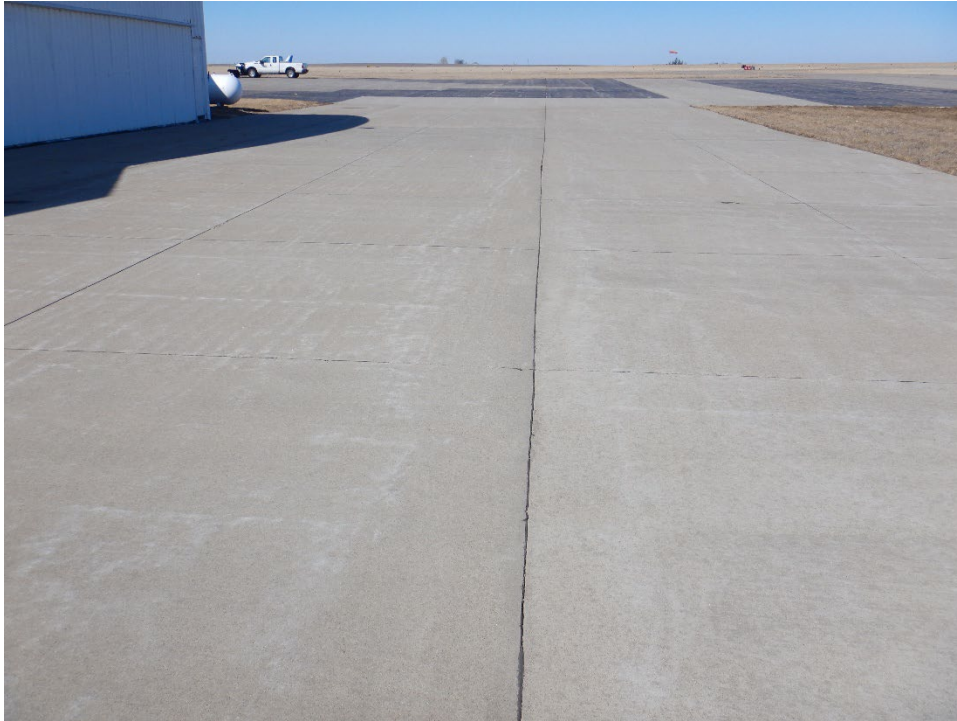
A01CN-04. Overview.

| Branch | Section | Surface Type | Section Area (sf) | LCD | 2025 PCI | % Distress Due to Load | % Distress Due to Climate/ Durability | % Distress Due to Other | Type of Distress |
|---|---|---|---|---|---|---|---|---|---|
| A01CN | 04 | PCC | 8,100 | 4/1/2016 | 91 | 45 | 20 | 35 | Corner Spalling, Joint Spalling, Joint Seal Damage, LTD Cracking, Small Patch |

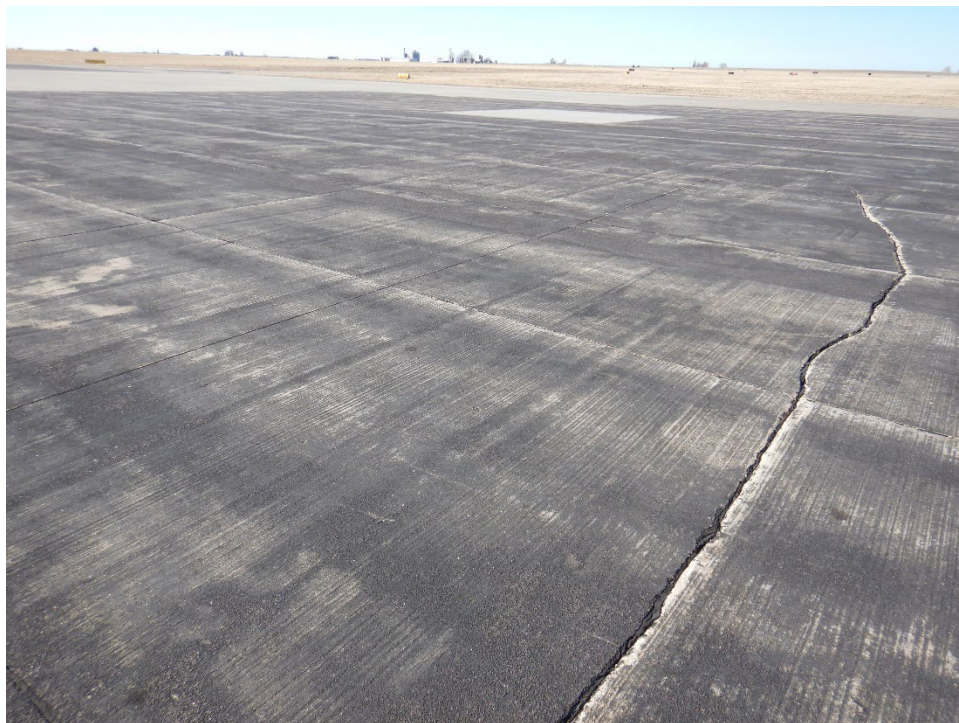
A02CN-01. Overview.

| Branch | Section | Surface Type | Section Area (sf) | LCD | 2025 PCI | % Distress Due to Load | % Distress Due to Climate/ Durability | % Distress Due to Other | Type of Distress |
|---|---|---|---|---|---|---|---|---|---|
| A02CN | 01 | PCC | 18,725 | 6/1/1981 | 47 | 56 | 14 | 30 | ASR, Corner Break, Corner Spalling, Joint Spalling, Joint Seal Damage, Large Patch, LTD Cracking, Shattered Slab |

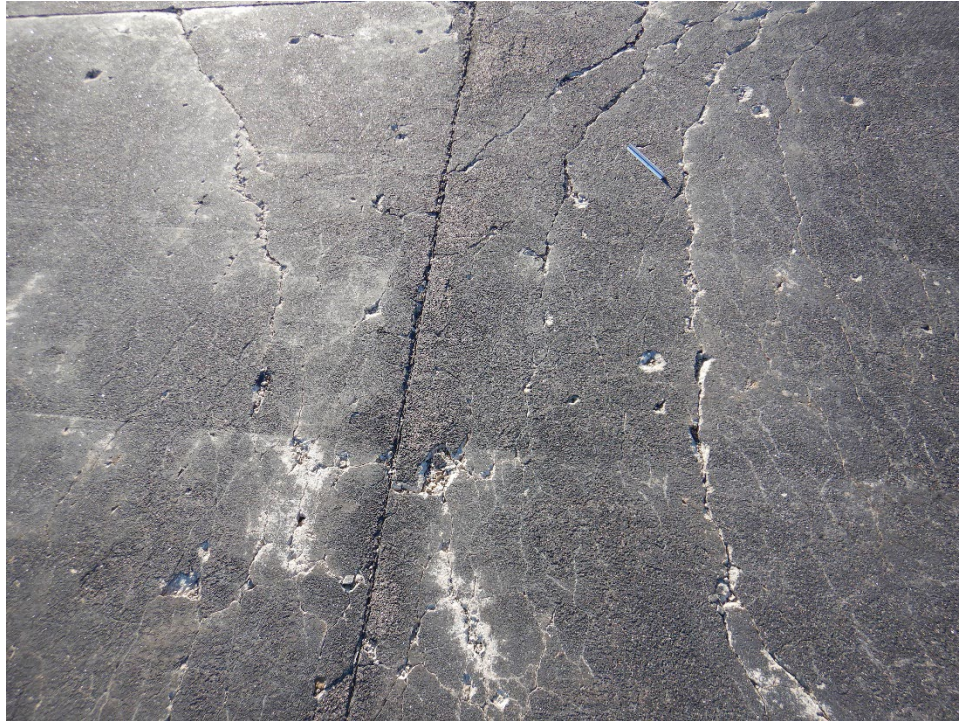
A02CN-01. ASR (Sample Unit No. 05).

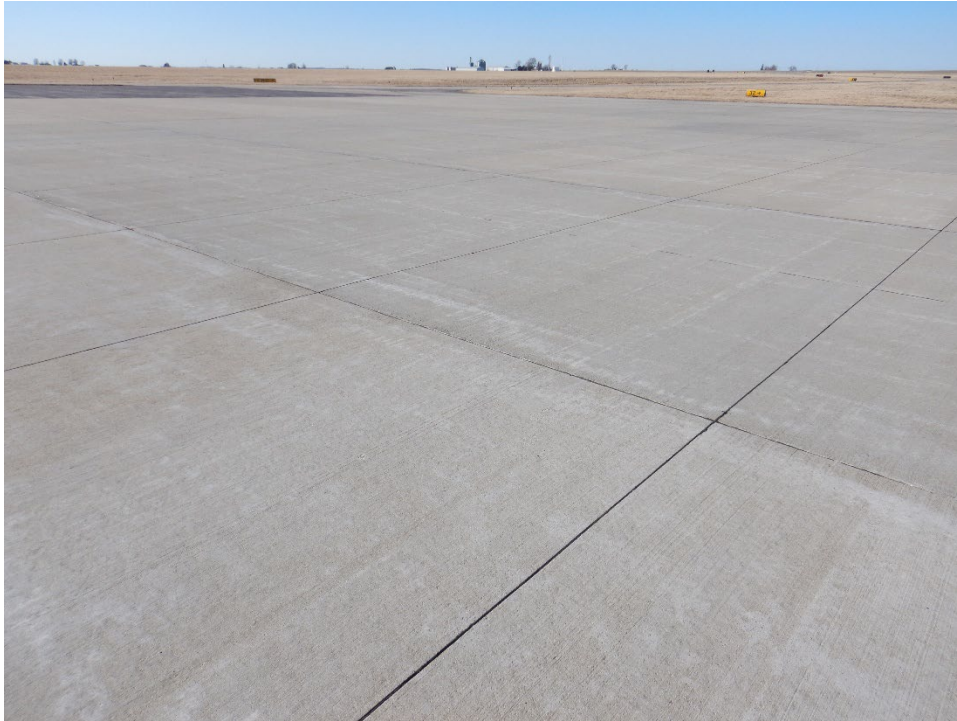
A02CN-02. Overview.

| Branch | Section | Surface Type | Section Area (sf) | LCD | 2025 PCI | % Distress Due to Load | % Distress Due to Climate/ Durability | % Distress Due to Other | Type of Distress |
|---|---|---|---|---|---|---|---|---|---|
| A02CN | 02 | PCC | 33,191 | 5/2/2020 | 98 | 0 | 71 | 29 | Joint Spalling, Joint Seal Damage |

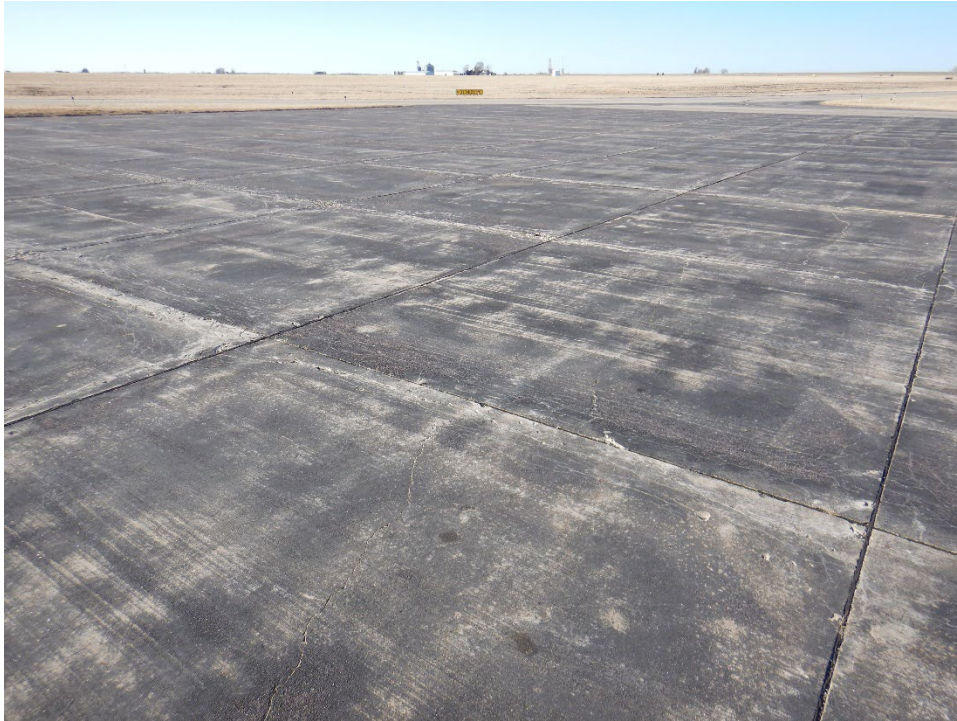
A02CN-03. Overview.

| Branch | Section | Surface Type | Section Area (sf) | LCD | 2025 PCI | % Distress Due to Load | % Distress Due to Climate/ Durability | % Distress Due to Other | Type of Distress |
|---|---|---|---|---|---|---|---|---|---|
| A02CN | 03 | PCC | 18,060 | 6/1/1984 | 9 | 14 | 8 | 78 | ASR, Joint Seal Damage, LTD Cracking |

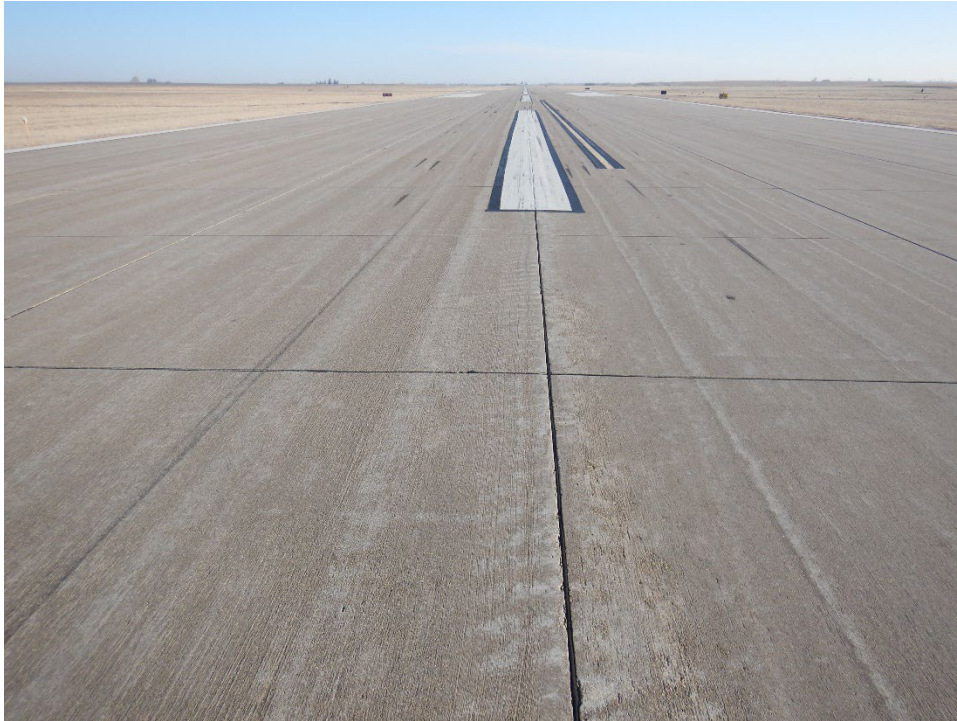
R03CN-01. Overview (1).

| Branch | Section | Surface Type | Section Area (sf) | LCD | 2025 PCI | % Distress Due to Load | % Distress Due to Climate/ Durability | % Distress Due to Other | Type of Distress |
|---|---|---|---|---|---|---|---|---|---|
| R03CN | 01 | PCC | 494,870 | 4/2/2010 | 91 | 40 | 47 | 13 | Corner Spalling, Joint Seal Damage, LTD Cracking, Scaling, Shattered Slab, Shrinkage Cracking |

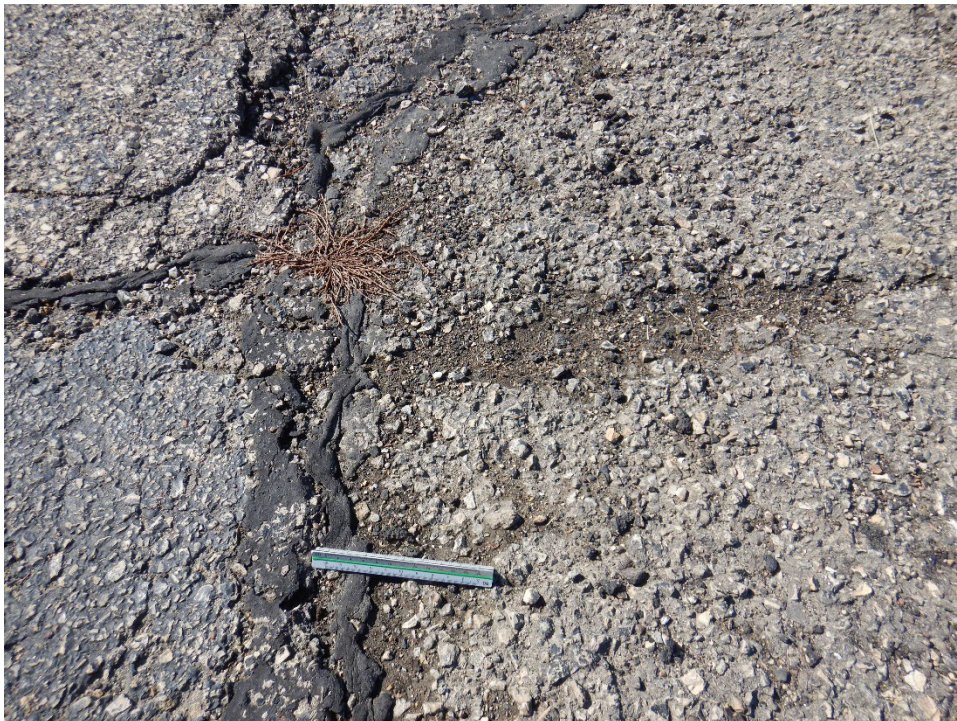
T04CN-01. Raveling (Sample Unit No. 01).

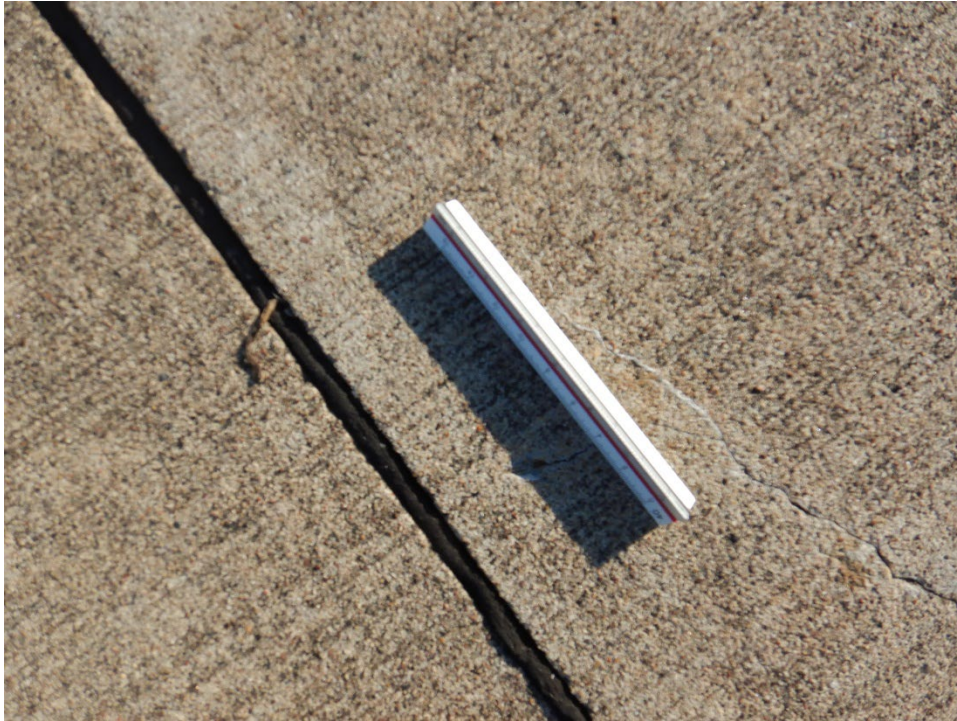
TA1CN-01. Corner Break (Sample Unit No. 04).

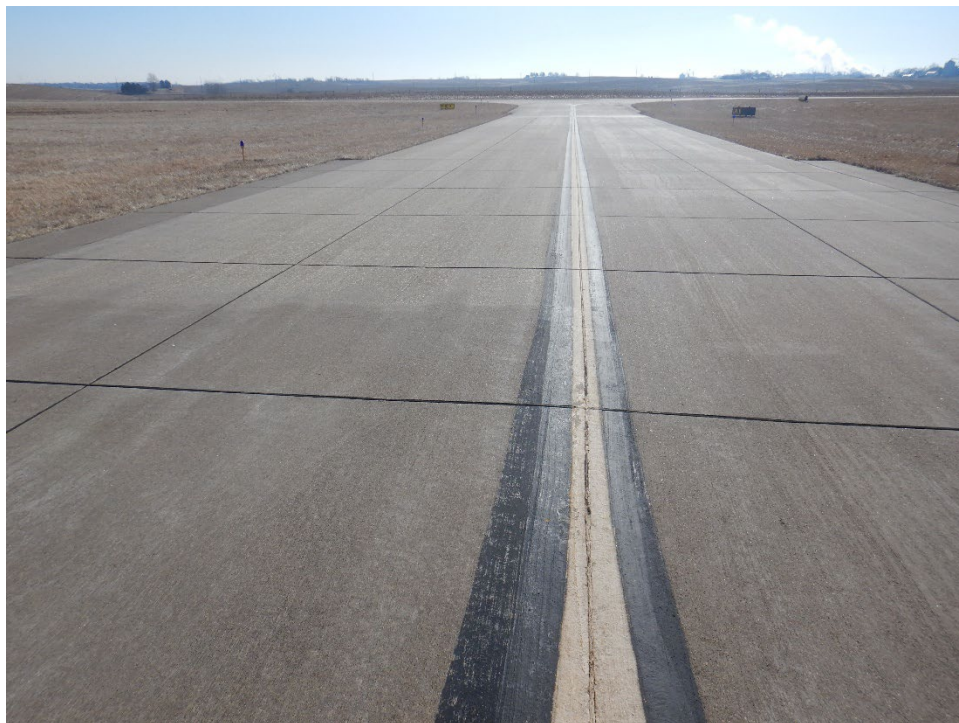
TA1CN-02. LTD Cracking (Sample Unit No. 05).

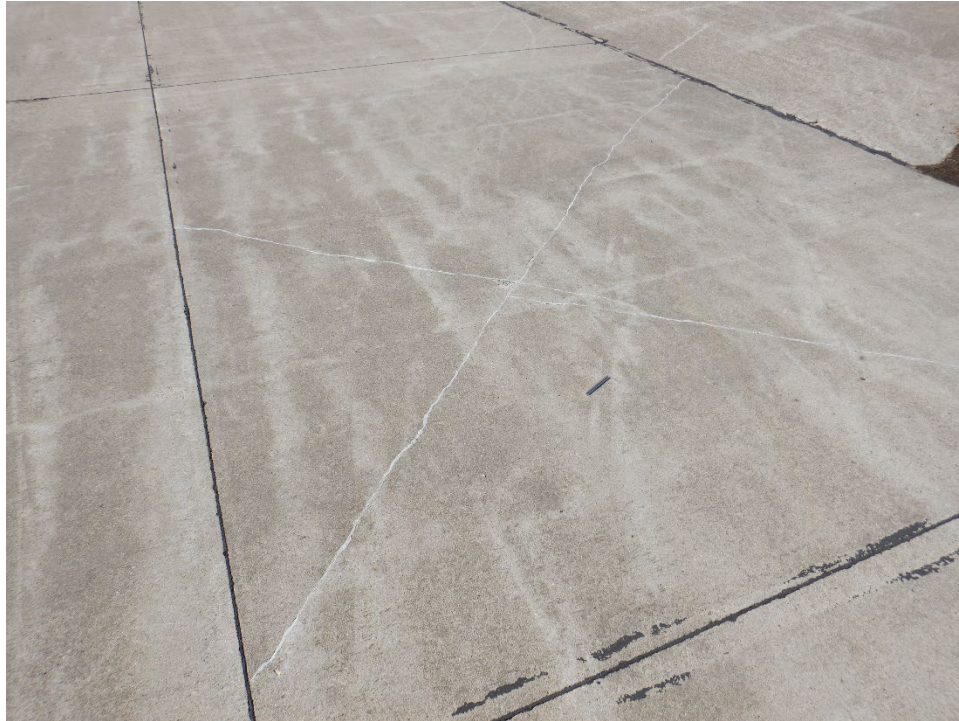
TH01CN-02. Shattered Slab (Sample Unit No. 01) (1).

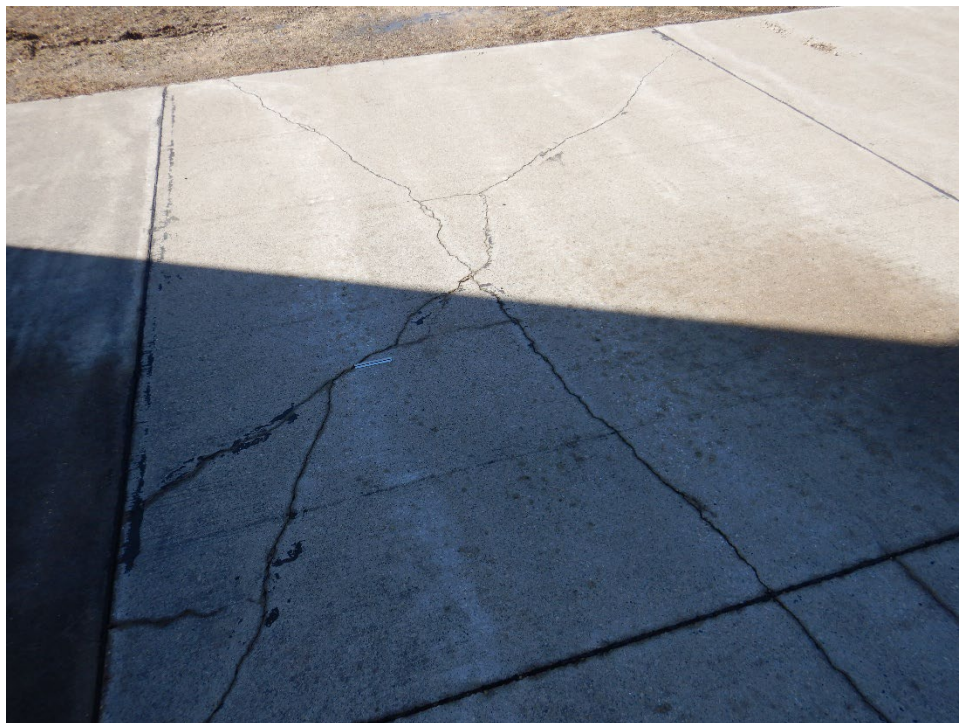
TH01CN-02. Shattered Slab (Sample Unit No. 01) (2).

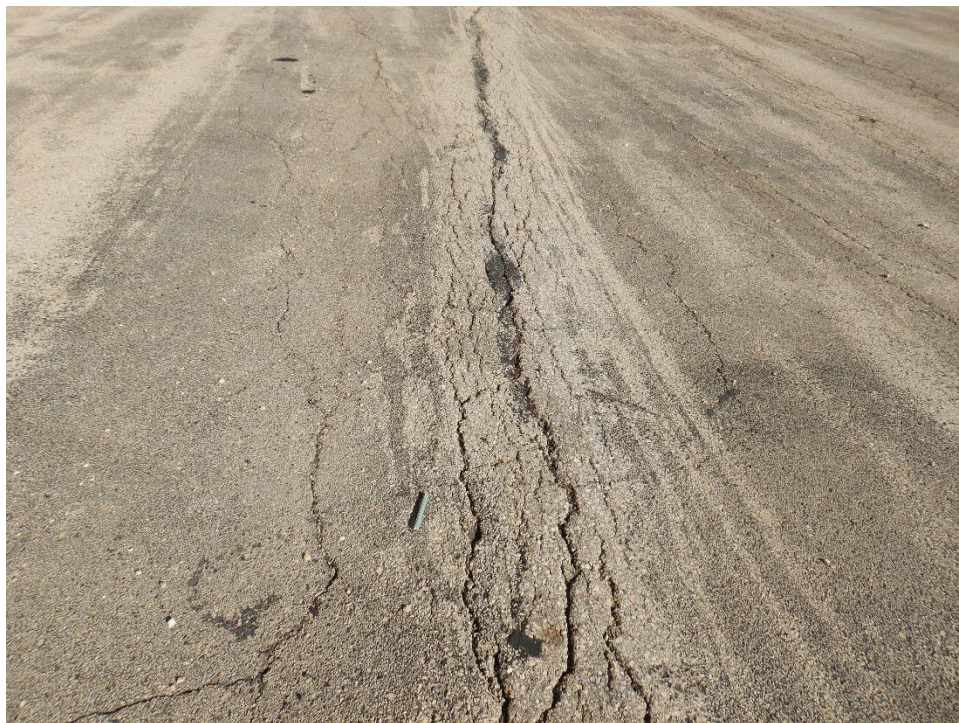
TH01CN-03. Swelling (Sample Unit No. 03).
