# Davenport Municipal Airport

## Pavement Management Report

**AUGUST 2026**

# DAVENPORT MUNICIPAL AIRPORT PAVEMENT MANAGEMENT REPORT

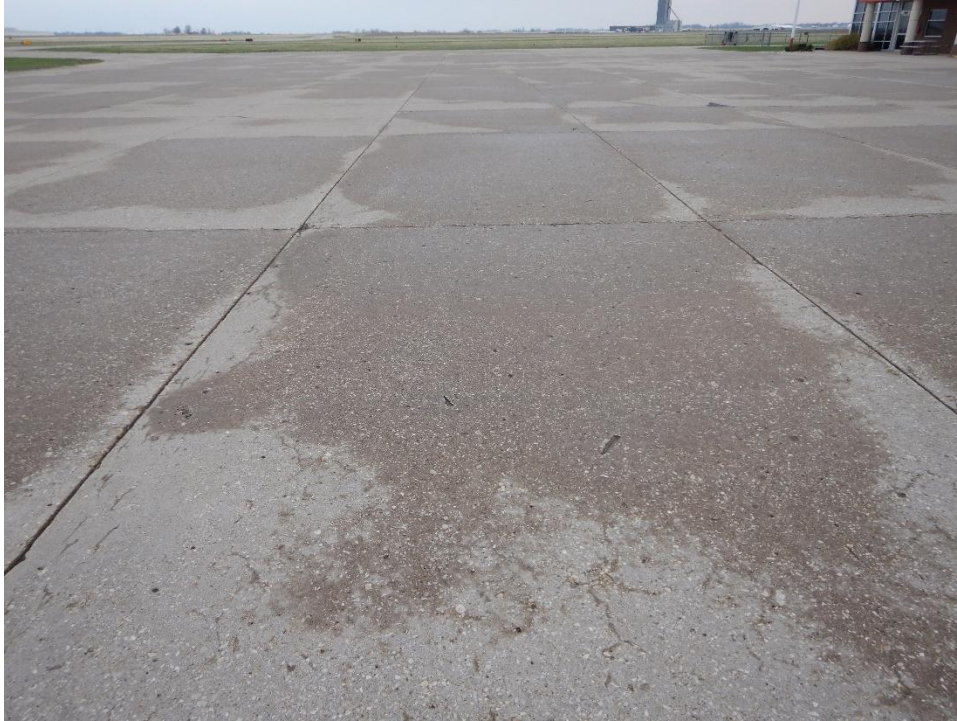
A01DA-01. Overview.

| Branch | Section | Surface Type | Section Area (sf) | LCD | 2026 PCI | % Distress Due to Load | % Distress Due to Climate/Durability | % Distress Due to Other | Type of Distress |
|---|---|---|---|---|---|---|---|---|---|
| A01DA | 01 | PCC | 45,000 | 6/2/1949 | 35 | 37 | 11 | 52 | ASR, Corner Break, Corner Spalling, Joint Spalling, Joint Seal Damage, LTD Cracking, Popouts, Pumping, Shrinkage Cracking, Small Patch |

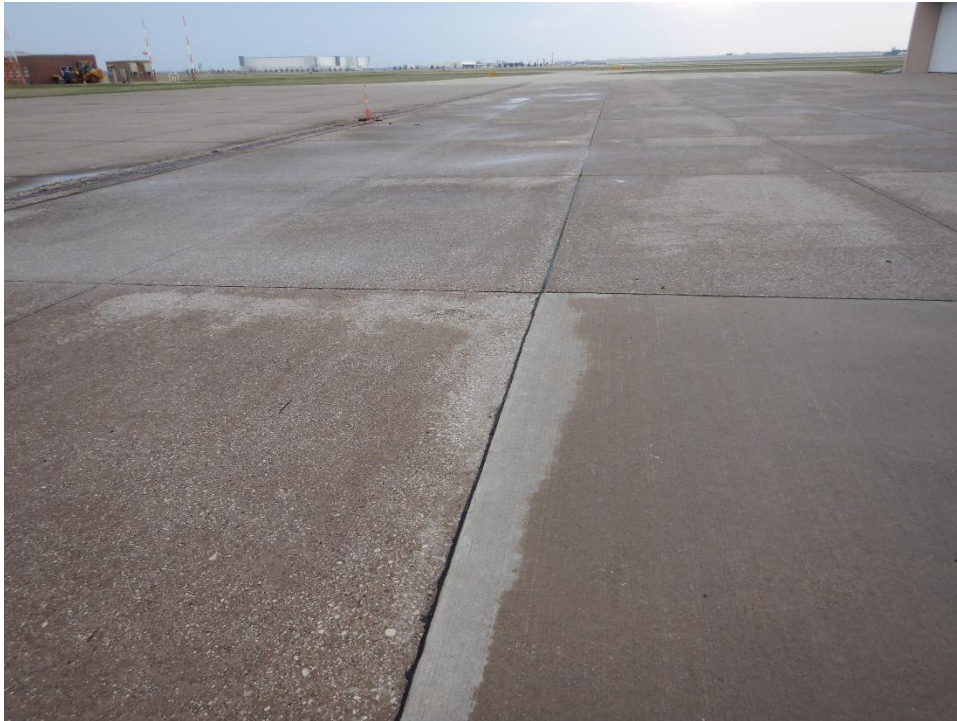
A02DA-01. Overview.

| Branch | Section | Surface Type | Section Area (sf) | LCD | 2026 PCI | % Distress Due to Load | % Distress Due to Climate/Durability | % Distress Due to Other | Type of Distress |
|---|---|---|---|---|---|---|---|---|---|
| A02DA | 01 | PCC | 61,421 | 6/1/2001 | 53 | 47 | 8 | 45 | ASR, Corner Break, Corner Spalling, Faulting, Joint Spalling, Joint Seal Damage, LTD Cracking, Scaling, Shattered Slab, Shrinkage Cracking, Small Patch |

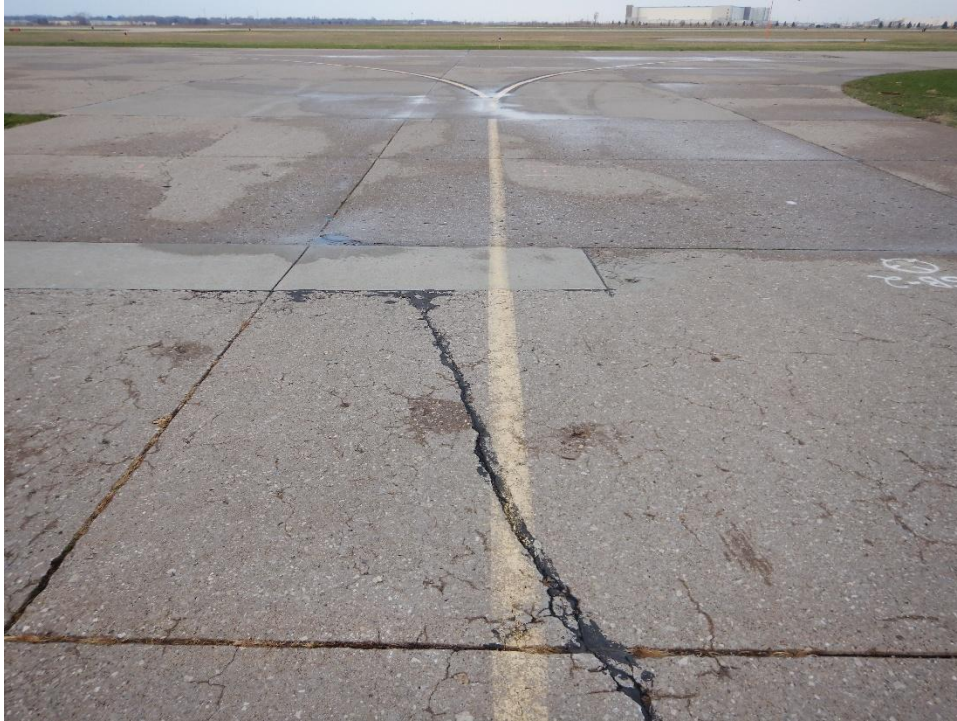
T04DA-01. Overview.

| Branch | Section | Surface Type | Section Area (sf) | LCD | 2026 PCI | % Distress Due to Load | % Distress Due to Climate/Durability | % Distress Due to Other | Type of Distress |
|---|---|---|---|---|---|---|---|---|---|
| T04DA | 01 | PCC | 7,628 | 6/1/1948 | 10 | 38 | 7 | 55 | ASR, Joint Seal Damage, Large Patch, LTD Cracking, Popouts, Shattered Slab, Small Patch |

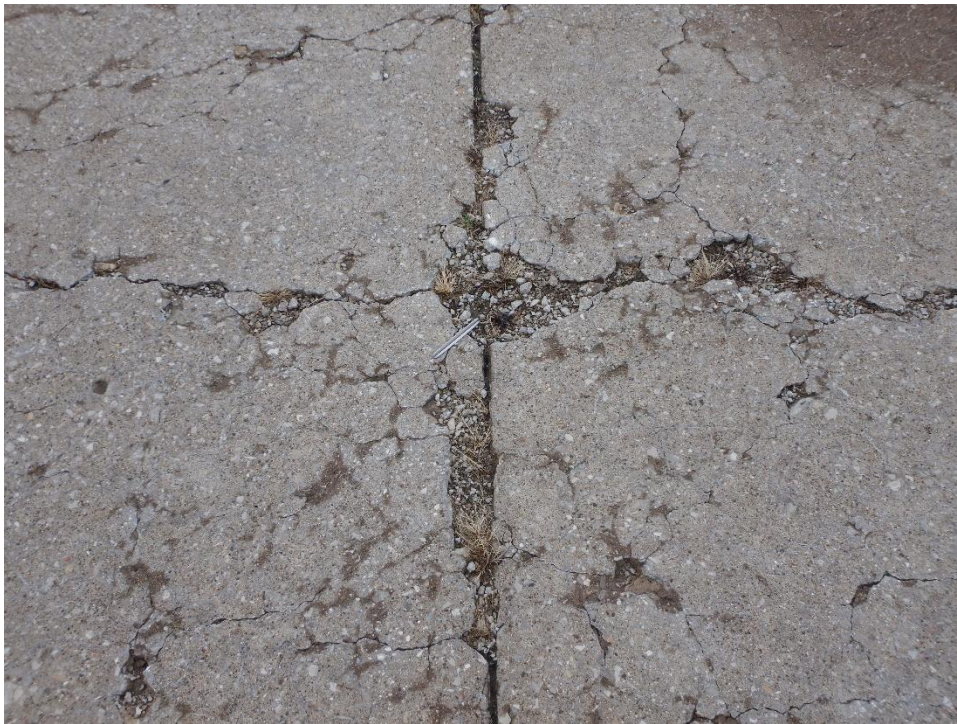
T04DA-01. ASR (Sample Unit No. 01).

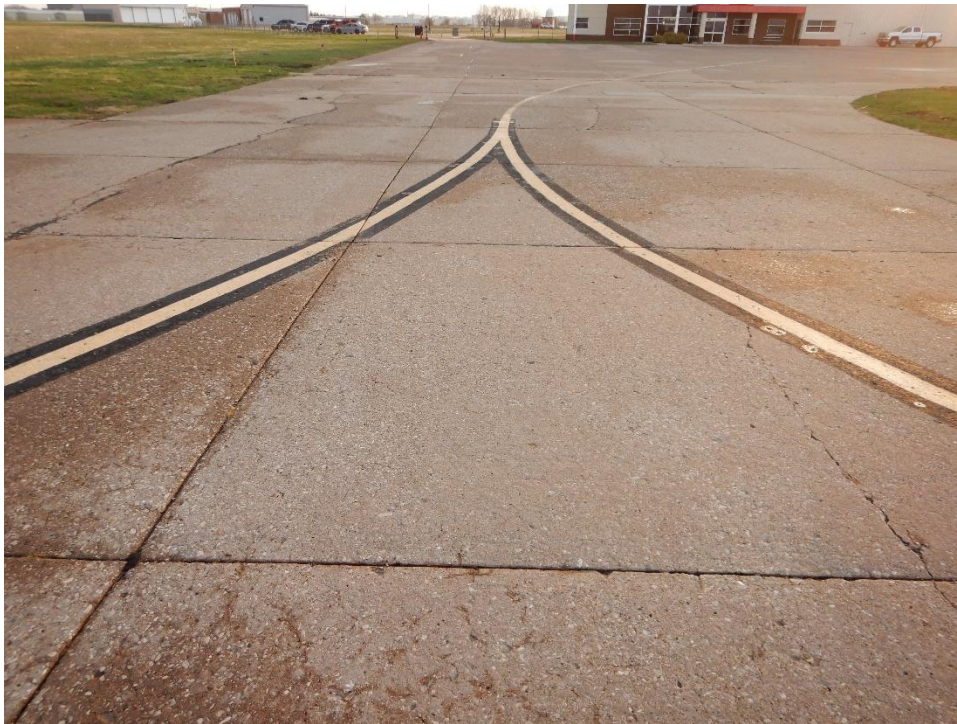
T05DA-01. Overview.

| Branch | Section | Surface Type | Section Area (sf) | LCD | 2026 PCI | % Distress Due to Load | % Distress Due to Climate/Durability | % Distress Due to Other | Type of Distress |
|---|---|---|---|---|---|---|---|---|---|
| T05DA | 01 | PCC | 7,628 | 6/1/1948 | 15 | 42 | 7 | 51 | ASR, Corner Break, Faulting, Joint Spalling, Joint Seal Damage, Large Patch, LTD Cracking, Popouts, Shattered Slab, Small Patch |

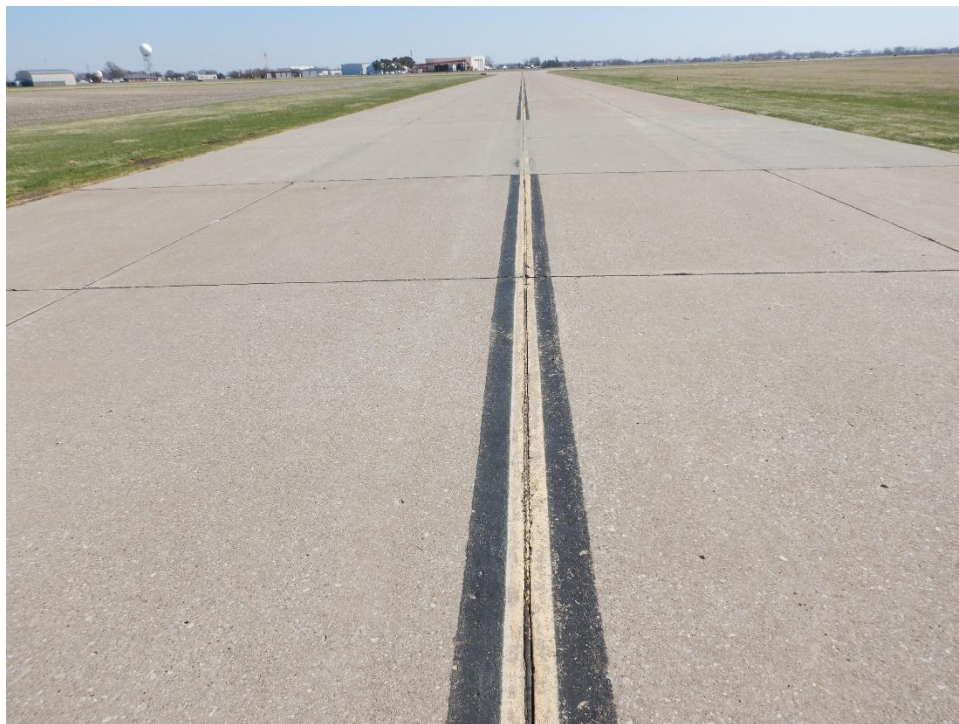
TADA-01. Overview.

| Branch | Section | Surface Type | Section Area (sf) | LCD | 2026 PCI | % Distress Due to Load | % Distress Due to Climate/ Durability | % Distress Due to Other | Type of Distress |
|---|---|---|---|---|---|---|---|---|---|
| TADA | 01 | PCC | 55,043 | 6/2/1949 | 75 | 6 | 17 | 77 | ASR, Corner Spalling, Faulting, Joint Spalling, Joint Seal Damage, LTD Cracking, Scaling, Shrinkage Cracking |

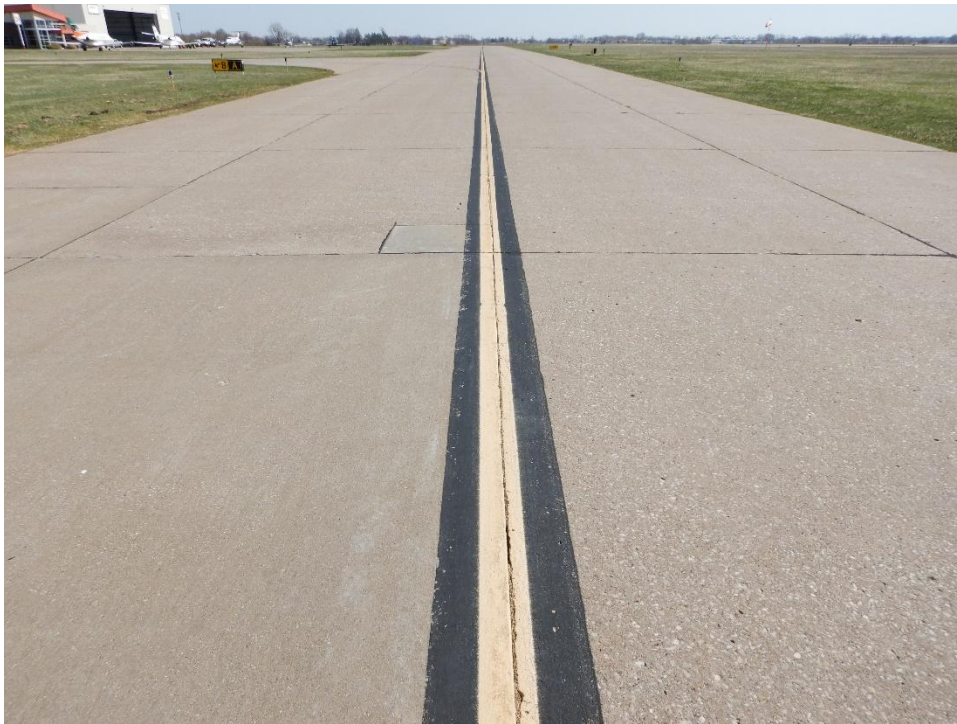
TADA-02. Overview.

| Branch | Section | Surface Type | Section Area (sf) | LCD | 2026 PCI | % Distress Due to Load | % Distress Due to Climate/ Durability | % Distress Due to Other | Type of Distress |
|---|---|---|---|---|---|---|---|---|---|
| TADA | 02 | PCC | 78,251 | 6/1/1949 | 49 | 7 | 19 | 74 | ASR, Corner Break, Corner Spalling, Joint Spalling, Joint Seal Damage, Large Patch, LTD Cracking, Popouts, Scaling, Shrinkage Cracking, Small Patch |

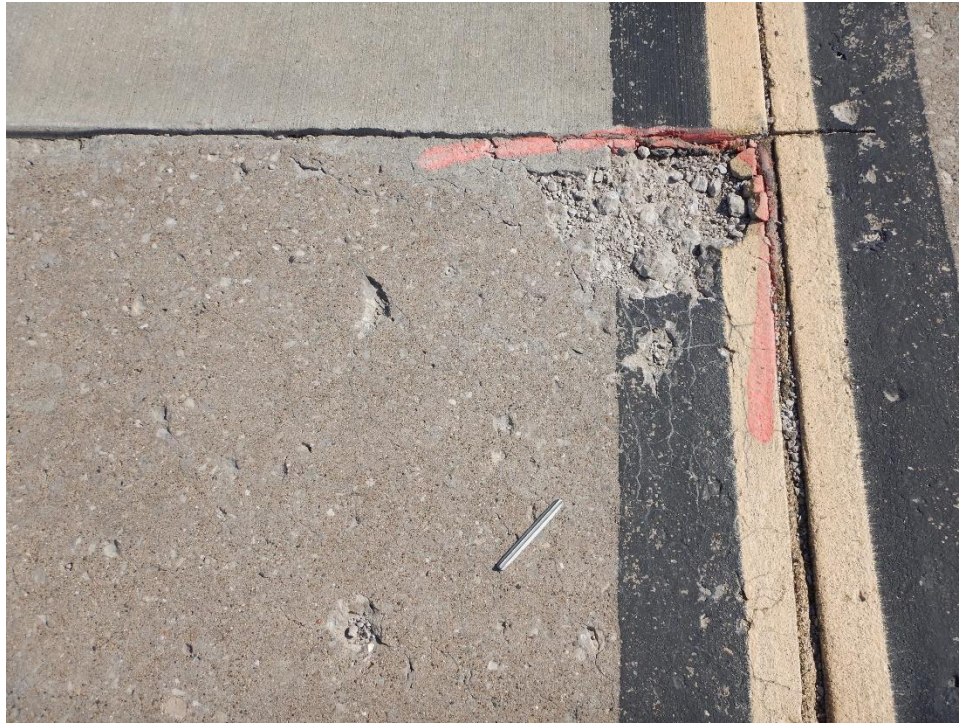
TADA-02. ASR (Sample Unit No. 08) (1).

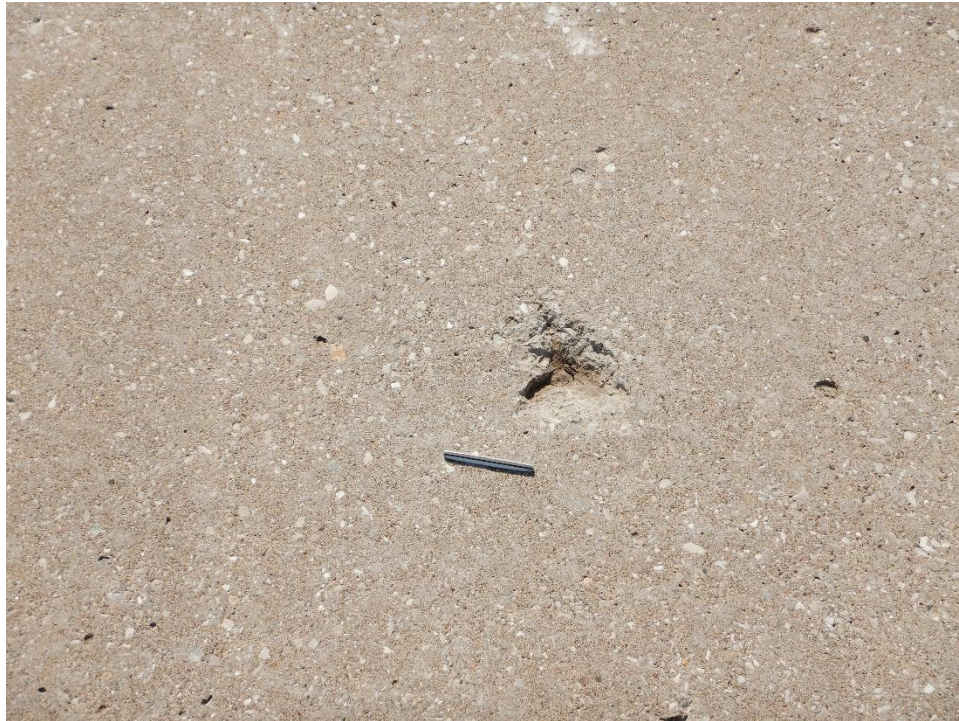
TADA-02. Scaling (Sample Unit No. 04).

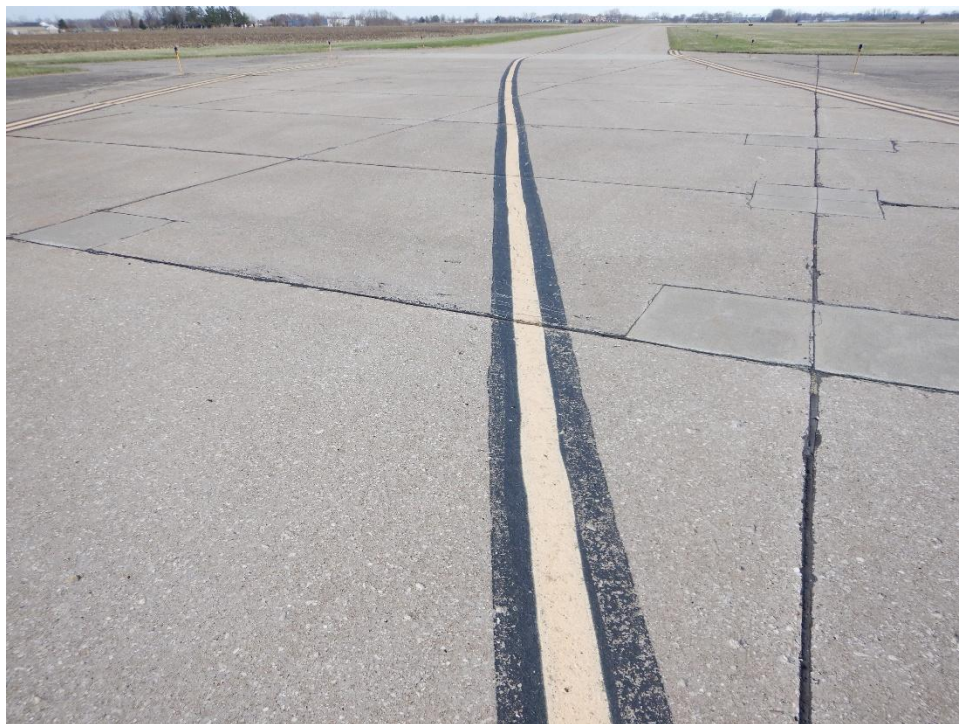
TADA-03. Overview.

| Branch | Section | Surface Type | Section Area (sf) | LCD | 2026 PCI | % Distress Due to Load | % Distress Due to Climate/ Durability | % Distress Due to Other | Type of Distress |
|---|---|---|---|---|---|---|---|---|---|
| TADA | 03 | PCC | 22,277 | 6/2/1949 | 18 | 29 | 10 | 61 | ASR, Corner Break, Corner Spalling, Joint Spalling, Joint Seal Damage, Large Patch, LTD Cracking, Scaling, Small Patch |

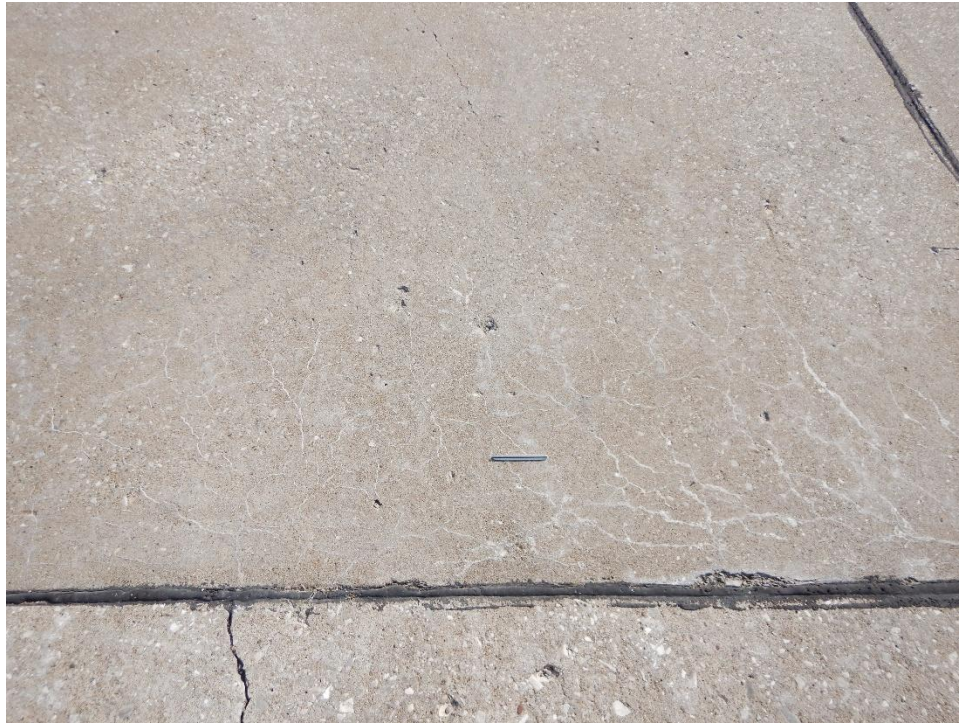
TADA-03. ASR (Sample Unit No. 01).

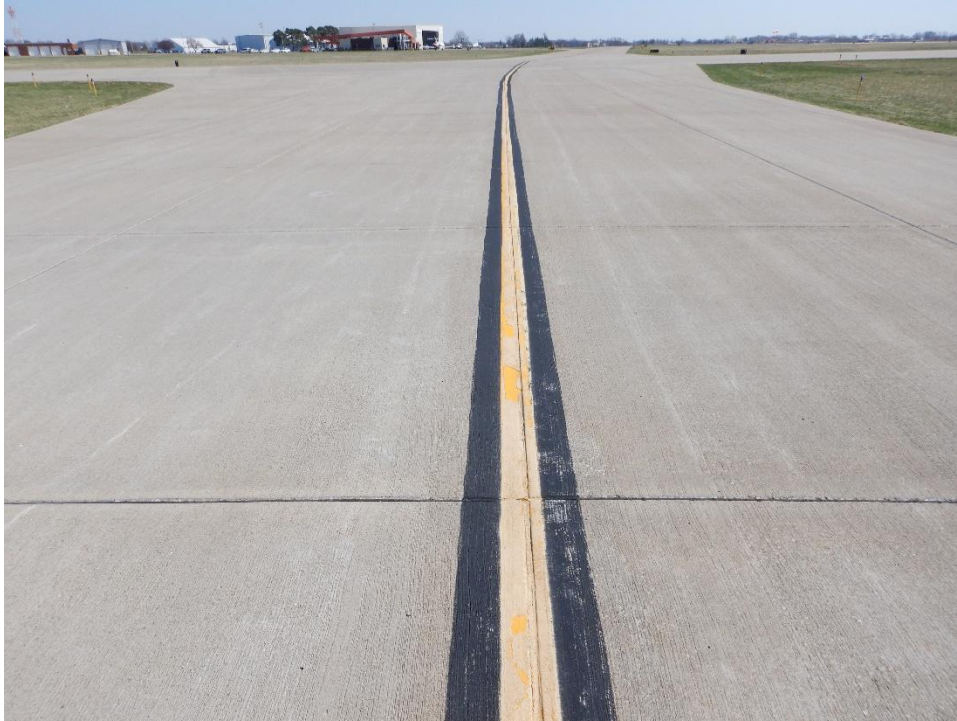
TADA-05. Overview.

| Branch | Section | Surface Type | Section Area (sf) | LCD | 2026 PCI | % Distress Due to Load | % Distress Due to Climate/ Durability | % Distress Due to Other | Type of Distress |
|---|---|---|---|---|---|---|---|---|---|
| TADA | 05 | PCC | 23,533 | 6/3/2015 | 92 | 43 | 57 | 0 | Corner Break, Joint Seal Damage, LTD Cracking |

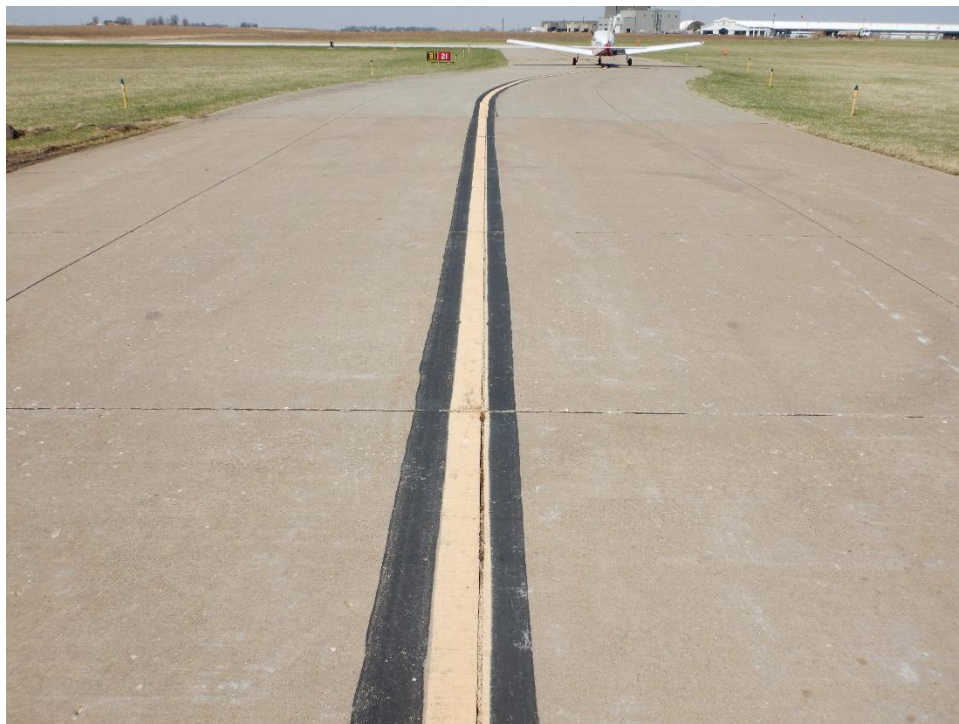
TB1DA-01. Overview.

| Branch | Section | Surface Type | Section Area (sf) | LCD | 2026 PCI | % Distress Due to Load | % Distress Due to Climate/ Durability | % Distress Due to Other | Type of Distress |
|---|---|---|---|---|---|---|---|---|---|
| TB1DA | 01 | PCC | 3,040 | 6/1/1979 | 33 | 23 | 11 | 66 | ASR, Corner Break, Faulting, Joint Seal Damage, Large Patch, LTD Cracking, Popouts, Shattered Slab |

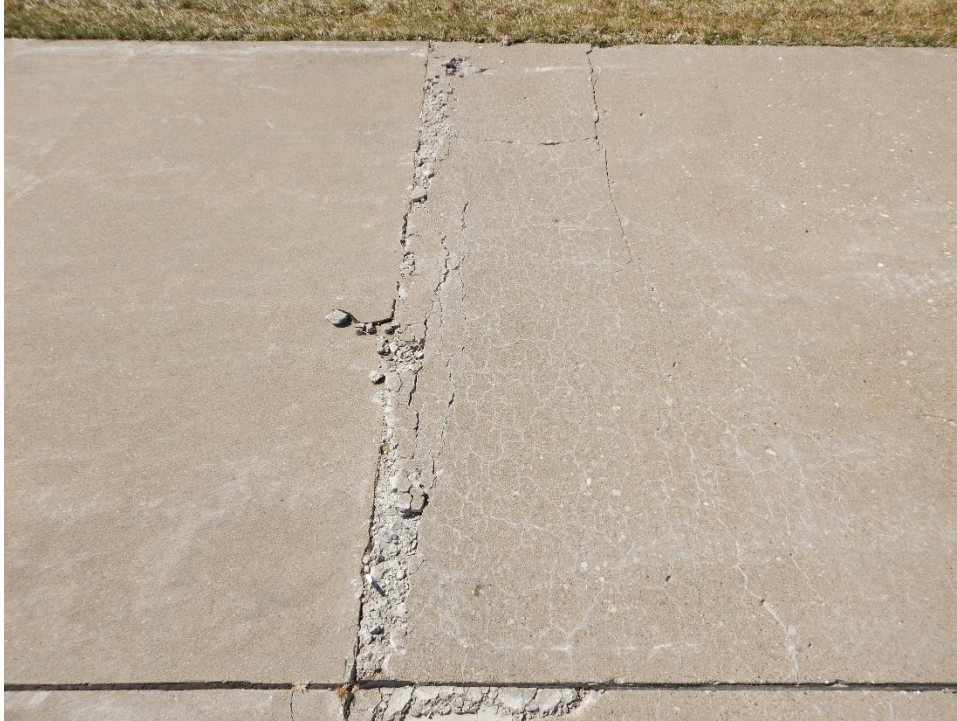
TB1DA-01. ASR (Sample Unit No. 01).

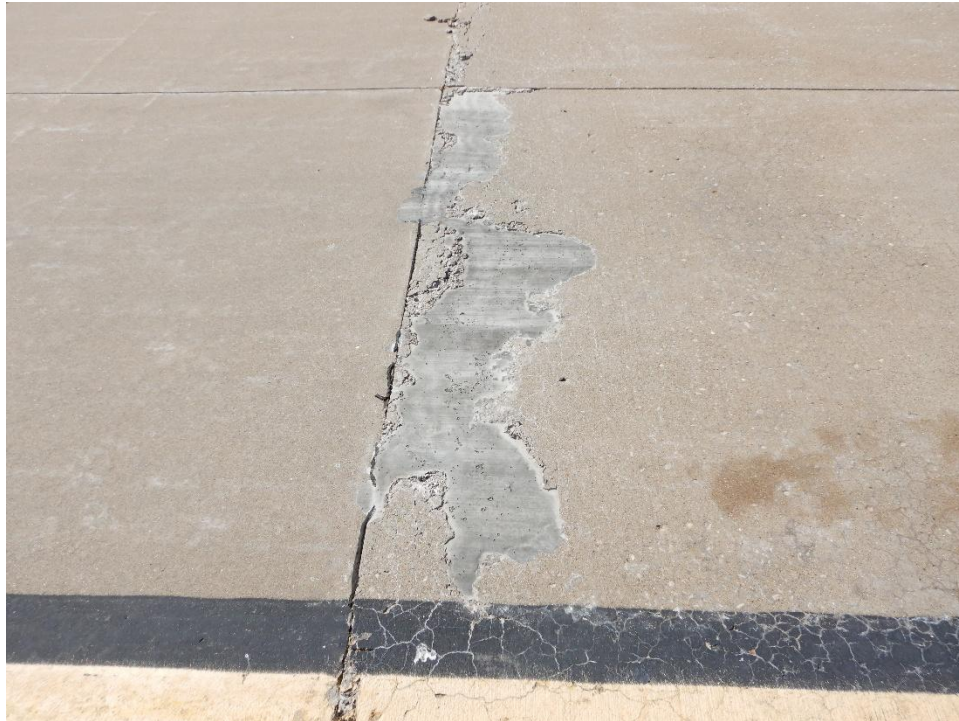
TB1DA-01. Large Patching (Sample Unit No. 01).

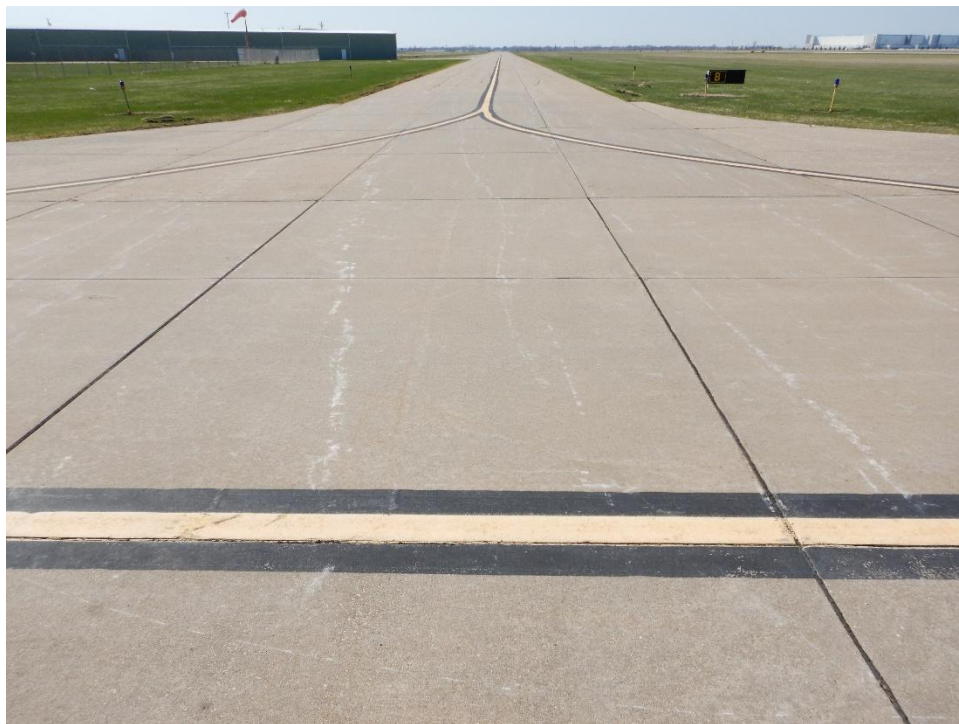
TB1DA-02. Overview.

| Branch | Section | Surface Type | Section Area (sf) | LCD | 2026 PCI | % Distress Due to Load | % Distress Due to Climate/ Durability | % Distress Due to Other | Type of Distress |
|---|---|---|---|---|---|---|---|---|---|
| TB1DA | 02 | PCC | 10,494 | 1/1/2005 | 66 | 20 | 29 | 51 | ASR, Corner Break, Corner Spalling, Joint Spalling, Joint Seal Damage, Large Patch, LTD Cracking, Popouts |

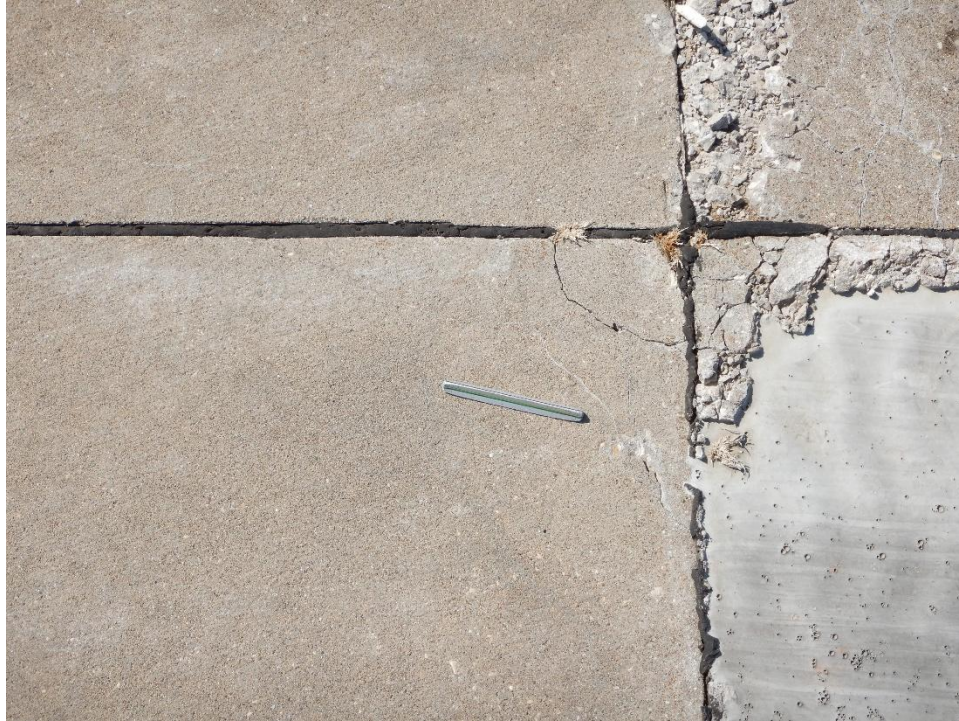
TB1DA-02. ASR (Sample Unit No. 01).

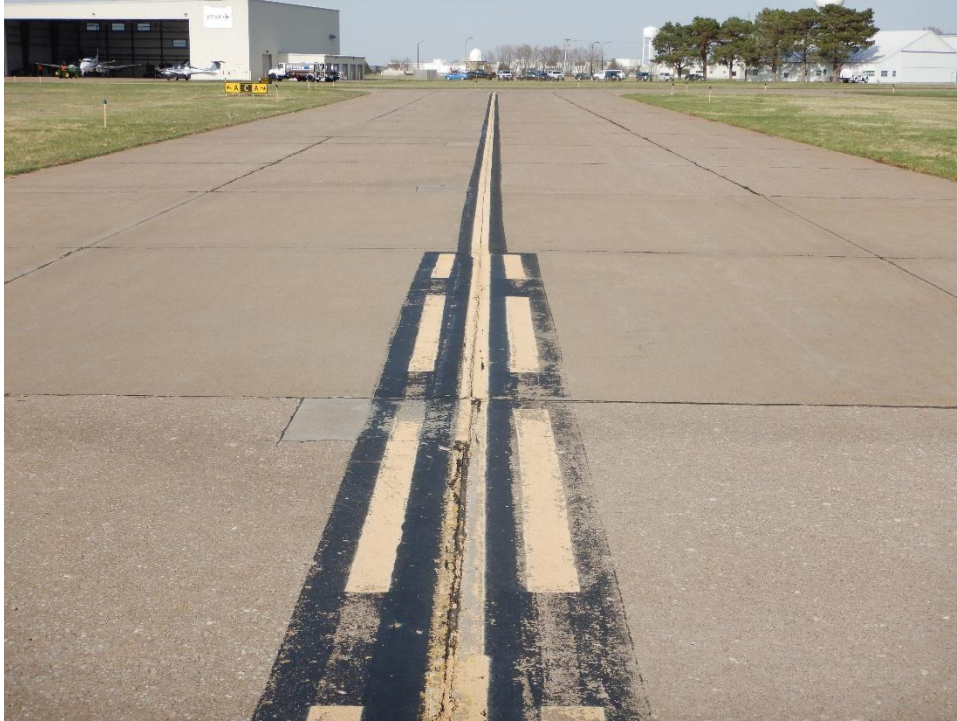
TCDA-02. ASR (Sample Unit No. 02).

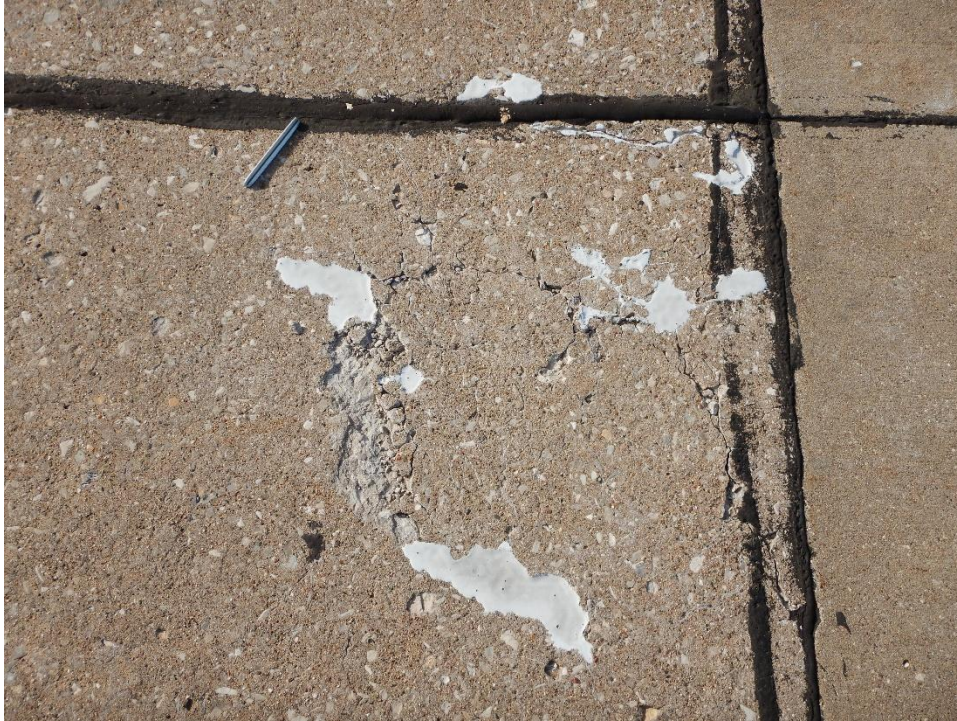
TCDA-02. Large Patching (Sample Unit No. 04).

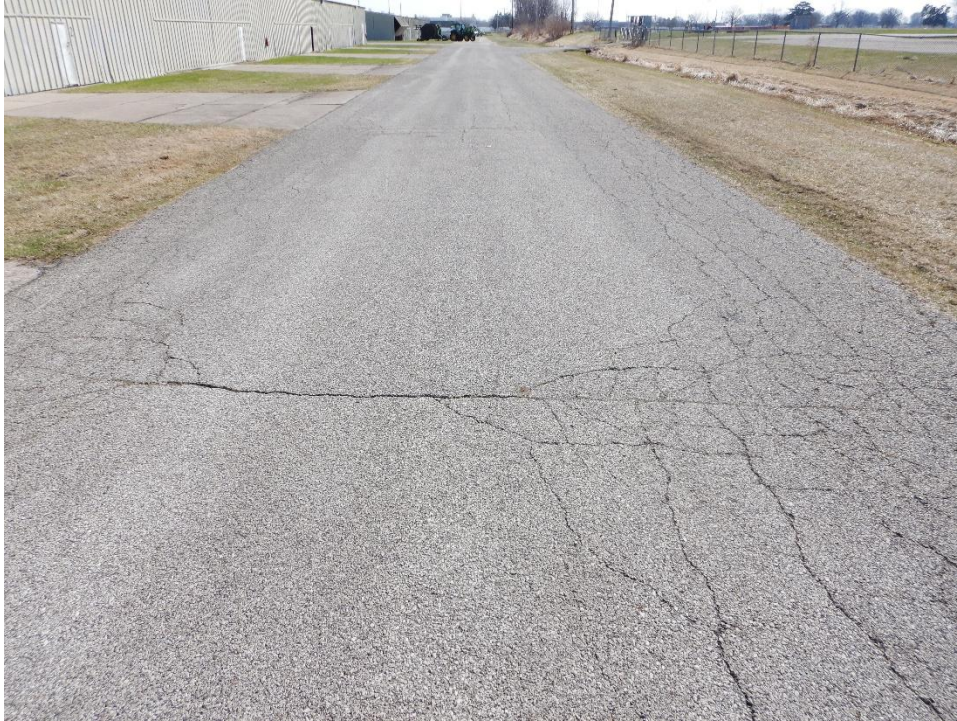
TH01DA-01. Alligator Cracking (Sample Unit No. 02).

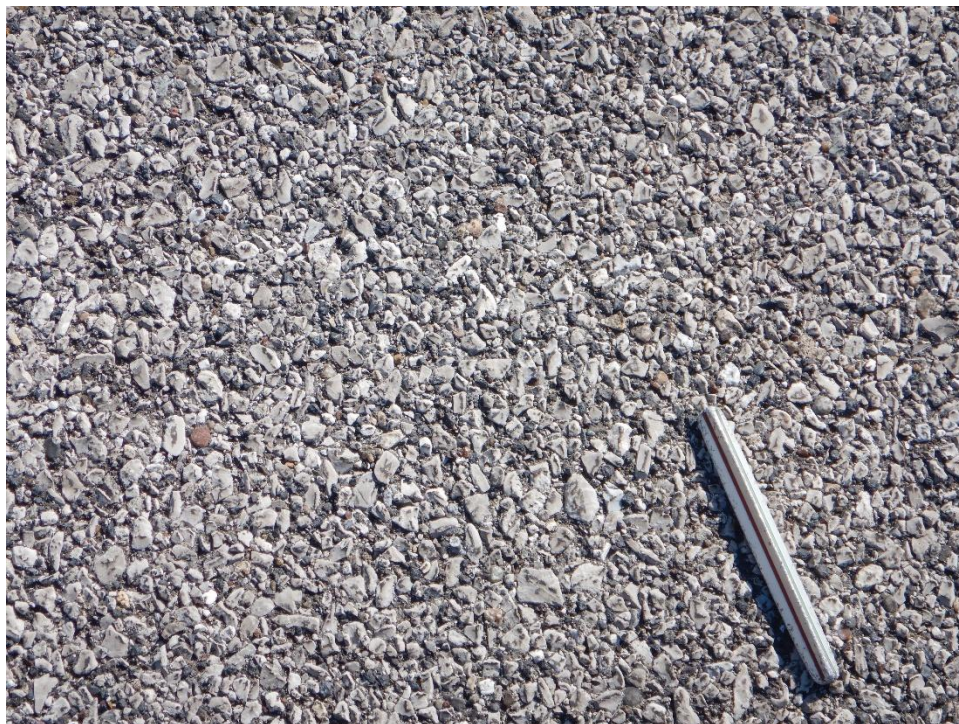
TH01DA-02. Overview.

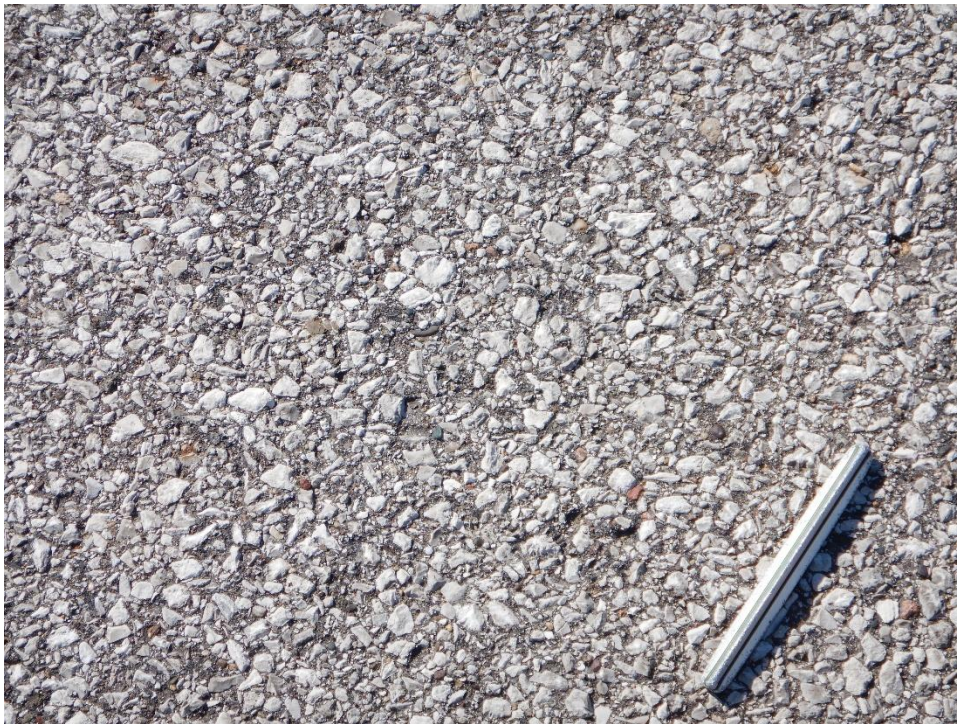
TH01DA-03. Overview.
