# Denison Municipal Airport

## Pavement Management Report

**AUGUST 2025**

# DENISON MUNICIPAL AIRPORT PAVEMENT MANAGEMENT REPORT

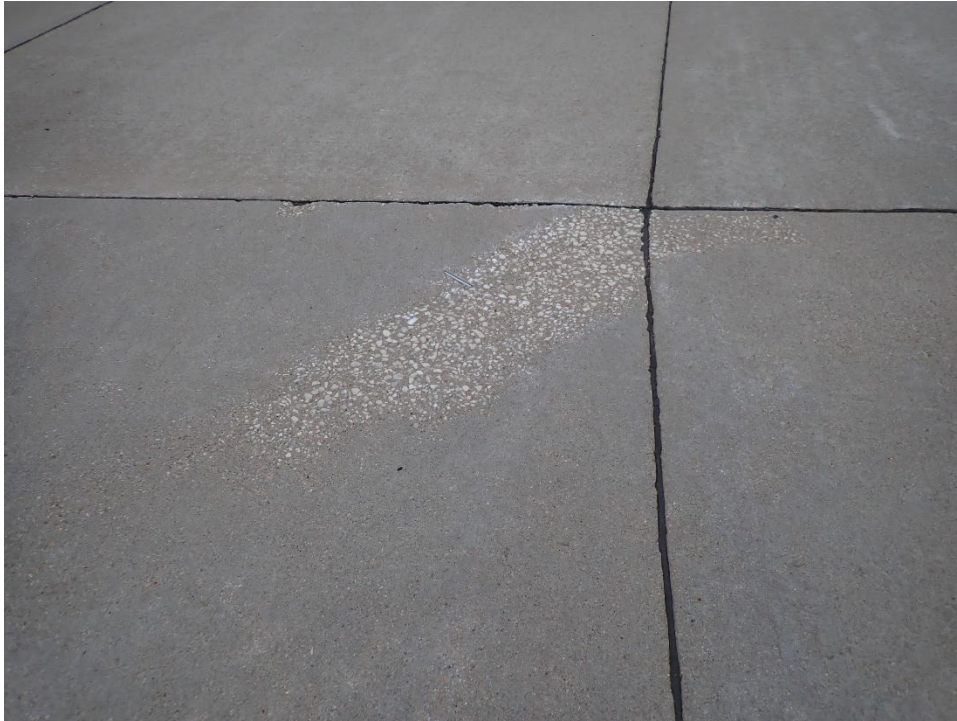
TH01DN-03. Scaling (Sample Unit No. 01).
