Marshalltown Municipal Airport

#### AUGUST 2025

# MARSHALLTOWN MUNICIPAL AIRPORT PAVEMENT MANAGEMENT REPORT

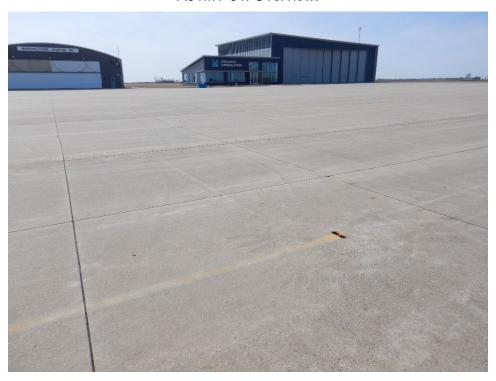
A01MT-01. Overview.

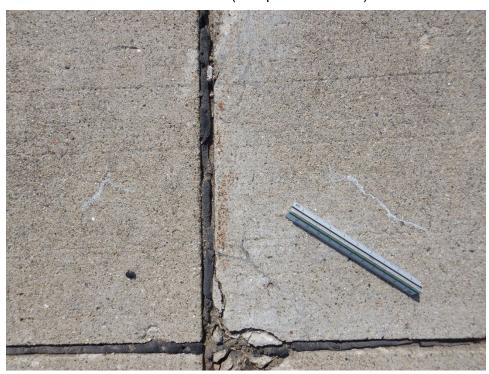
A01MT-01. ASR (Sample Unit No. 04).

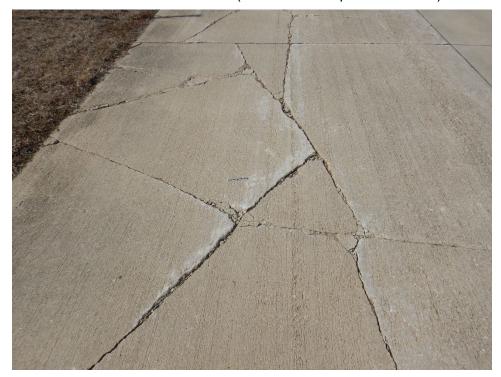
A01MT-01. Shattered Slab (Additional Sample Unit No. 23).

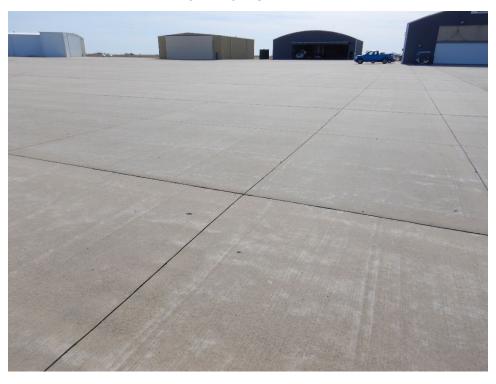
A02MT-01. Overview.

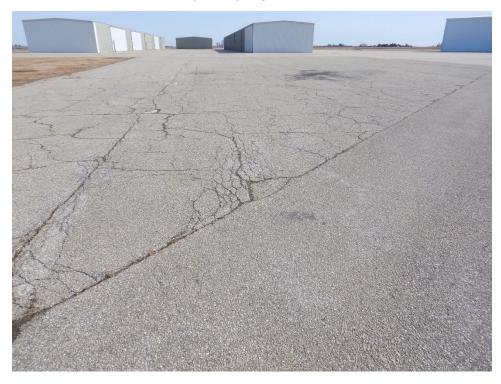
A02MT-02. Overview.

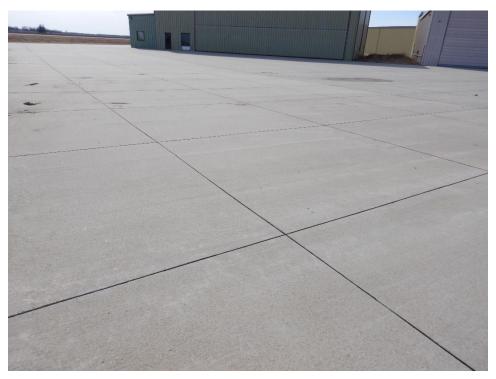
A03MT-01. Overview.

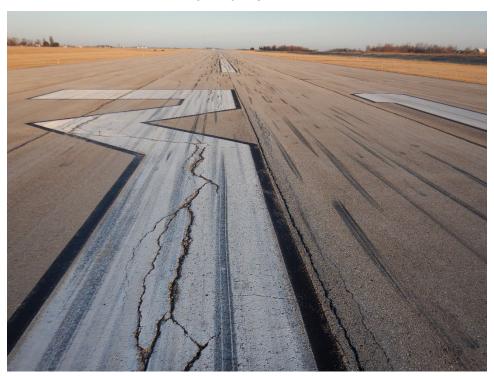
R13MT-02. Overview.

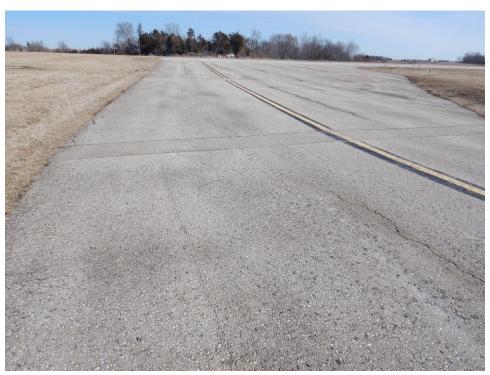
R13MT-03. Overview.

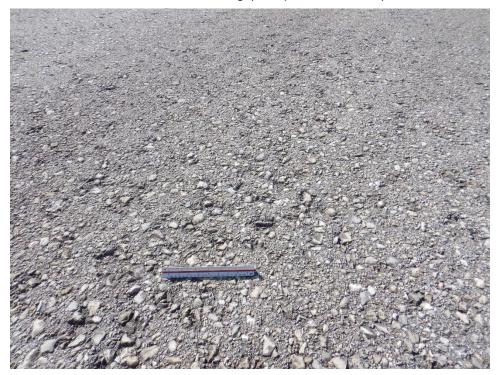
R13MT-03. Raveling (Sample Unit No. 01).

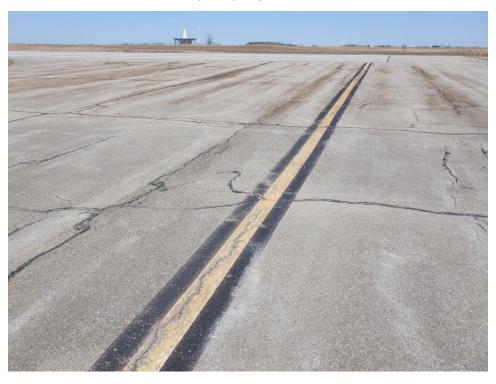
R13MT-04. Overview.

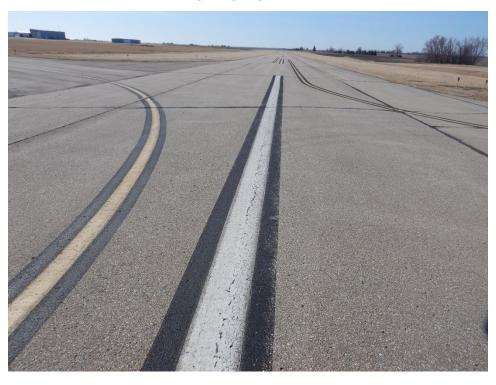
R18MT-01. Overview.

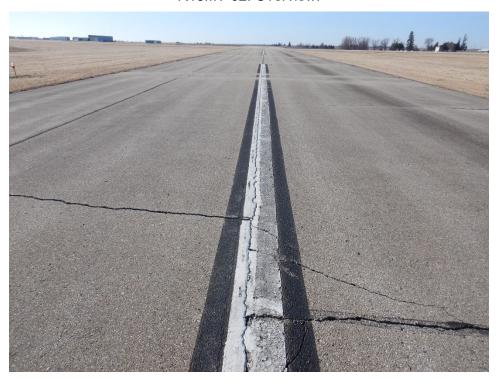
R18MT-02. Overview.

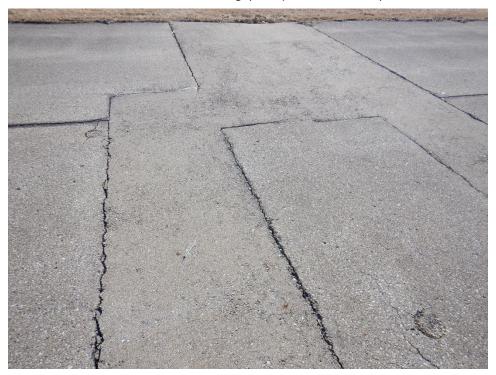
R18MT-02. Patching (Sample Unit No. 03).

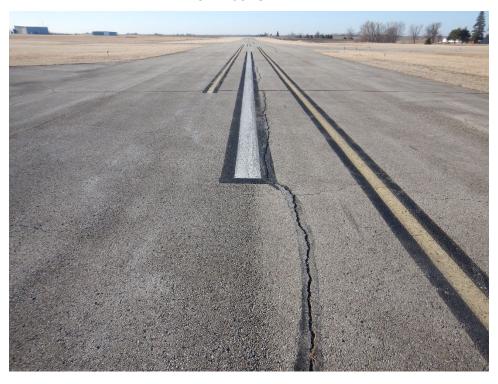
R18MT-03. Overview.

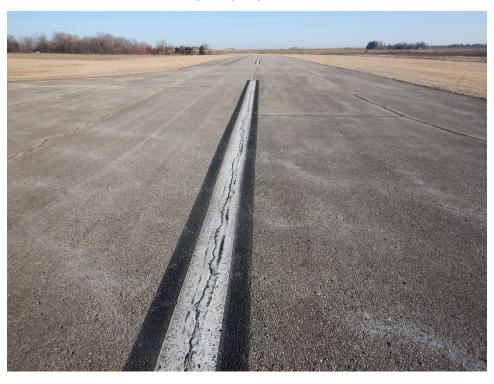
R18MT-04. Overview.

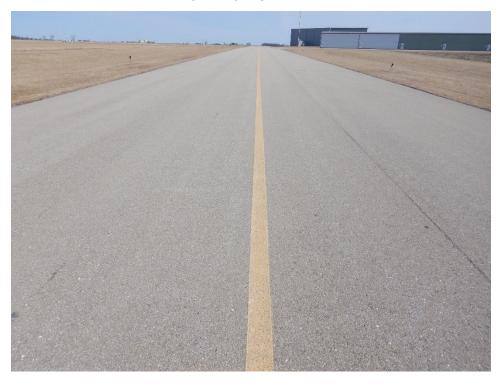
T01MT-01. Overview.

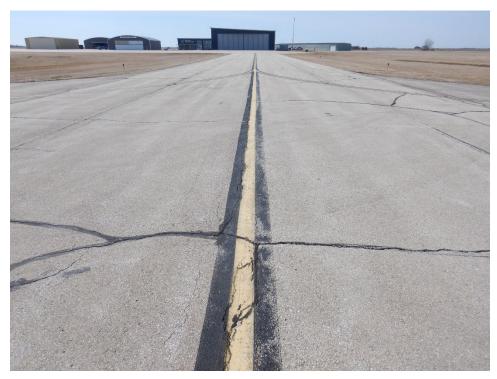
T02MT-01. Overview.

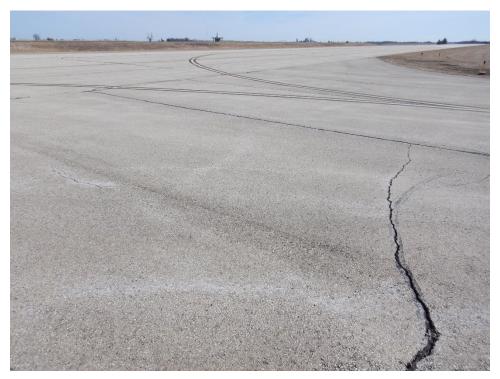
T02MT-02. Overview.

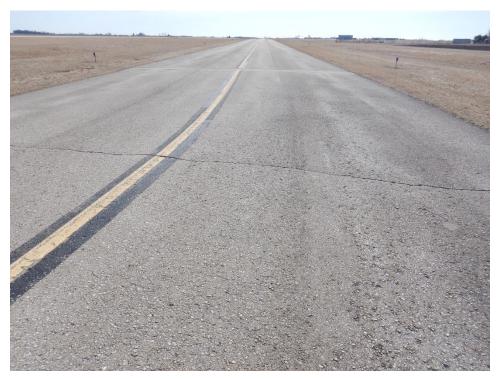
T03MT-01. Overview.

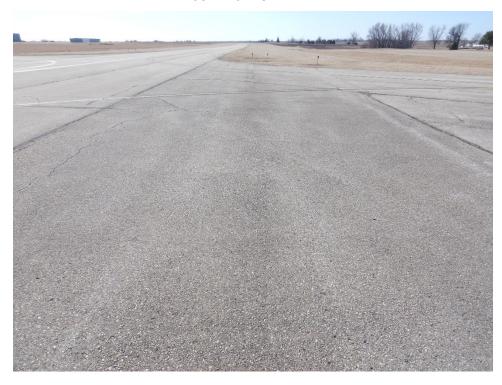
T03MT-02. Overview.

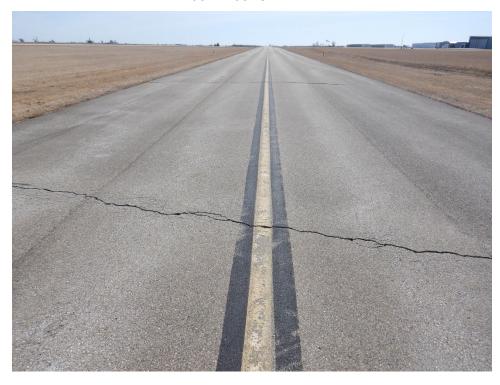
T03MT-03. Overview.

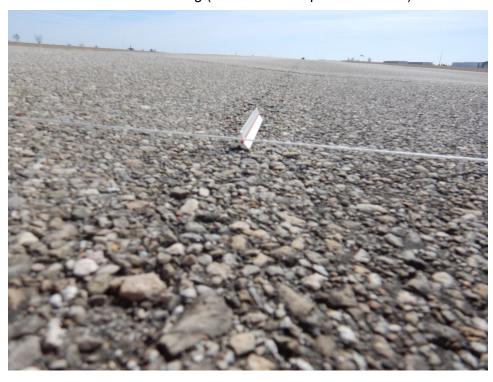
T03MT-03. Rutting (Additional Sample Unit No. 05).

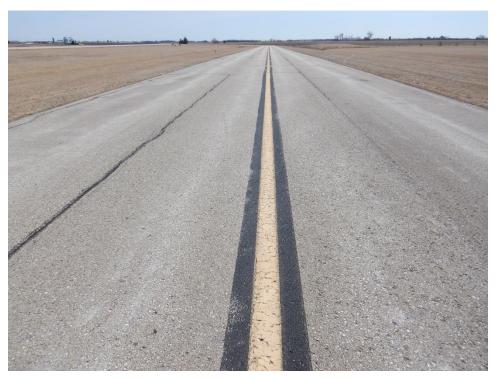
T04MT-01. Overview.

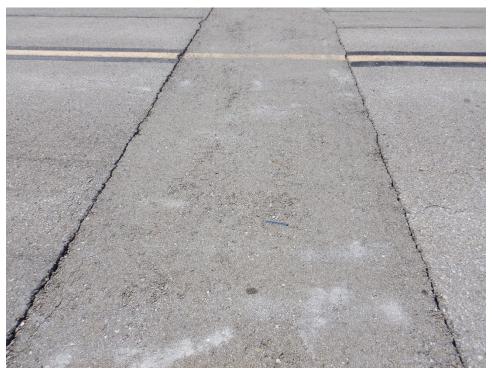
T04MT-01. Patching (Sample Unit No. 03).

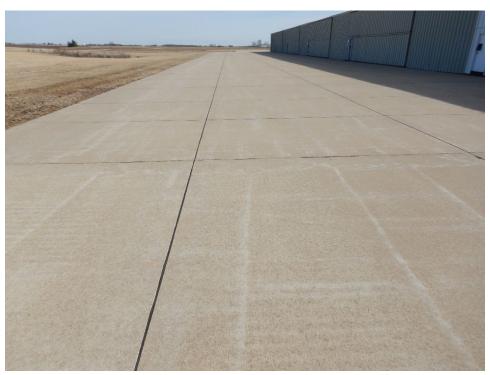
TH01MT-01. Overview.

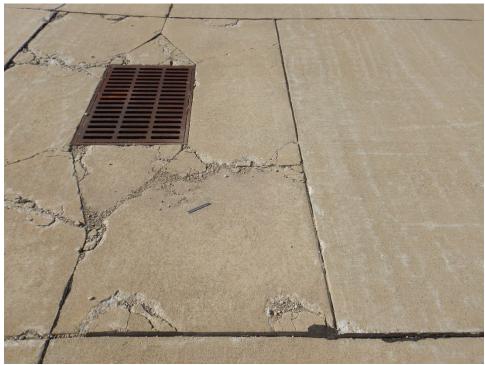
TH01MT-01. Large Patching (Additional Sample Unit No. 07).

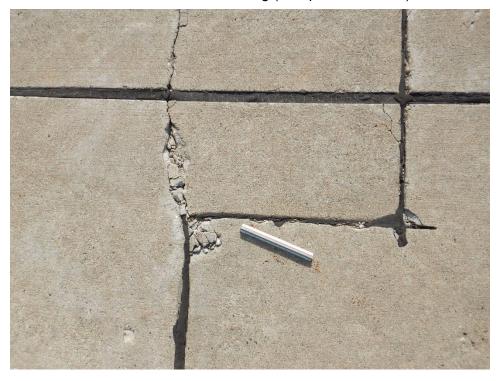
TH01MT-01. Small Patching (Sample Unit No. 11).

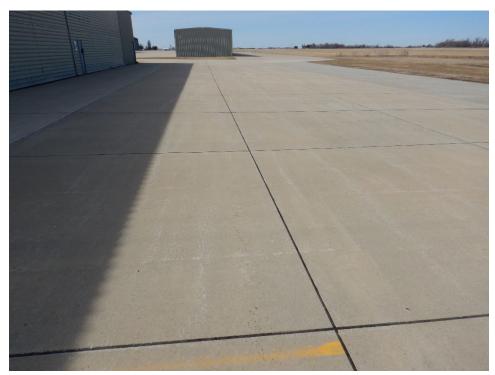
TH01MT-02. Overview.

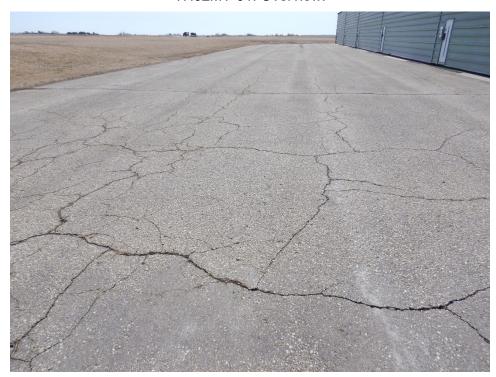
TH02MT-01. Overview.
